Deepwater Horizon Accident Investigation Report

September 8, 2010

This is the report of an internal BP incident investigation team. The report does not represent the views of any individual or entity other than the investigation team. The investigation team has produced the report exclusively for and at the request of BP in accordance with its Terms of Reference, and any decision to release the report publicly is the responsibility of BP. It has not been prepared in response to any third party investigation, inquiry or litigation.

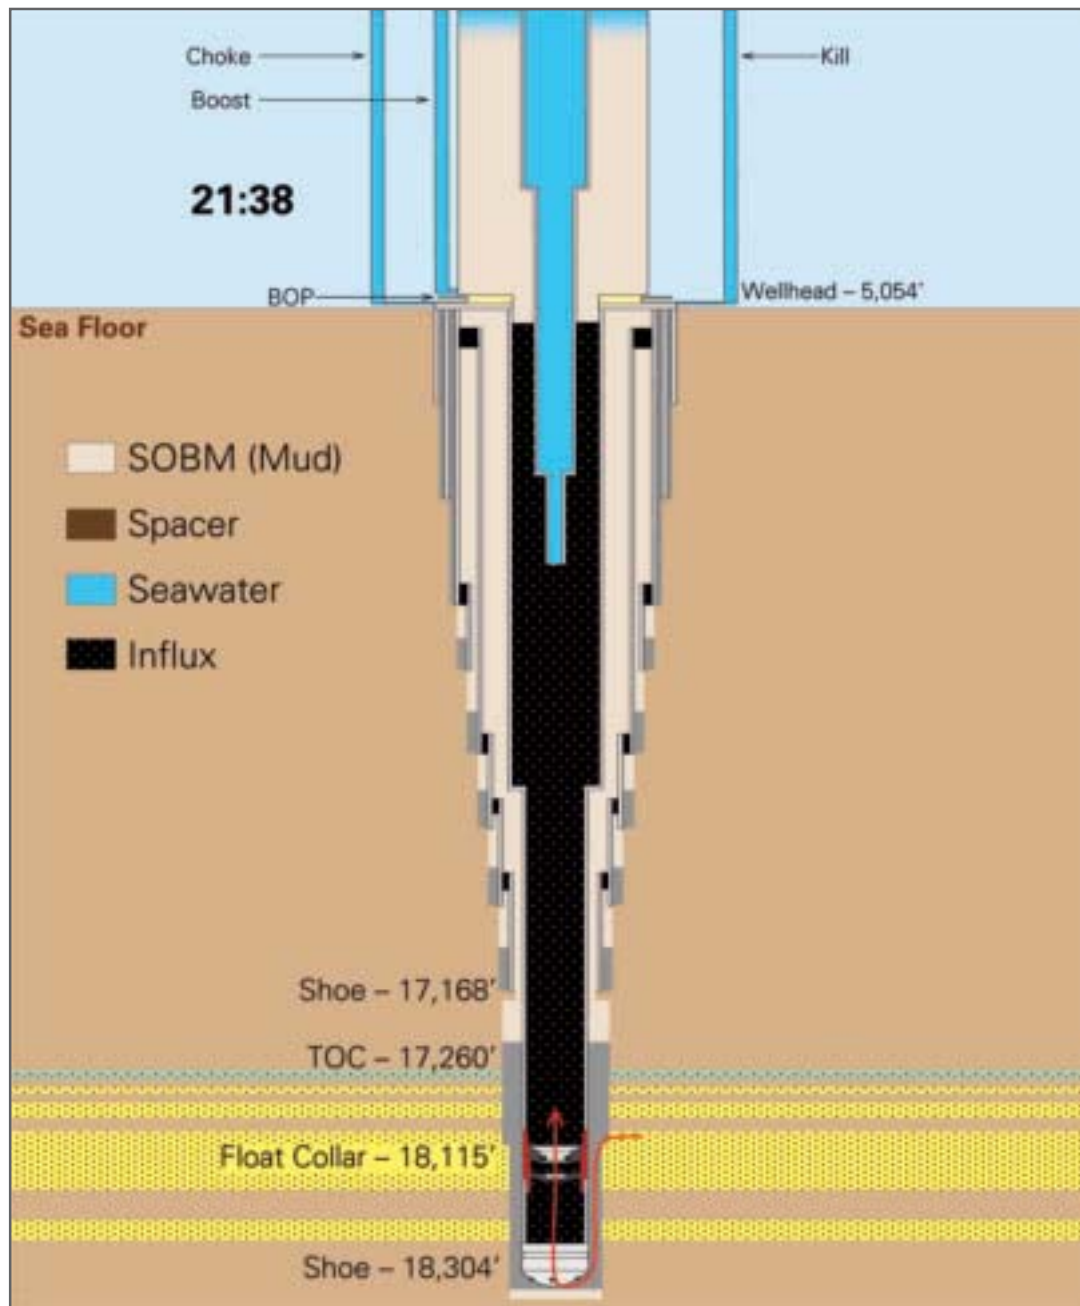
Figure 4. Hydrocarbons Entering the Riser.

- 4 Influx was not recognized until hydrocarbons were in the riser.** With the negative-pressure test having been accepted, the well was returned to an overbalanced condition, preventing further influx into the wellbore. Later, as part of normal operations to temporarily abandon the well, heavy drilling mud was again replaced with seawater, underbalancing the well. Over time, this allowed hydrocarbons to flow up through the production casing and passed the BOP. Indications of influx with an increase in drill pipe pressure are discernable in real-time data from approximately 40 minutes before the rig crew took action to control the well. The rig crew's first apparent well control actions occurred after hydrocarbons were rapidly flowing to the surface. *The rig crew did not recognize the influx and did not act to control the well until hydrocarbons had passed through the BOP and into the riser.*

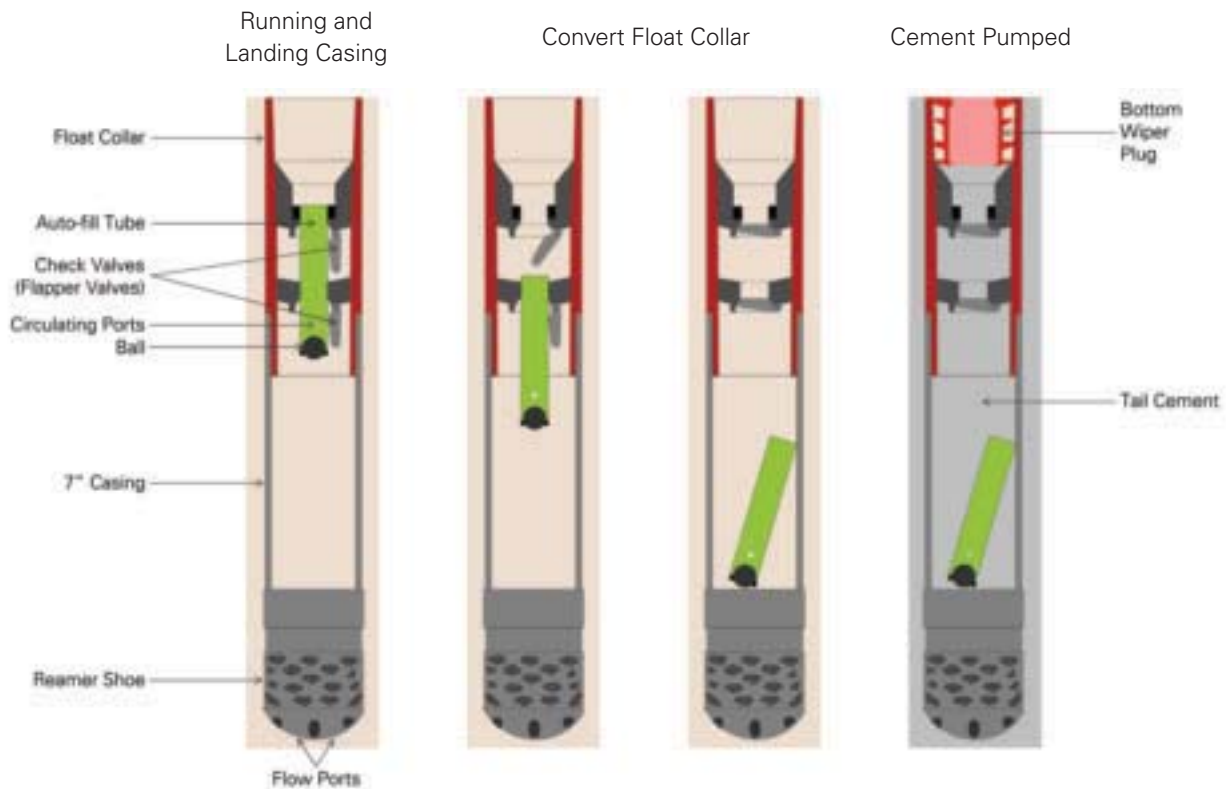
Figure 5. Float Collar Conversion.

The BP Macondo well team interpreted the float collar testing after cement placement as successful. This was further documented in the Halliburton post-job report, which indicated that the float collar was holding backpressure. (Backpressure is the difference between hydrostatic pressure in the annulus and hydrostatic pressure inside the casing, which results from different fluid densities and heights.) However, the investigation team concluded that, with the 38 psi backpressure predicted in the Halliburton April 18, 2010, OptiCem™ program, the backpressure test that was conducted was not a reliable indicator that the float collar sealed.

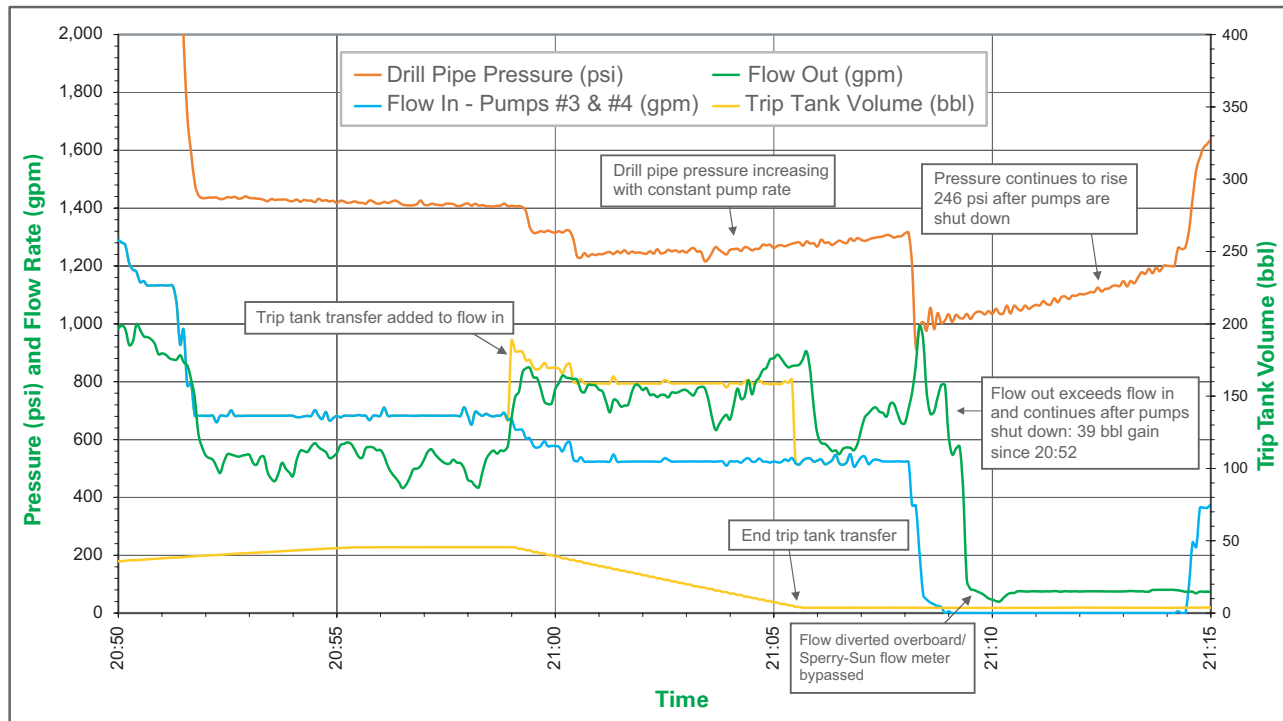
Figure 8. Flow Indication Graph Showing Anomalies (Real-time Data).

The first indication of flow likely would have been at 20:58 hours, but emptying of the trip tank could have masked this flow indication in the real-time data. The pressure abnormality starting at 21:01 hours would have been the first clear indication of flow visible to the rig crew and mudloggers.

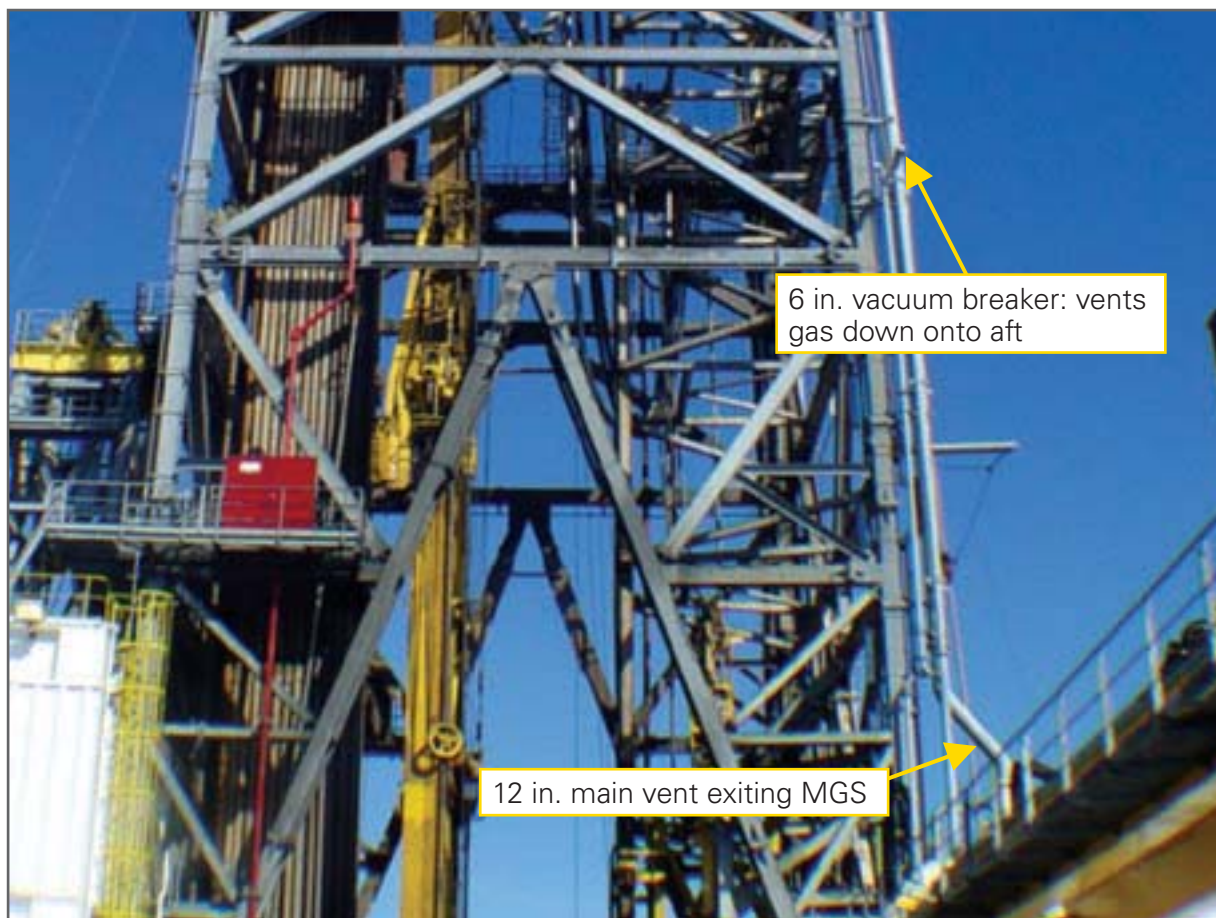
Figure 5. Photograph of 6 in. Vacuum Breaker Line Gooseneck Vent.

6 Diversion to the mud gas separator resulted in gas venting onto the rig. Once diverted to the MGS, hydrocarbons were vented directly onto the rig through the 12 in. goosenecked vent exiting the MGS, and other flow-lines also directed gas onto the rig. This increased the potential for the gas to reach an ignition source. *The design of the MGS system allowed diversion of the riser contents to the MGS vessel although the well was in a high flow condition. This overwhelmed the MGS system.*
