Deepwater Horizon Accident Investigation Report

September 8, 2010

This is the report of an internal BP incident investigation team. The report does not represent the views of any individual or entity other than the investigation team. The investigation team has produced the report exclusively for and at the request of BP in accordance with its Terms of Reference, and any decision to release the report publicly is the responsibility of BP. It has not been prepared in response to any third party investigation, inquiry or litigation.

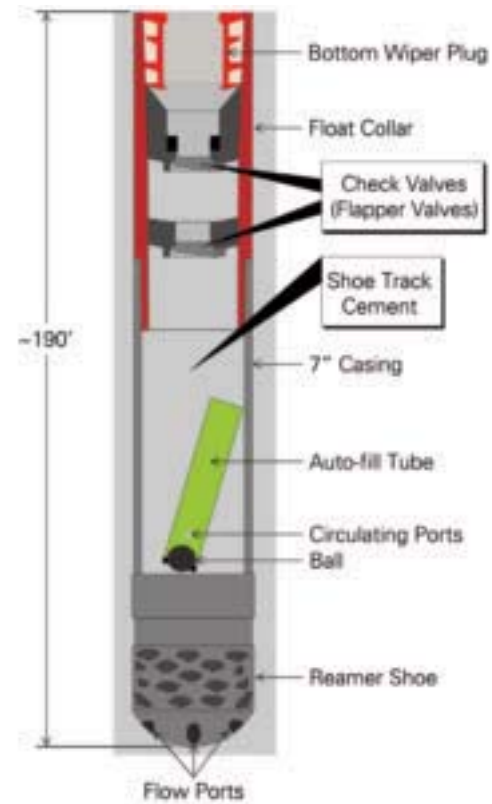
Figure 2. Shoe Track Barriers.

Based on available evidence, hydrostatic pressure calculations, OLGA® well flow modeling and analysis of data from the Macondo well static kill on August 4, 2010, hydrocarbons entered the casing through the shoe track. Therefore, the shoe track cement and the float collar must have failed to prevent this ingress. The investigation team has not established whether this failure was attributable to the design of the cement, contamination of the cement by mud in the wellbore, commingling of cement with nitrogen due to nitrogen breakout from the nitrified foam cement slurry, swapping of the shoe track cement with the mud in the rathole (bottom of the well) or some combination of these factors.

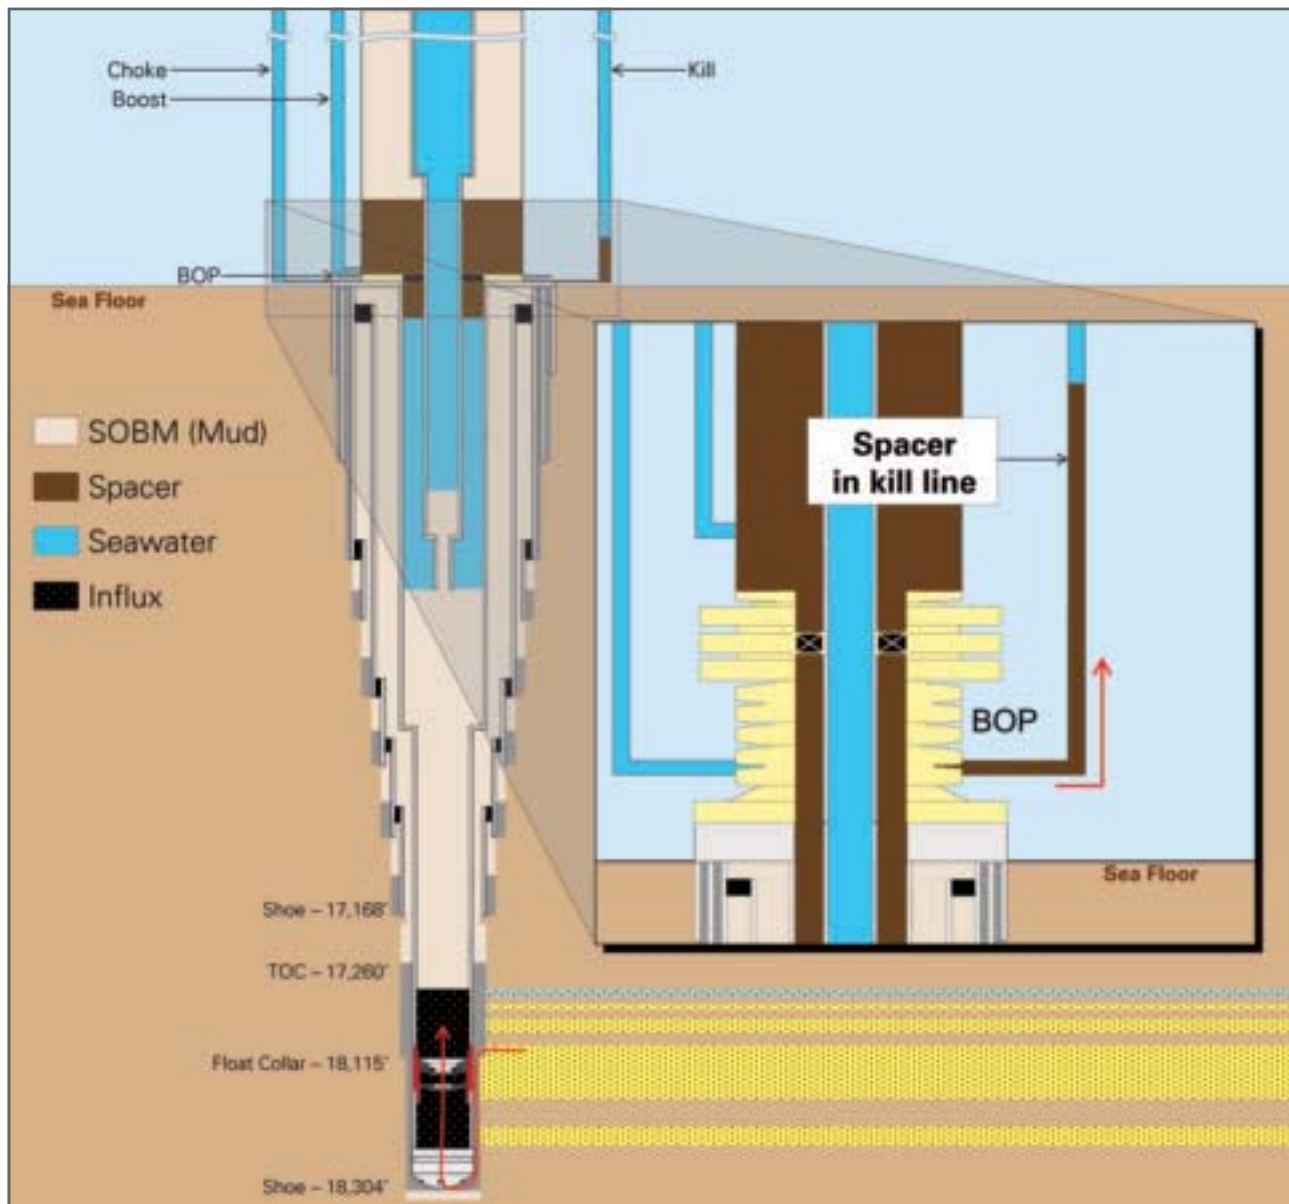
Figure 3. Possible Movement of Spacer into the Kill Line.

From 18:00 hours to 18:35 hours, the drill pipe pressure increased from approximately 50 psi to 1,400 psi. To resume the negative-pressure test, the kill line was filled and then opened, 0.2 bbls flowed, and no further flow was observed from the kill line during a 30-minute period of monitoring. The drill pipe pressure was constant at 1,400 psi.

This pressure of 1,400 psi on the drill pipe was misinterpreted by the rig crew and the well site leaders. According to witness accounts, the toolpusher proposed that the pressure on the drill pipe was caused by a phenomenon referred to as 'annular compression' or 'bladder effect.' The toolpusher and driller stated that they had previously observed this phenomenon. After discussing this concept, the rig crew and the well site leaders accepted the explanation. The investigation team could find no evidence that this pressure effect exists.

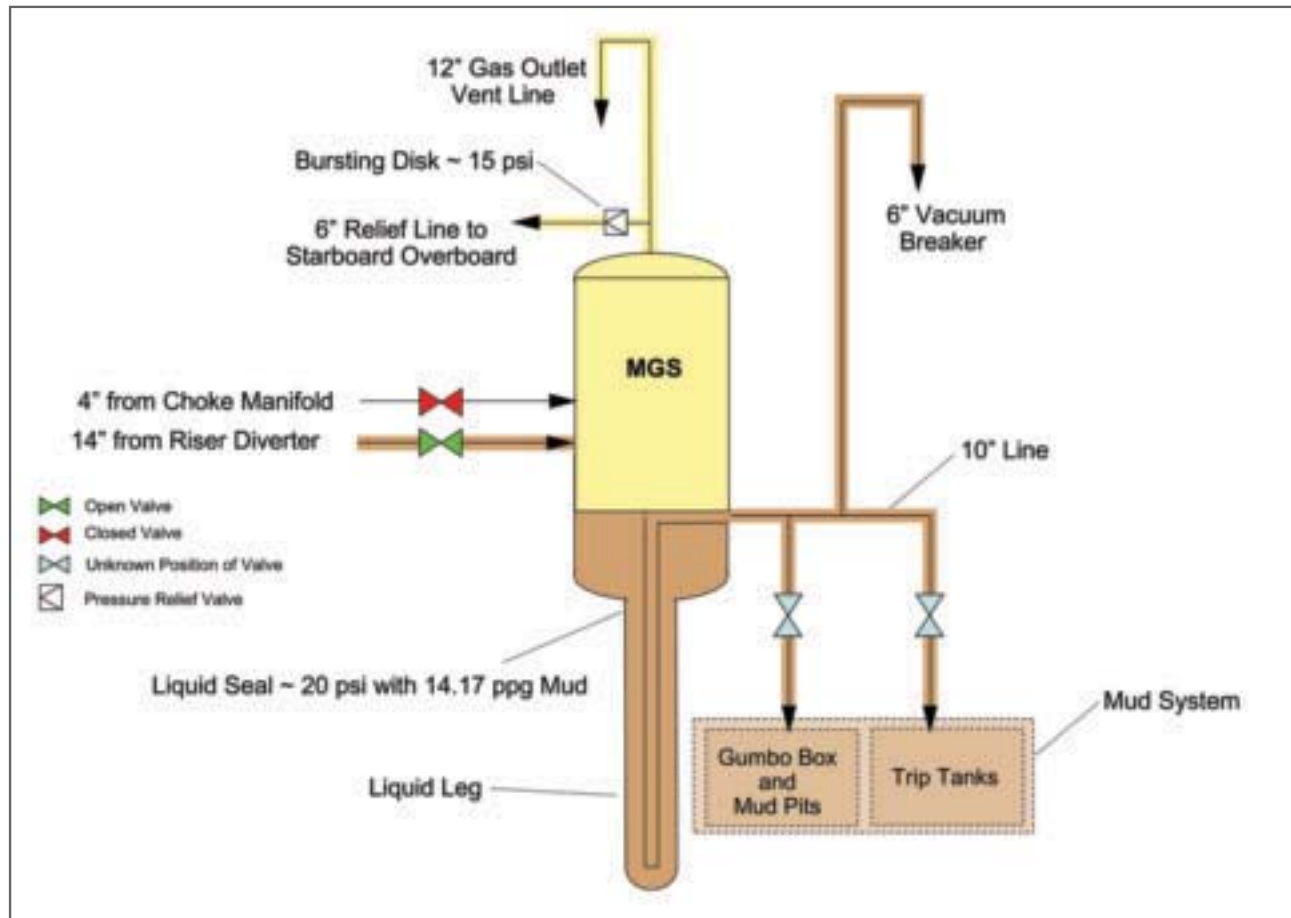
Figure 5. Mud Gas Separator.

The diversion of fluids overboard, rather than to the MGS, may have given the rig crew more time to respond and may have reduced the consequences of the accident.

Transocean's shut-in protocols did not fully address how to respond in high flow emergency situations after well control has been lost. Well control actions taken prior to the explosion suggest the rig crew was not sufficiently prepared to manage an escalating well control situation.

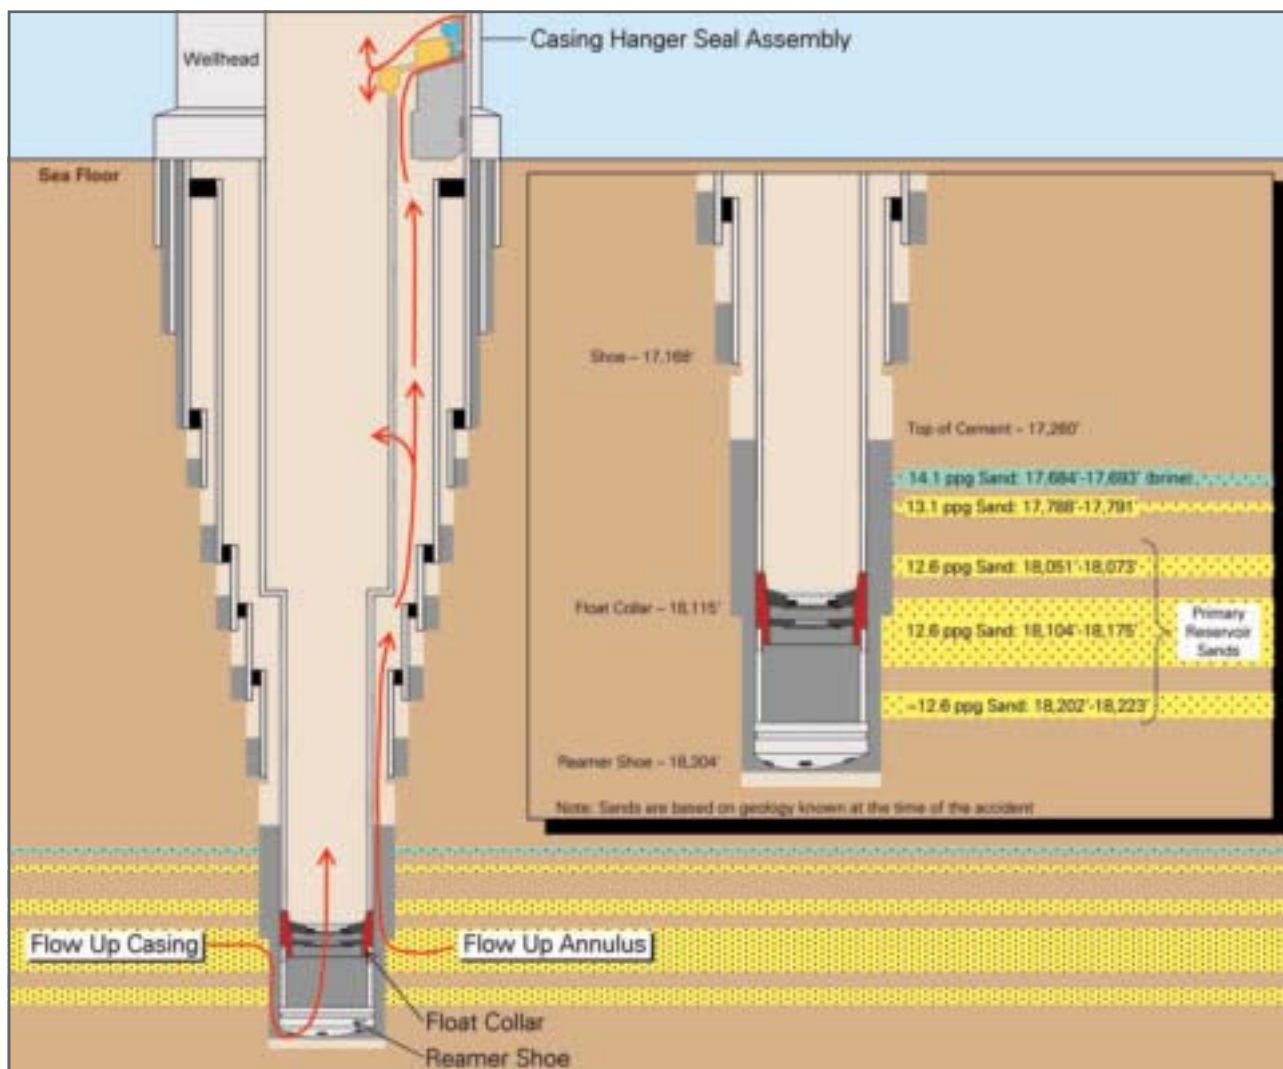
Figure 1. Hydrocarbon Zones and Potential Flow Paths.

The annulus cement barrier failed to prevent hydrocarbons from entering the annulus after cement placement. The investigation team assessed possible failure modes and paths that led to hydrocarbon migration from the formation into the wellbore. (Refer to Figure 1.)

A combination of factors could have contributed to the loss of well integrity, if hydrocarbons entered the wellbore before, during or after cement placement.

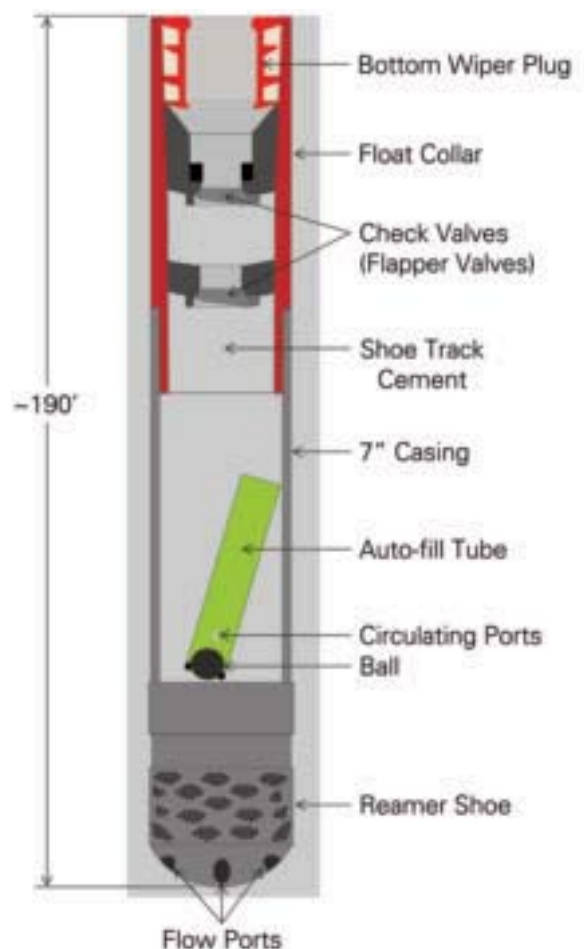
Figure 4. Shoe Track.

Based on available evidence, hydrostatic pressure calculations, OLGA® well flow modeling and analysis of data from the Macondo well static kill on August 4, 2010, hydrocarbons entered the casing through the shoe track. Therefore, the shoe track cement and the float collar must have failed to prevent this ingress. The investigation team has not

established whether this failure was attributable to the design of the cement, contamination of the cement by mud in the wellbore, commingling of cement with nitrogen due to nitrogen breakout from the foam cement slurry, swapping of the shoe track cement with the mud in the rathole (bottom of the well), or some combination of these factors.

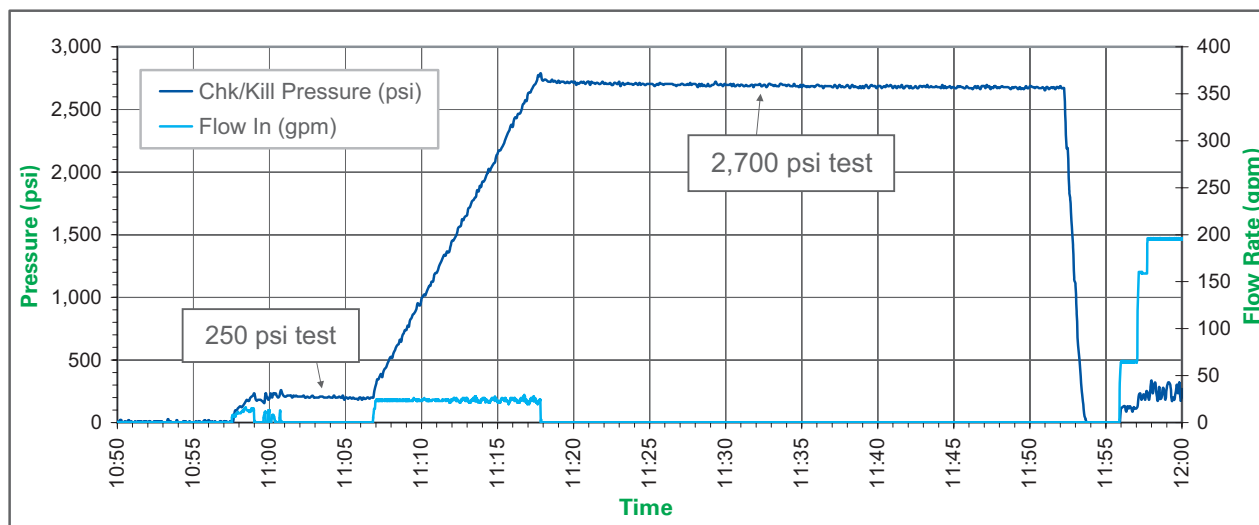
Figure 1. Positive-pressure Test (Real-time Data).

First, after closing the blind shear rams (BSRs) in the BOP, wellbore pressure was increased through the kill line to 250 psi and held for 5 minutes. Second, after no leaks were observed, wellbore pressure was increased to 2,700 psi and held for 30 minutes. The rig crew determined that the test was successful after the observed pressure did not decline more than the criteria specified by the MMS (no more than 10% decline in 30 minutes). The investigation team's review of the test data confirmed that the test was successful.

Figure 1 shows the successful pressure test.

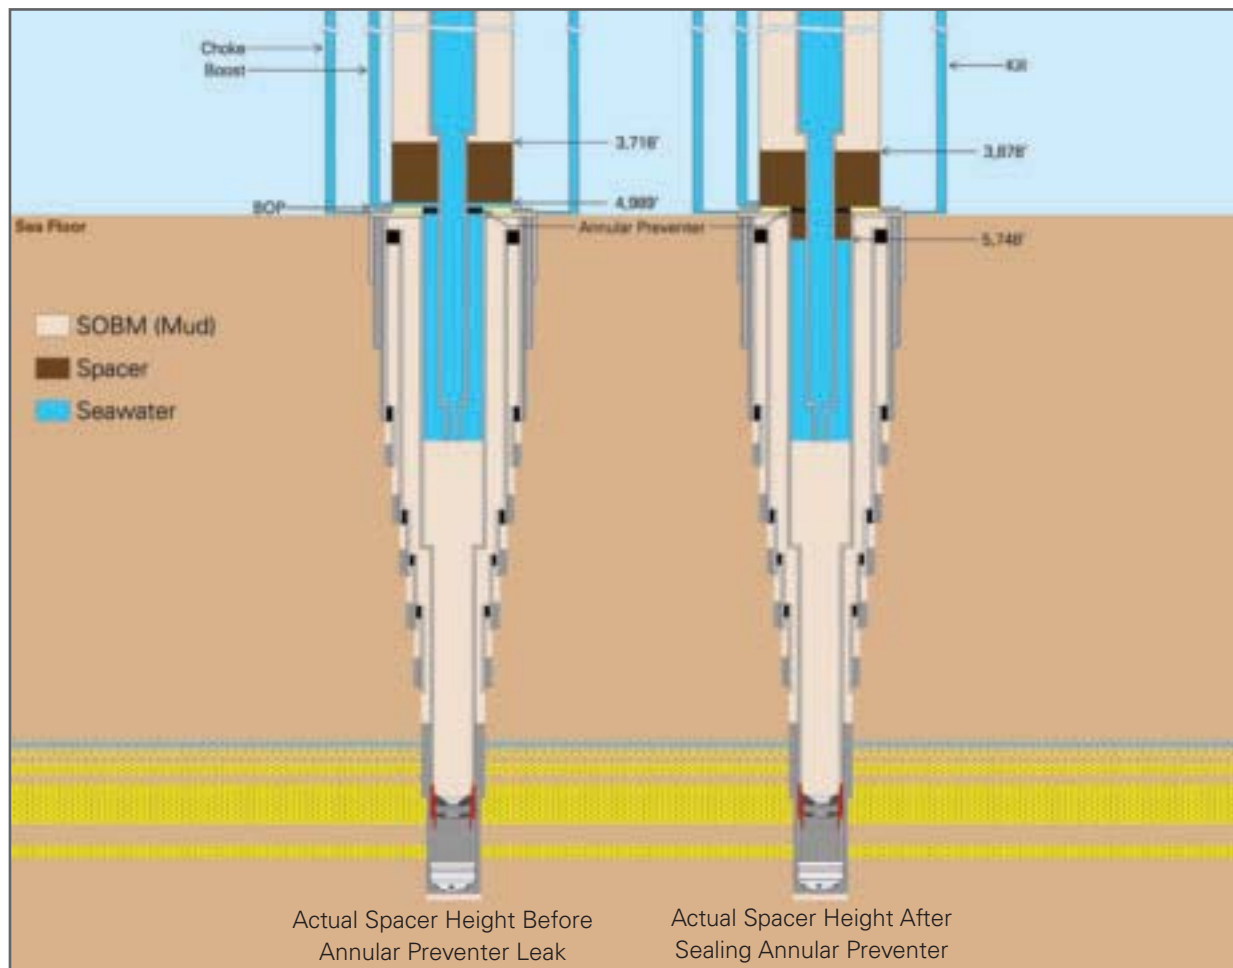
Figure 2. Spacer Placement.

- During the initial attempted negative-pressure test on the drill pipe, the annular preventer was closed, but it failed to seal on the drill pipe, resulting in approximately 50 bbls of spacer leaking past the annular preventer into the BOP during the bleed-off of drill pipe pressure. The investigation team believes that the spacer or spacer/seawater interface was across the BOP during the negative-pressure test procedure. (Refer to *2.3 Opened the Drill Pipe to Bleed Pressure* of this analysis.) The bottom of the spacer, therefore, was not above the upper annular preventer as intended. *Figure 2* shows the actual spacer placement before and after sealing the annular preventer.

- The presence of the spacer across the kill line inlet could have complicated the interpretation of the negative-pressure test. (Refer to *2.5 Continued the Negative-pressure Test on the Kill Line* of this analysis for a discussion of the anomalous pressure readings during the negative-pressure test.)

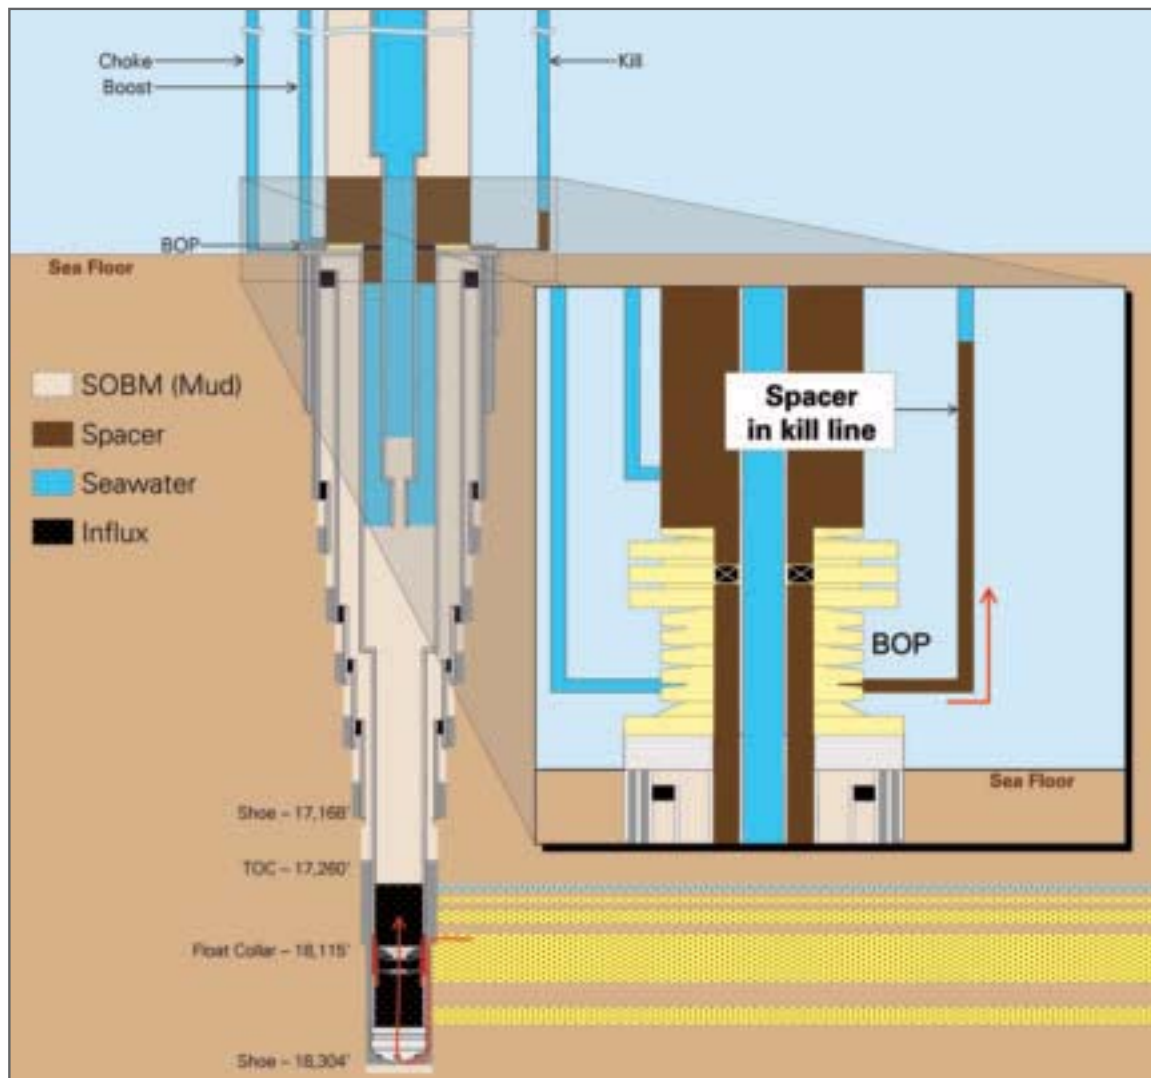
Figure 3. Possible Movement of Spacer into Kill Line.

As previously discussed in *2.2 Displaced Mud to Seawater* of this analysis, spacer material was unintentionally placed across the kill line at the BOP. At least 3 bbls of highly viscous fluid (occupying approximately 150 ft. in the kill line) could have been drawn into the kill line during this part of the test. (Refer to Figure 3.)

In this situation, where the drill pipe should have been in direct pressure communication with the kill line and there was 1,400 psi on the drill pipe, flow should have exited the kill line when the kill line was opened to the mini trip tank. However, the rig crew observed no flow into the mini trip tank. The investigation team considered the following possible reasons for the lack of flow:

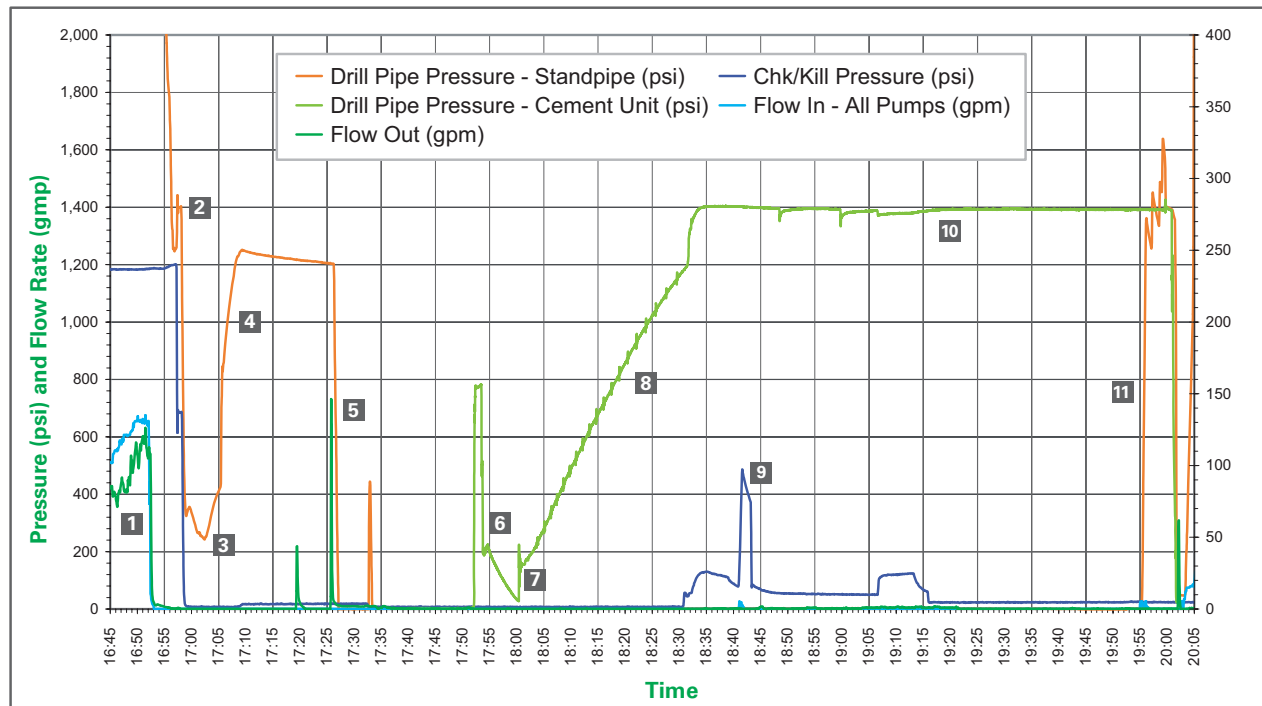
A successful negative-pressure test is indicated by no flow from either the kill line or the drill pipe; however, there was 1,400 psi on the drill pipe, an indication of communication with the reservoir.

| <p>1 Spacer displacement complete; mud pumps stopped.</p> <p>2 Annular preventer closed; attempt to bleed drill pipe pressure to zero.</p> <p>3 Drill pipe pressure decreases to only 273 psi; annular preventer leaking.</p> <p>4 Drill pipe pressure increases as annular preventer leaks; hydraulic closing pressure increased to seal annulus.</p> <p>5 Drill pipe pressure bled to zero for negative-pressure test.</p> <p>6 Decision made to conduct negative-pressure test via kill line; kill line opened; 3 bbls to 15 bbls bled to cement unit.</p> | <p>7 Shut in kill line at cement unit, drill pipe pressure starts to increase.</p> <p>8 Drill pipe pressure slowly increases to 1,400 psi.</p> <p>9 Fluid pumped into kill line to confirm full; kill line opened to mini trip tank for monitoring.</p> <p>10 Discussion ongoing about 'annular compression' and 'bladder effect' while monitoring kill line; drill pipe pressure static at 1,400 psi.</p> <p>11 Negative-pressure test concluded, declared a success; preparation made to continue displacement.</p> |

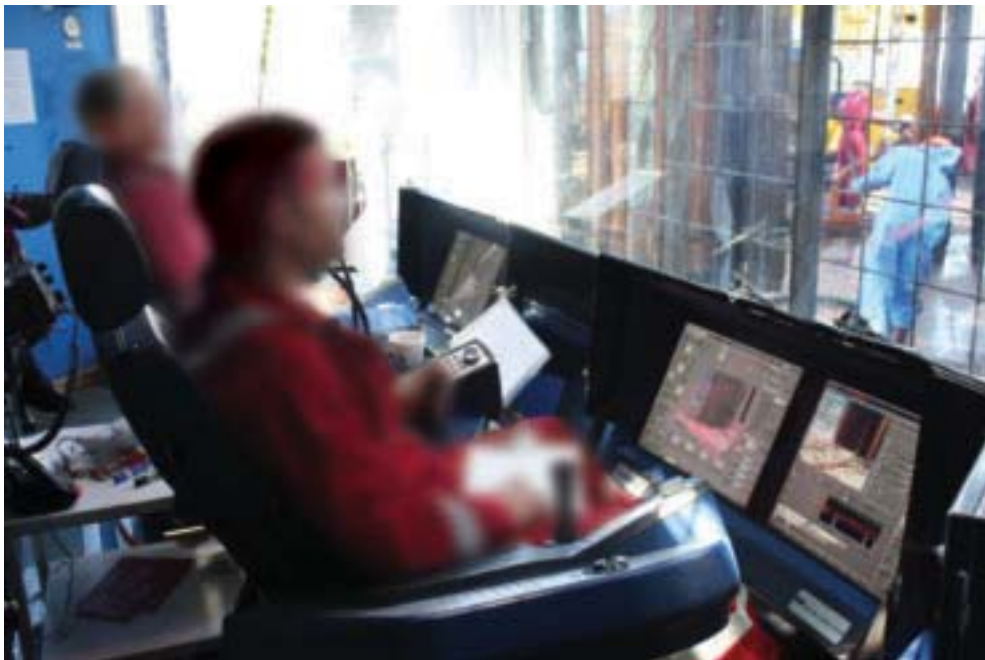
Figure 6. Typical Driller's Cabin on an Offshore Rig Similar to *Deepwater Horizon*.

A reliable method to monitor a well is to trend the fluid volumes in the pits. Other parameters for monitoring the well, such as pressure and flow, were available to both the driller and the mudlogger. (Refer to Figures 5A, 5B and 6 for typical mudlogger and driller displays. Figure 7 shows *Deepwater Horizon* driller's cabin.) Based on the information made available to the investigation team, there were two independent systems for measuring flow: Transocean's flow meter for the driller and a Sperry-Sun flow meter for the mudlogger. Only the Sperry-Sun real-time data was available to the investigation team.

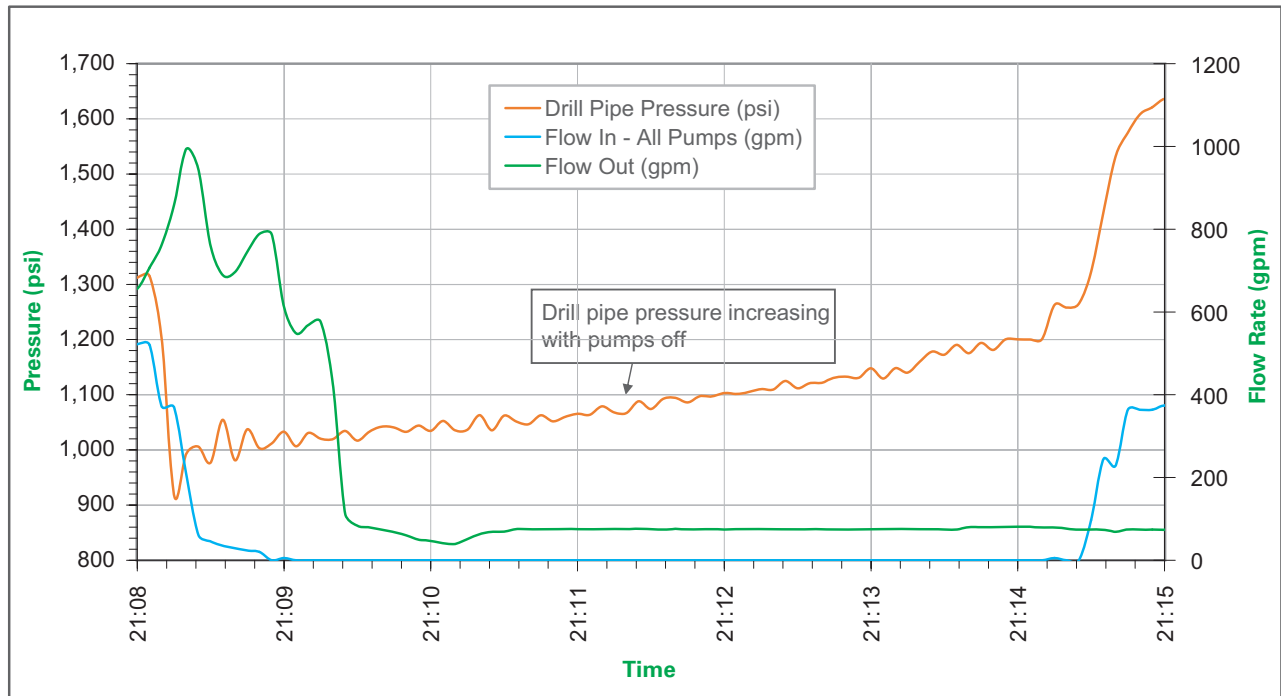
Figure 9. Pressure Increase During the Sheen Test (Real-time Data).

- The drill pipe pressure continued to increase from 1,017 psi at 21:08 hours to 1,263 psi at 21:14 hours. (Refer to Figure 9.) Modeling indicated this pressure increase was caused by 14.17 ppg mud rising above the stinger in the annulus. In addition, modeling suggested that this pressure increase was indicative of flow through the shoe track at a rate of approximately 9 bpm. (Refer to *Appendix G. Analysis Determining the Likely Source of In-flow* for the detailed analysis.)

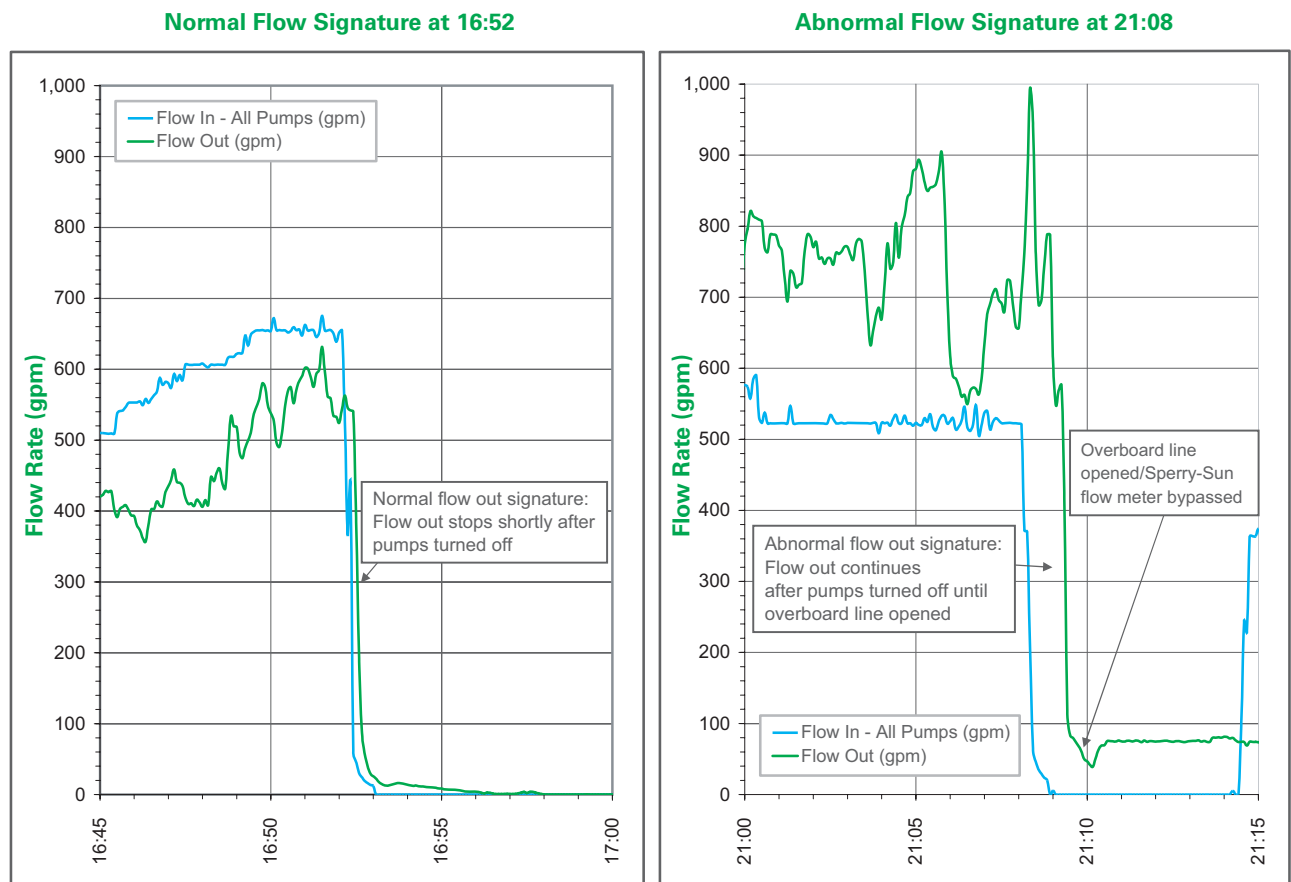
Figure 10. Normal Versus Abnormal Flow Out Signature as Pumps Shut Off (Real-time Data).

- The investigation team compared the flow out signature (i.e., the length of time it took the flow meter sensor to indicate zero flow after shutting the pumps off) to a time when the well was known to be stable. (Refer to Figure 10.) A distinctly different signature was observed at that time, indicating that the well was flowing.

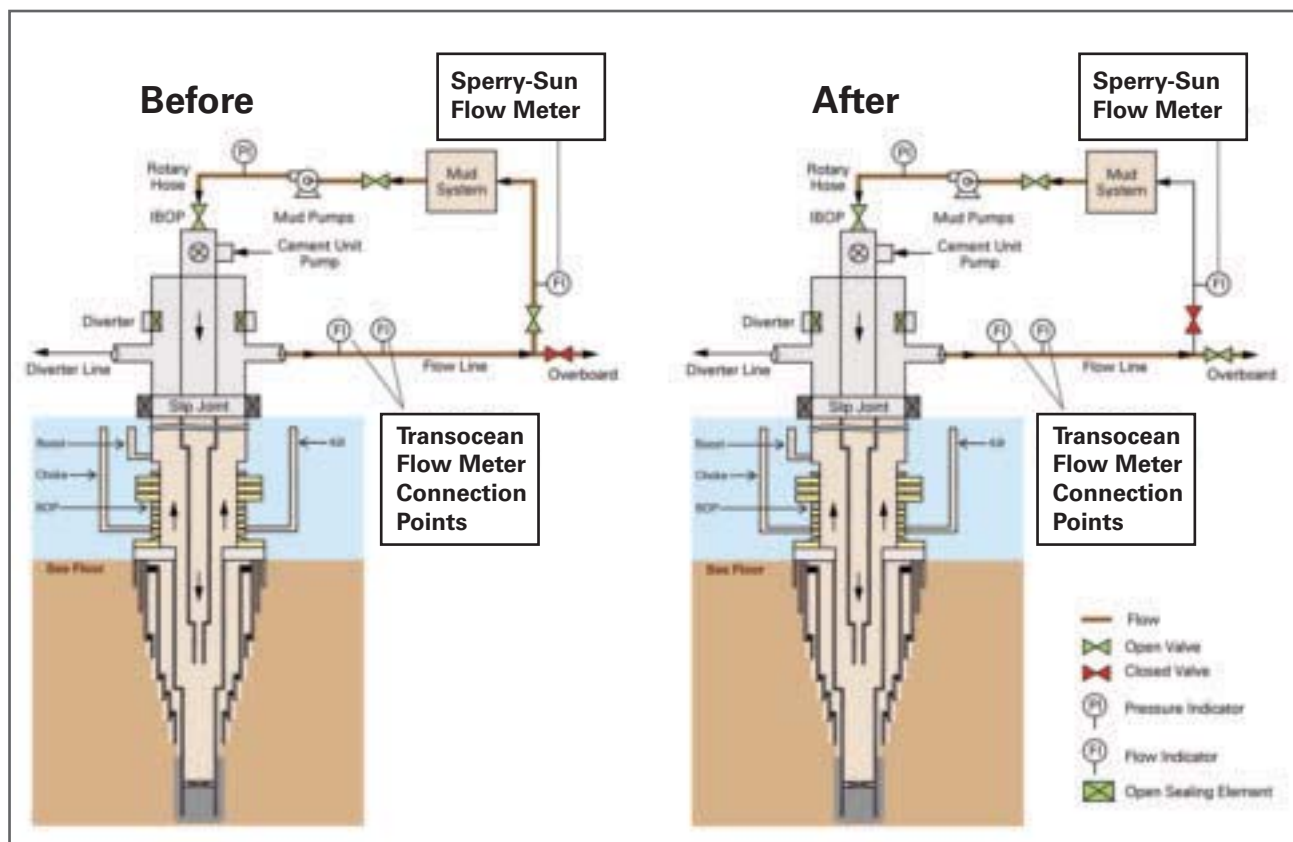
Figure 11. Flow Path Before and After Routing the Spacer Overboard.

The driller should have been able to monitor flow from the well, even after routing the flow overboard. Even though the Sperry-Sun flow meter was not sensing flow after 21:10 hours, information available to the investigation team showed that separate Transocean flow sensors would have been available to the driller. (Refer to Table 1 and Figure 11.)

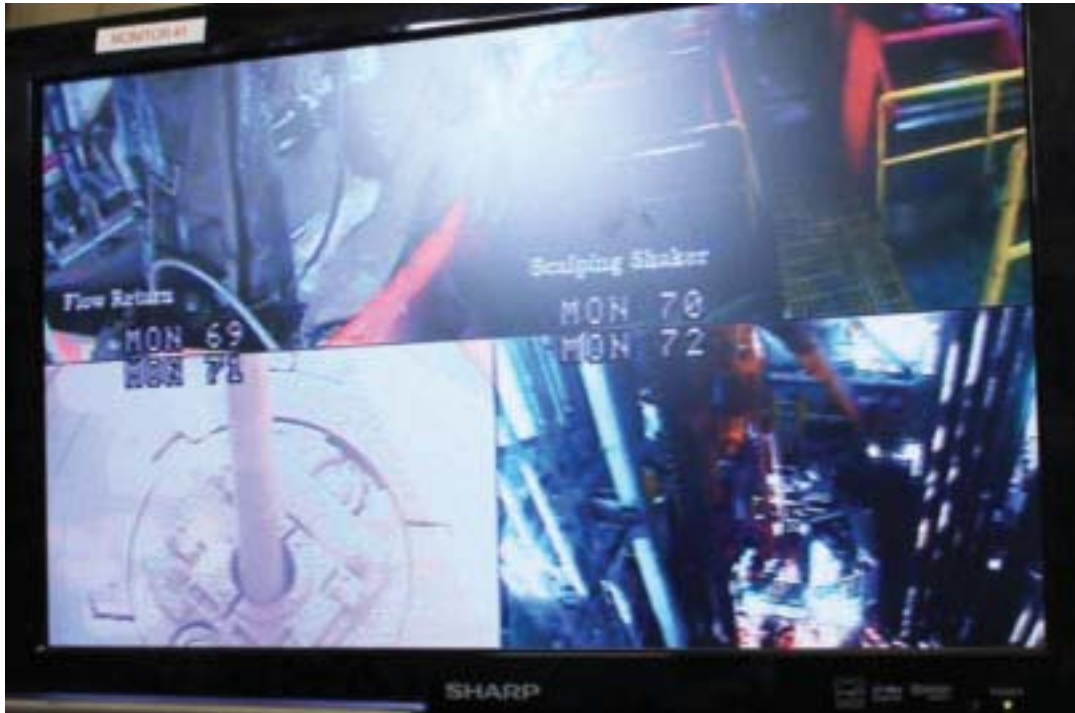
Figure 12. Typical Video Camera Displays in the Driller's Cabin (not *Deepwater Horizon*).

In addition, display screens should have provided visual indication to the driller (through video cameras) until the flow path was changed to the overboard line. When the flow path was diverted overboard, visual indication of flow on the display screen was no longer available. (Refer to Figure 12 for an example of display screens that are available to the driller.)

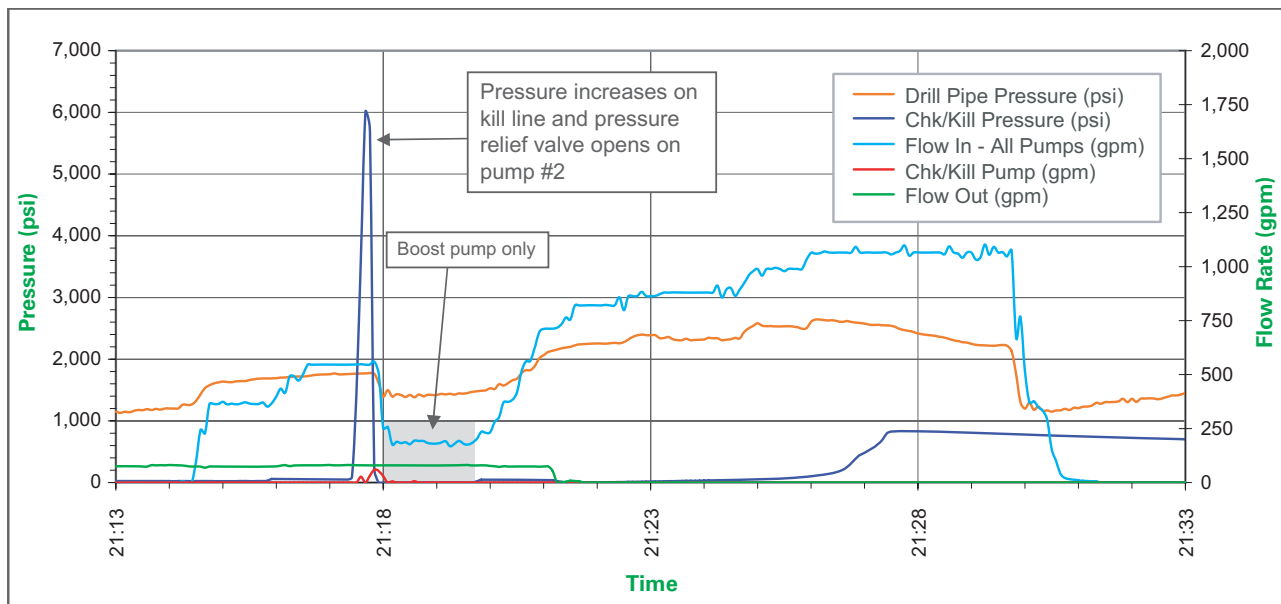
Figure 13. Mud Pump #2 Pressure Increase at 21:17 Hours (Real-time Data).

- An analysis of real-time data combined with MBI testimony suggested that the rig crew was trying to bring mud pump #2 online at 21:17 hours (32 minutes before the explosion). The pump was likely started against a closed valve, lifting the pressure relief valve (PRV). (Refer to Figure 13.)
- Mud pumps #2, #3 and #4 were all shut down, and pump #1 continued to pump into the boost line. Three minutes later, pumps #3 and #4 were put back online, and several personnel were investigating the problem with pump #2. This was another operation that potentially distracted the rig crew from monitoring the well.

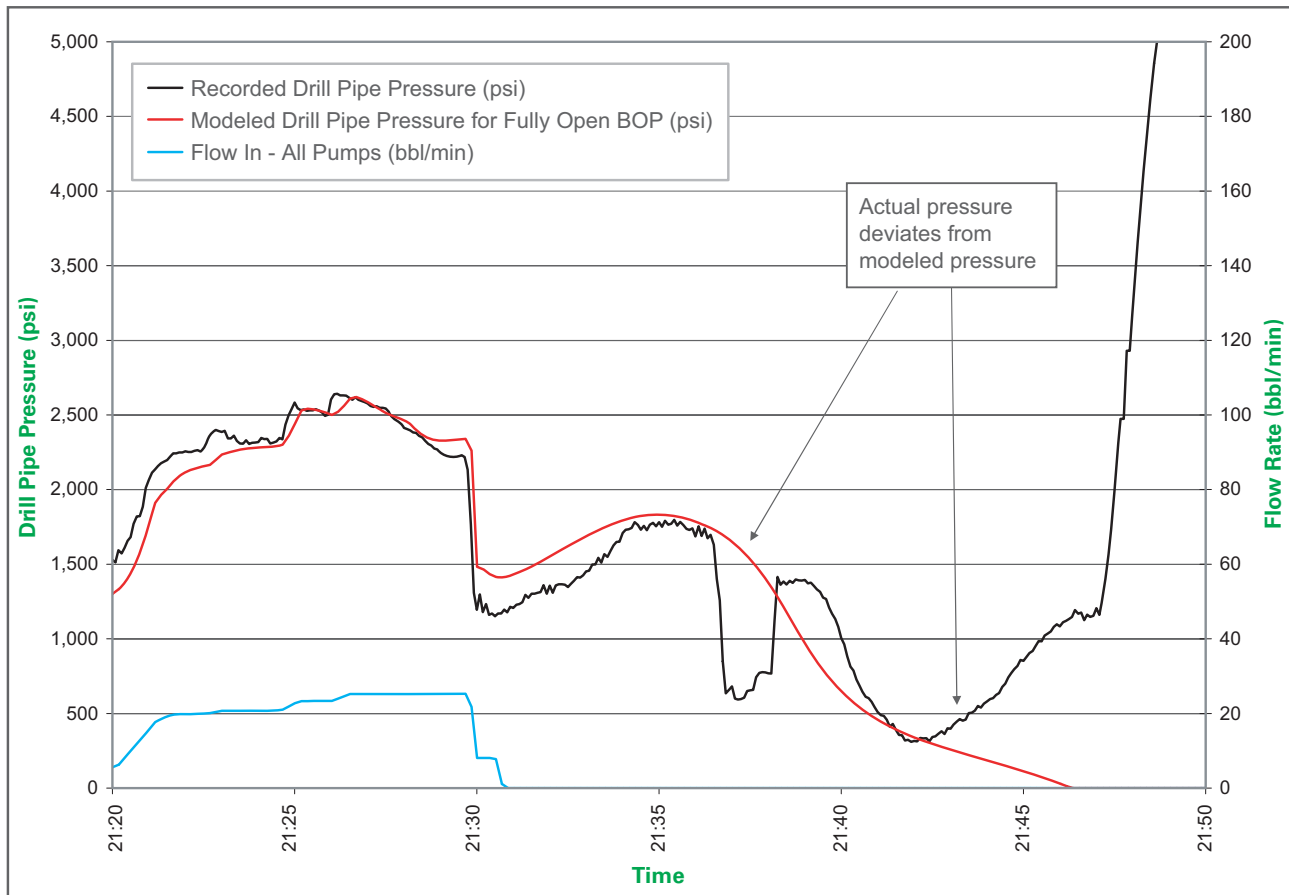
Figure 14. OLGA® Well Flow Modeling for Flow Condition with an Open Annular Preventer.

- As mentioned previously, at approximately 21:33 hours (approximately 21:30 hours per MBI testimony), the chief mate observed the toolpusher and the driller discussing 'differential pressure' on the well. This coincided with the real-time data showing the drill pipe pressure increasing at this time.
- The OLGA® well flow modeling predicted the pressure responses from 21:31 hours to 21:42 hours fairly accurately, with the exception of the sudden pressure changes shown in the real-time data from 21:36 hours to 21:38 hours. (Refer to Figure 14 for specific readings.)

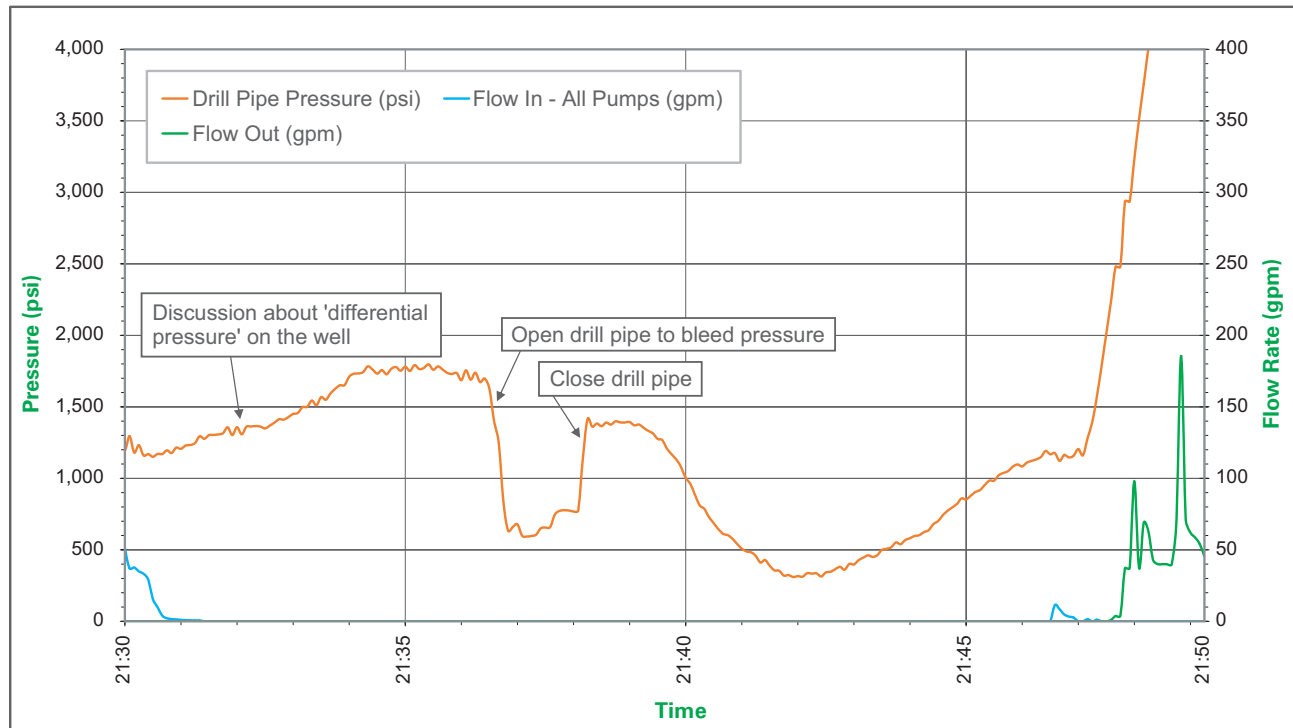
Figure 15. Investigation of Pressure Responses After Shutting Down Pumps (Real-time Data).

- The sudden pressure changes between 21:36 hours and 21:38 hours were indicative of a bleed-off at the surface. Modeling supported the bleeding of the drill pipe at the surface through a 4 in. surface line as the likely action taken at this time because the pressure response is immediate. (Refer to Figure 15.) A pressure transient caused by a pressure drop deep within the well would have been indicated by a slower pressure change on the real-time data.

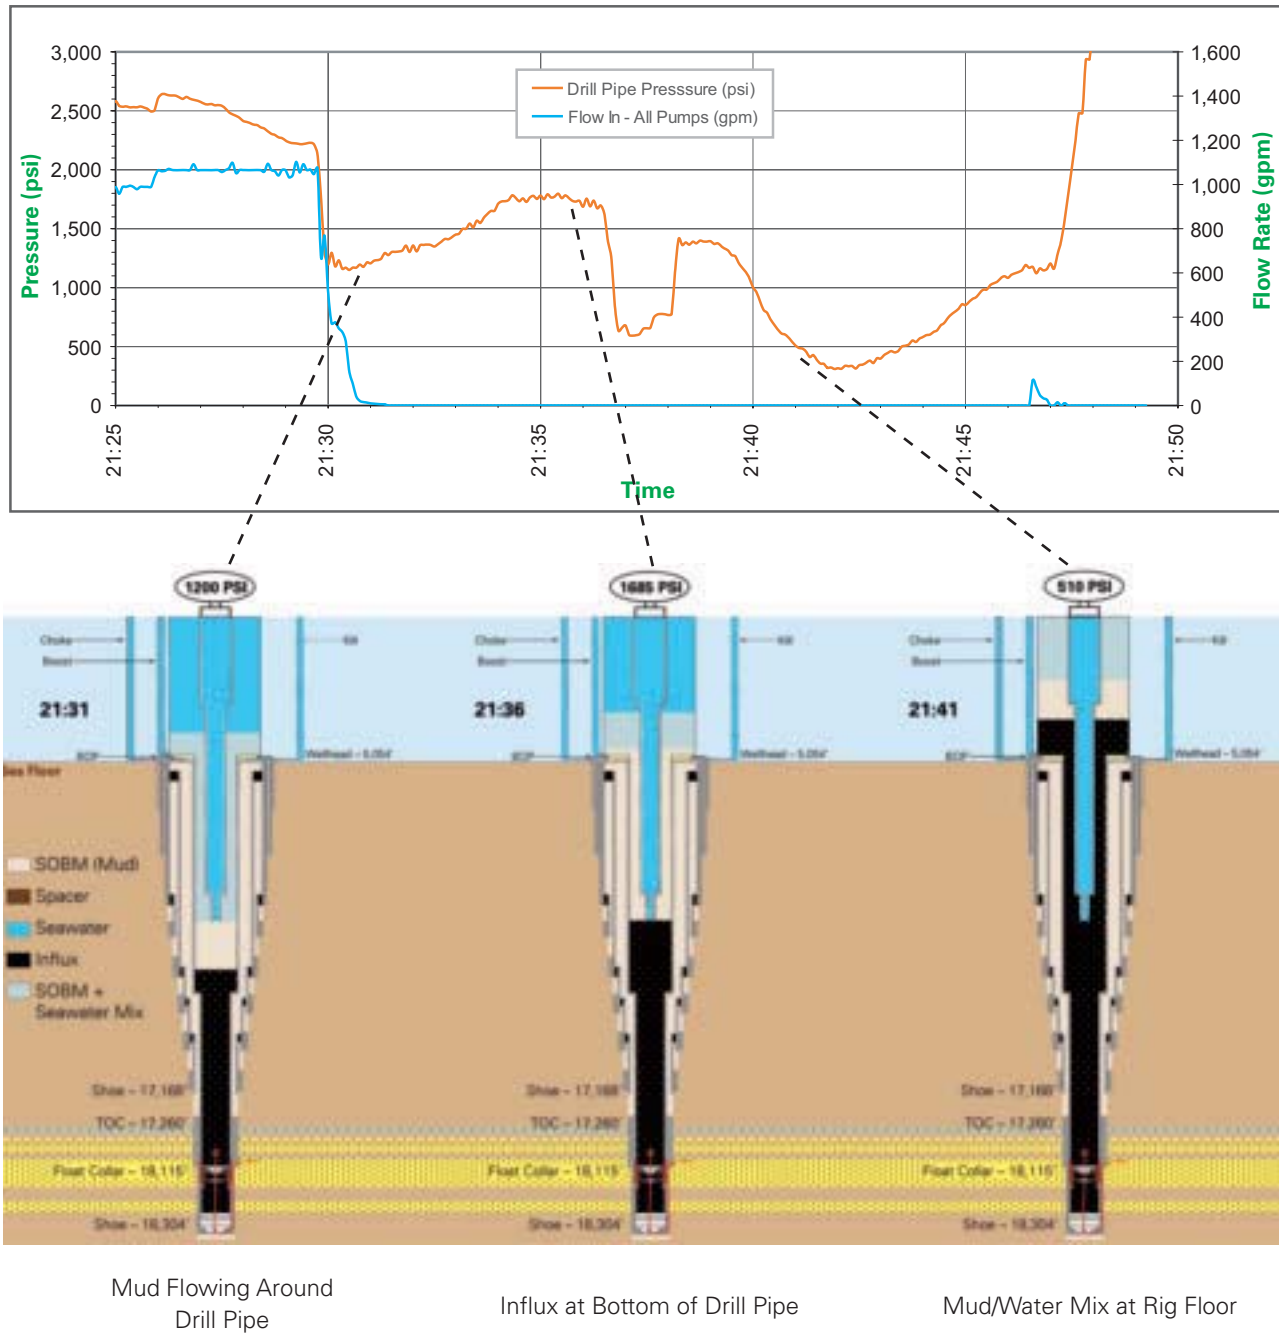
Figure 16. Modeled Pressure Responses Resulting from Hydrostatic Changes in the Wellbore.

- The rig crew may have conducted this bleed-off when they were investigating the 'differential pressure.' This action would not be consistent with a rig crew responding to a recognized well control condition.
- Other than the sudden pressure changes between 21:36 hours and 21:38 hours (interpreted to be the bleed-off of the drill pipe pressure), the drill pipe pressure increased until 21:35 hours as 14.17 ppg mud rose above the stinger and then declined after that as hydrocarbons rose above the stinger.
- Modeling indicated that this fluctuation was consistent with the change in fluid densities (spacer, seawater, mud and hydrocarbons) moving through the various cross-sectional areas in the well. *Figure 16* illustrates the hydrostatic changes occurring in the well and the corresponding pressure responses.
