Deepwater Horizon Accident Investigation Report

September 8, 2010

This is the report of an internal BP incident investigation team. The report does not represent the views of any individual or entity other than the investigation team. The investigation team has produced the report exclusively for and at the request of BP in accordance with its Terms of Reference, and any decision to release the report publicly is the responsibility of BP. It has not been prepared in response to any third party investigation, inquiry or litigation.

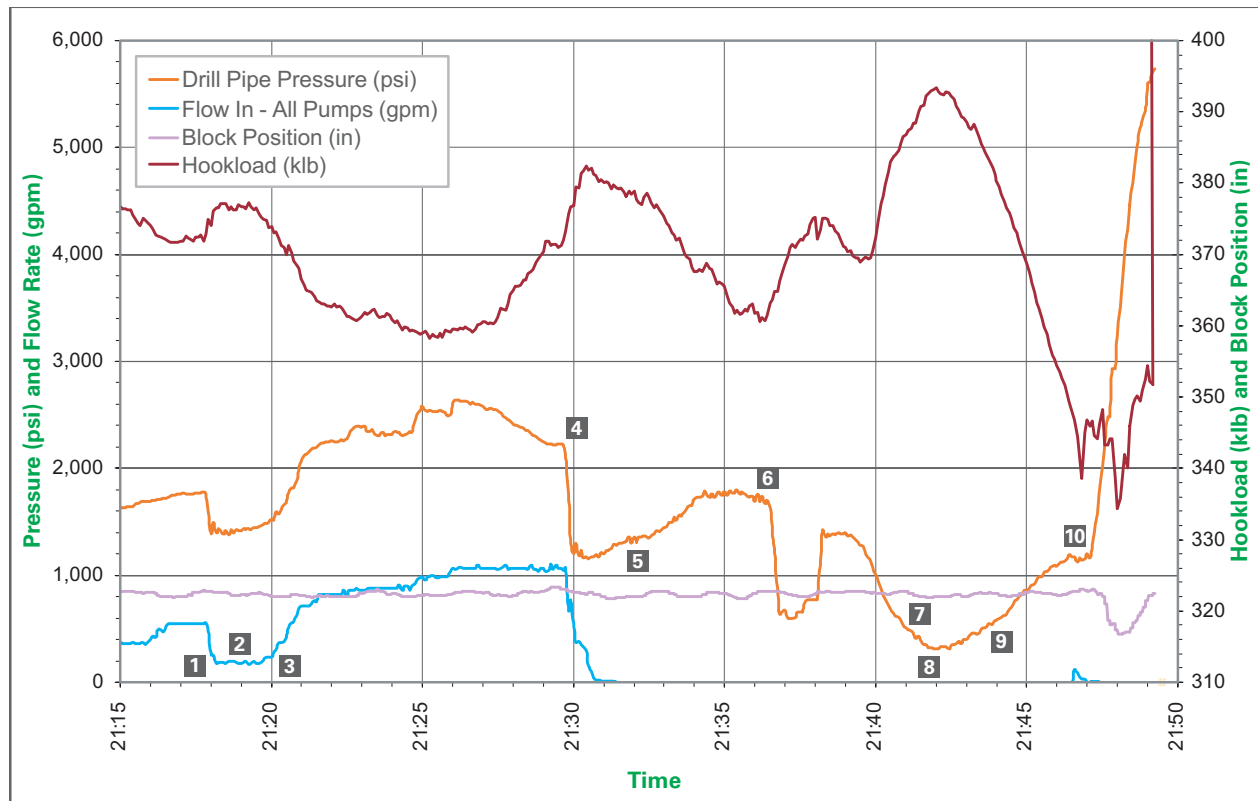
Figure 17. Interpretation of Well Control Response (Real-time Data).

- Analysis shows that to create the pressure increase observed on the drill pipe from 21:42 hours to 21:47 hours, the annular preventer was over 99% closed (but not fully sealed) around the drill pipe. If the annular preventer was fully closed and sealed during this time period, the pressure increase would have been more immediate. (Refer to *Analysis 5D. The Blowout Preventer Did Not Seal the Well* of this section for a detailed explanation.)

- One of two possible actions would have caused the rapid pressure increase to 5,730 psi from 21:47 hours to 21:49 hours:
 - The rig crew possibly first closed an annular preventer and then closed a VBR in accordance with Transocean’s protocol for handling well control events.

- The rig crew possibly first closed an annular preventer and then increased its closing pressure to create a seal.

| <p>1 Pressure relief valve on pump #2 opens; toolpusher called to rig floor.</p> <p>2 All pumps shut down except boost pump.</p> <p>3 Assistant driller called to pump room.</p> <p>4 Pumps shut off.</p> <p>5 Toolpusher and driller discuss 'differential pressure.'</p> <p>6 Opening of 4" surface line to bleed pressure.</p> | <p>7 Mud/water flows onto rig floor and then unloads through the derrick.</p> <p>8 Diverter and annular preventer activated; diverted to mud gas separator.</p> <p>9 Well site leader and senior toolpusher receive calls from rig floor; annular preventer attempting to close.</p> <p>10 BOP sealing.</p> |

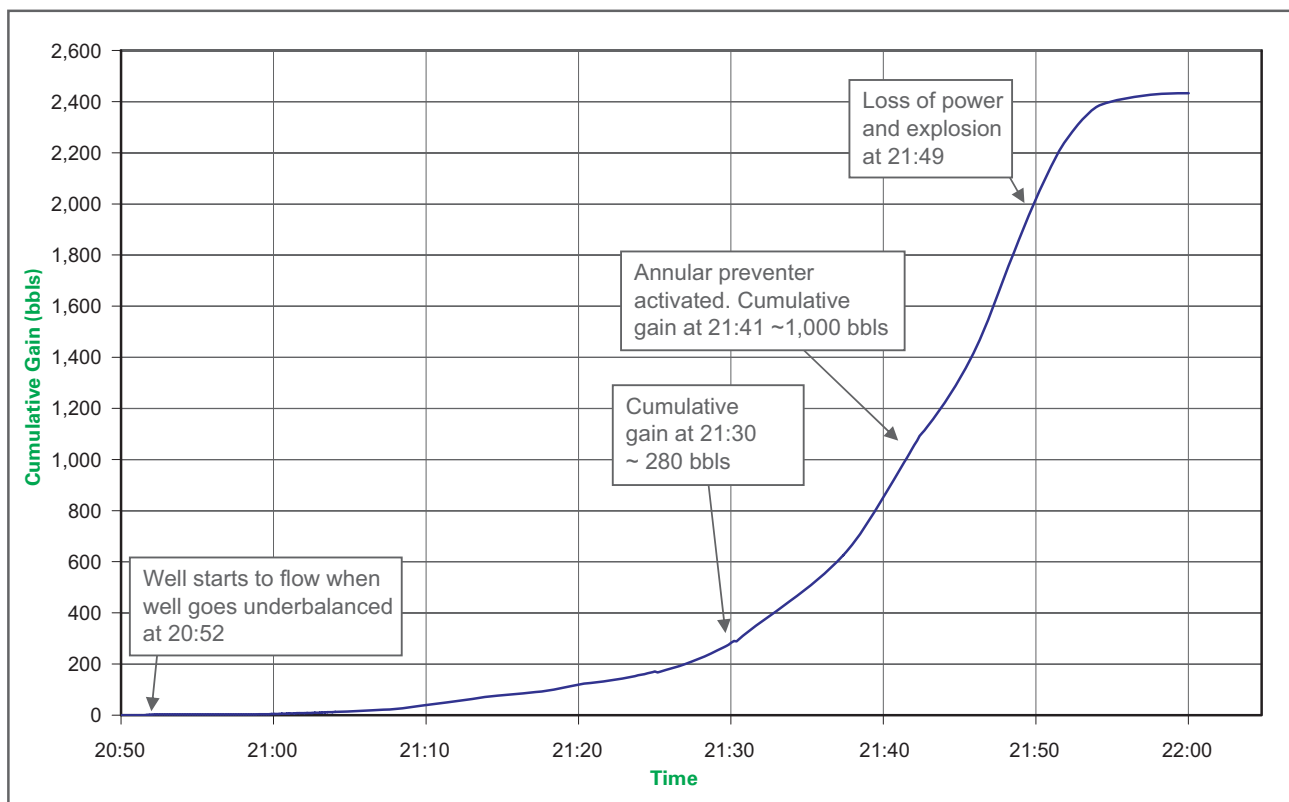
Figure 18. OLGA® Well Flow Modeling Prediction of Cumulative Gain Excluding Pumped Volumes 20:52 Hours–21:49 Hours.

When the annular preventer was activated at approximately 21:41 hours, the model estimated the influx volume to be approximately 1,000 bbls. By the time the explosion occurred at approximately 21:49 hours, the model estimated the gain to be approximately 2,000 bbls. (Refer to Figure 18 for the cumulative gain over time.)

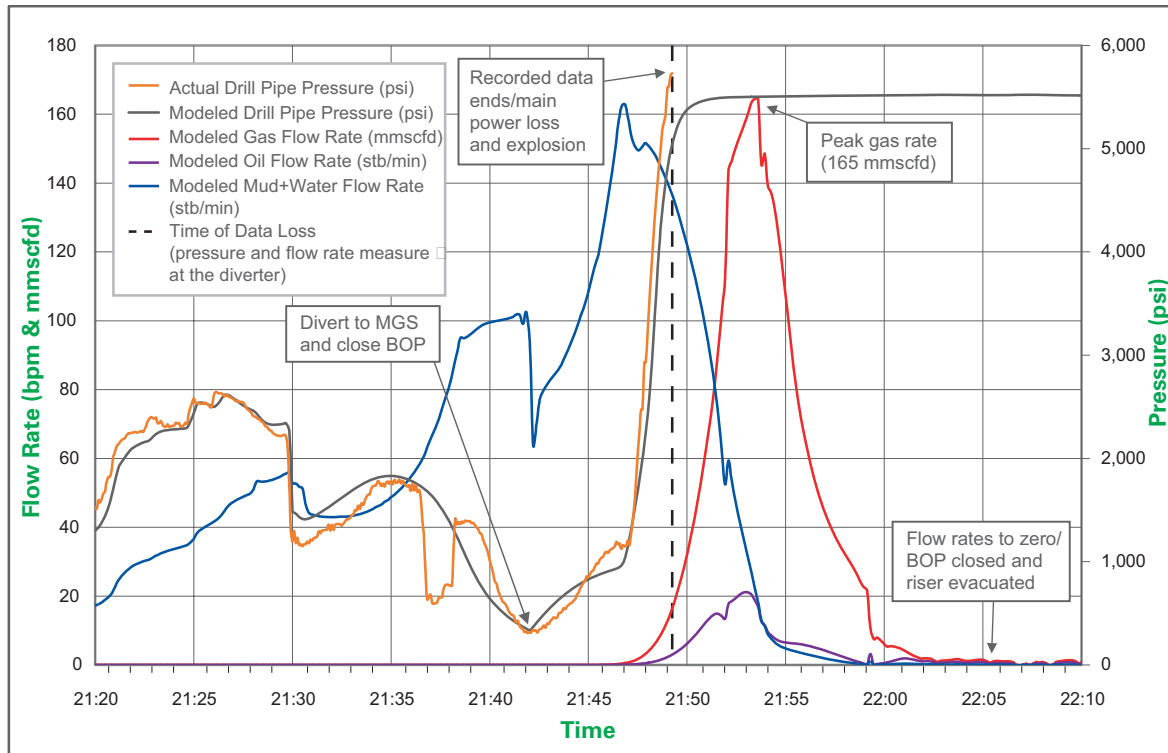
Figure 1. OLGA® Well Flow Modeling Prediction of Fluid Outflow from the Riser.

Figure 1 shows the predicted flow rates of mud/water, gas and oil. At approximately 21:46 hours, the gas reached the surface, and over a 5-minute period the flow of gas increased to more than 140 mmscfd. Simultaneously, the flow of mud and water to the surface reduced from 140 bpm to 20 bpm. The modeled timeline of flow to the surface aligns with eyewitness accounts described in *Table 1*.

Based on the assumption that the BOP remained closed and sealed around the drill pipe, *Figure 1* shows that predicted flow tails off approaching 22:00 hours, though it is evident from the actual event that this did not occur. (Refer to *Appendix W. Report–Dynamic Simulations Deepwater Horizon Incident BP.*) The failure modes that may have allowed the flow to continue are described in *3.5 Sustaining the Flow Following the Closure of the BOP* of this analysis.

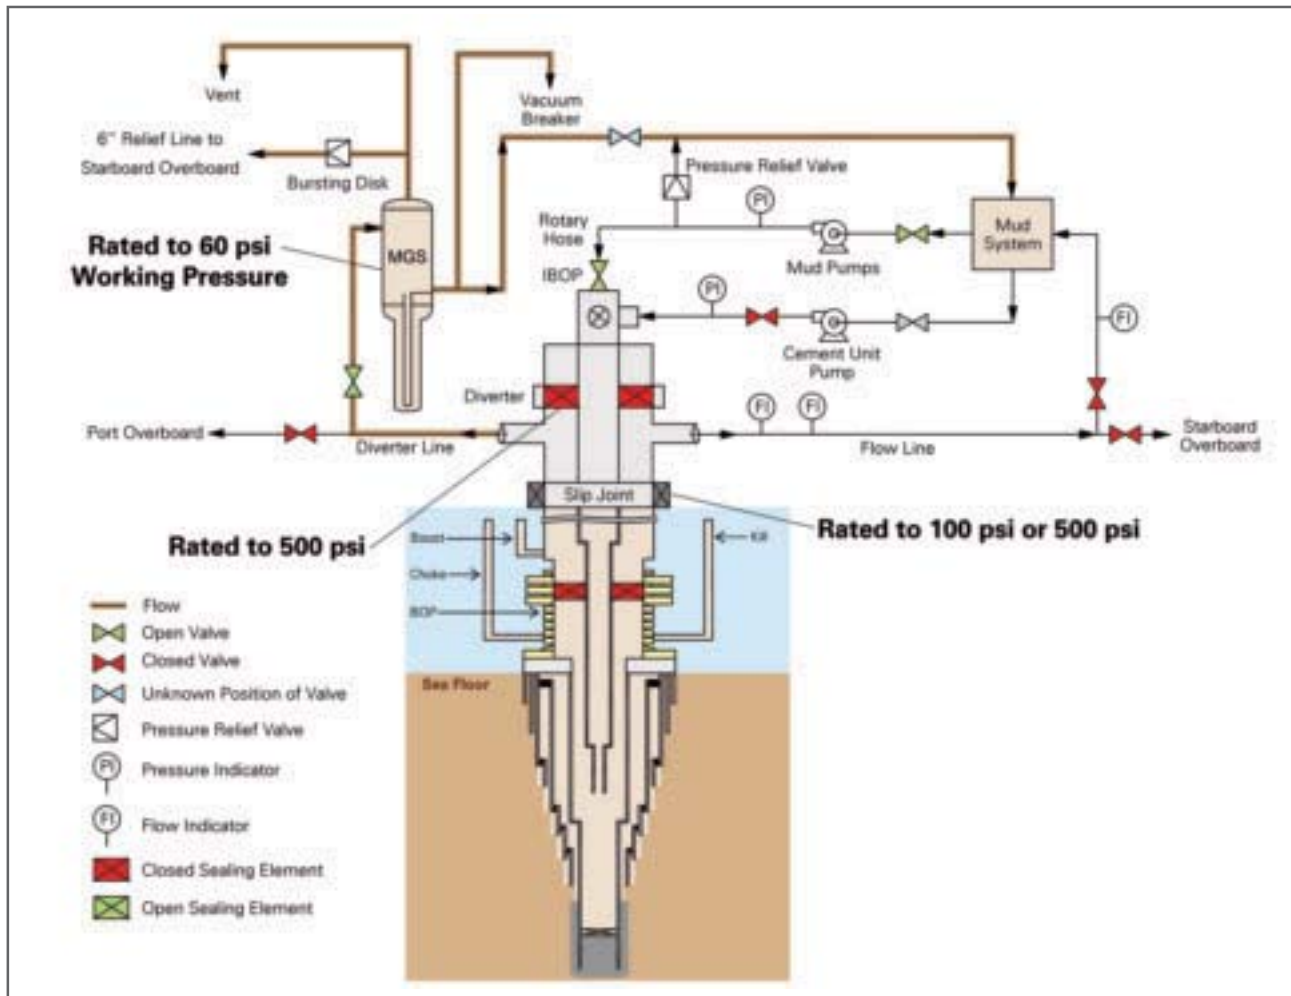
Figure 2. Simplified Process Flow Diagram of Selected *Deepwater Horizon* Surface Equipment.

Witness accounts support the view that the diverter was activated and the flow diverted to the MGS at approximately 21:41 hours.

Based on these modeled pressures, it appears that some of the surface equipment could have begun to fail and release hydrocarbons. (Refer to Figure 2.) The two most vulnerable pieces of equipment were the MGS vessel, which was rated for 60 psi; and, if selected in low-pressure mode, the riser slip joint seal, which was rated for 100 psi.

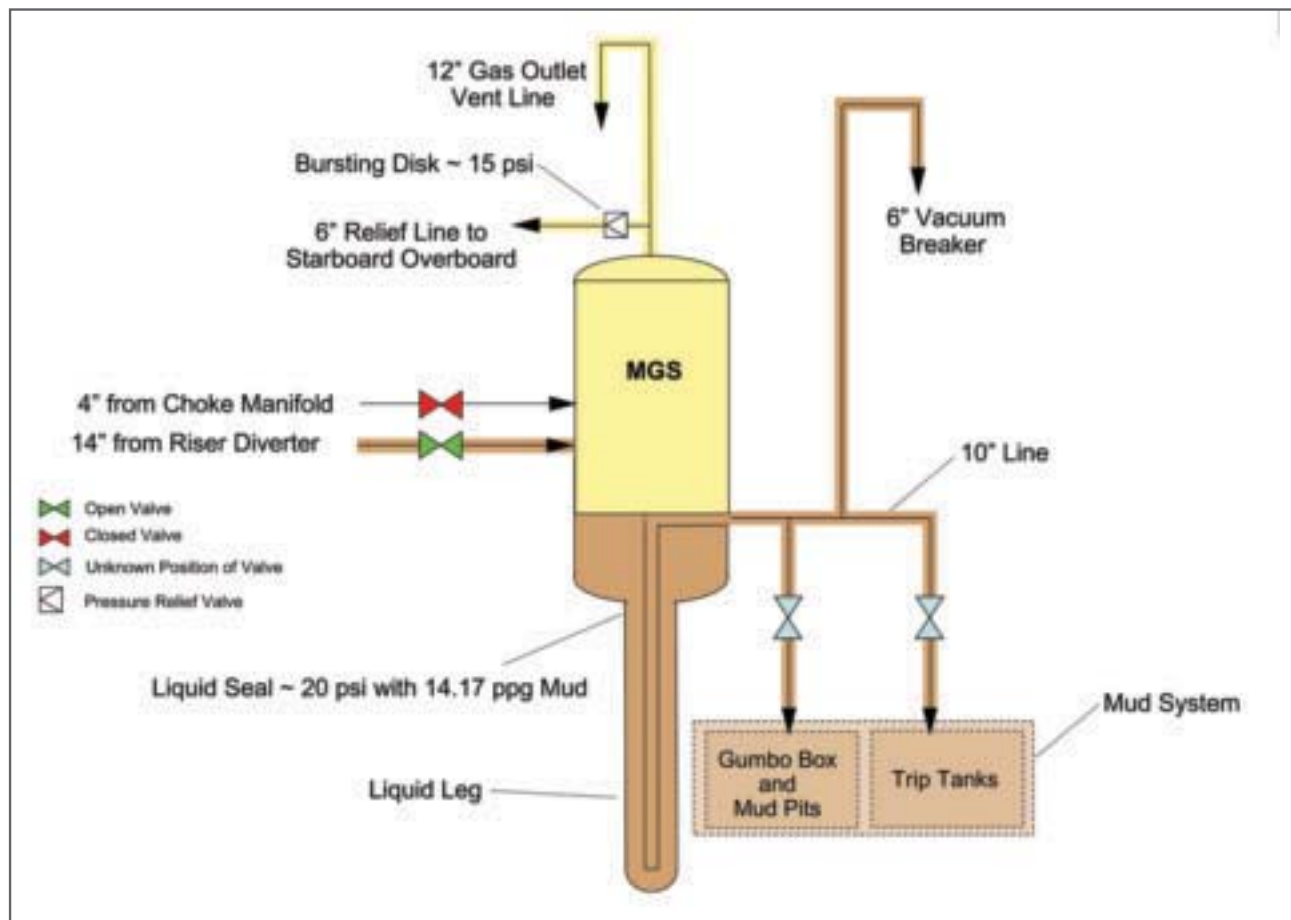
Figure 3. Simplified Drawing of the MGS.

- 14 in. inlet line from the riser diverter.
- 4 in. inlet line from the choke manifold.
- 12 in. outlet vent line terminating at the top of the derrick.
- 10 in. liquid outlet that could be lined up to either the gumbo box or the trip tanks.
- 6 in. relief line flowing overboard to the starboard side.
- 6 in. vacuum breaker terminating approximately one-third of the way up the derrick.

Because the 12 in. MGS outlet vent and the 6 in. vacuum breaker vent were goosenecked, they would have diverted flow back down toward the rig.

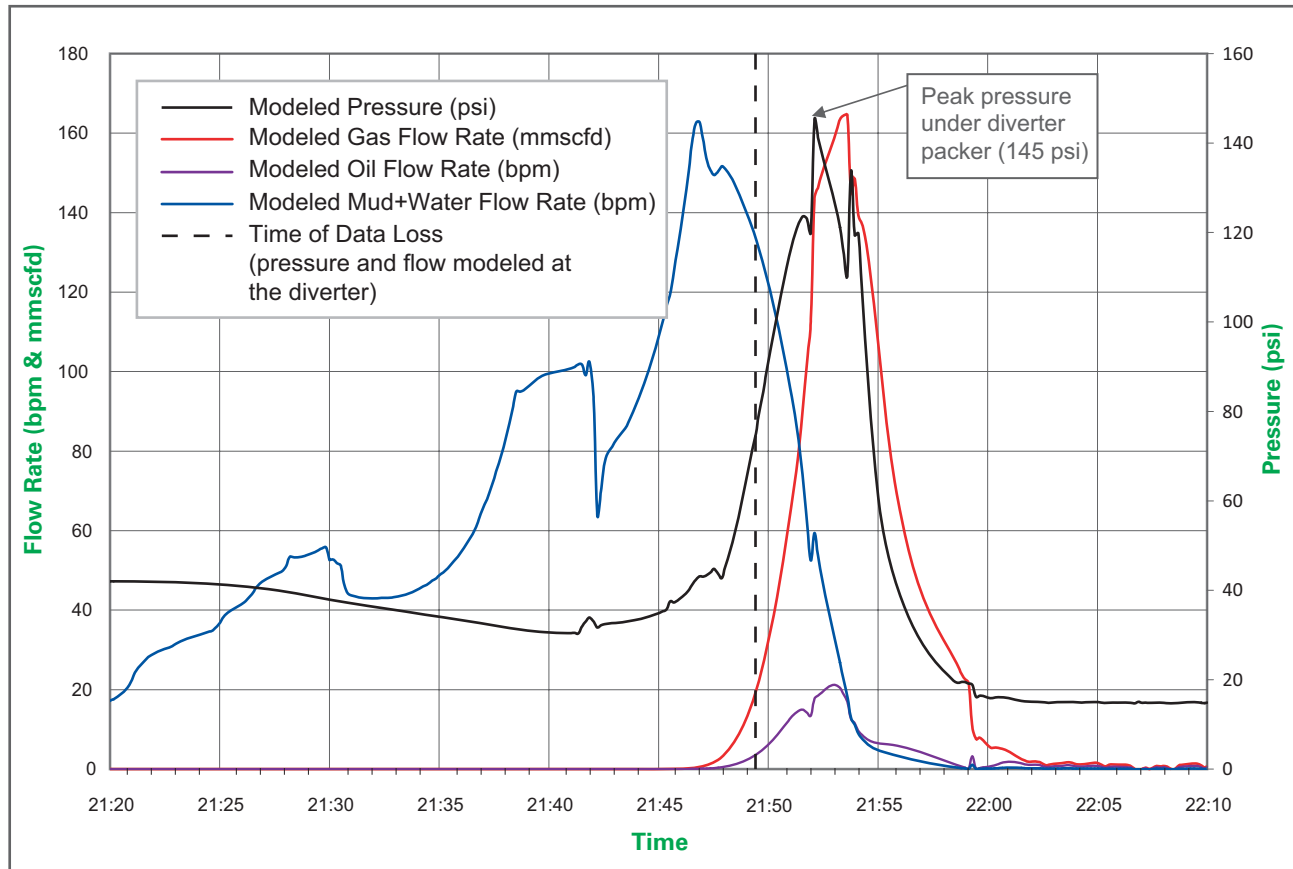
Figure 4. OLGA® Well Flow Modeling Prediction of Backpressure and Flow at the Diverter Packer.

A simplified model of surface equipment was used to determine the backpressure at the diverter packer. As shown in *Figure 4*, this pressure could have reached 145 psi.

At these pressures it was possible that some components of the MGS vessel such as flange connections began to fail, but it was unlikely that the vessel itself ruptured.

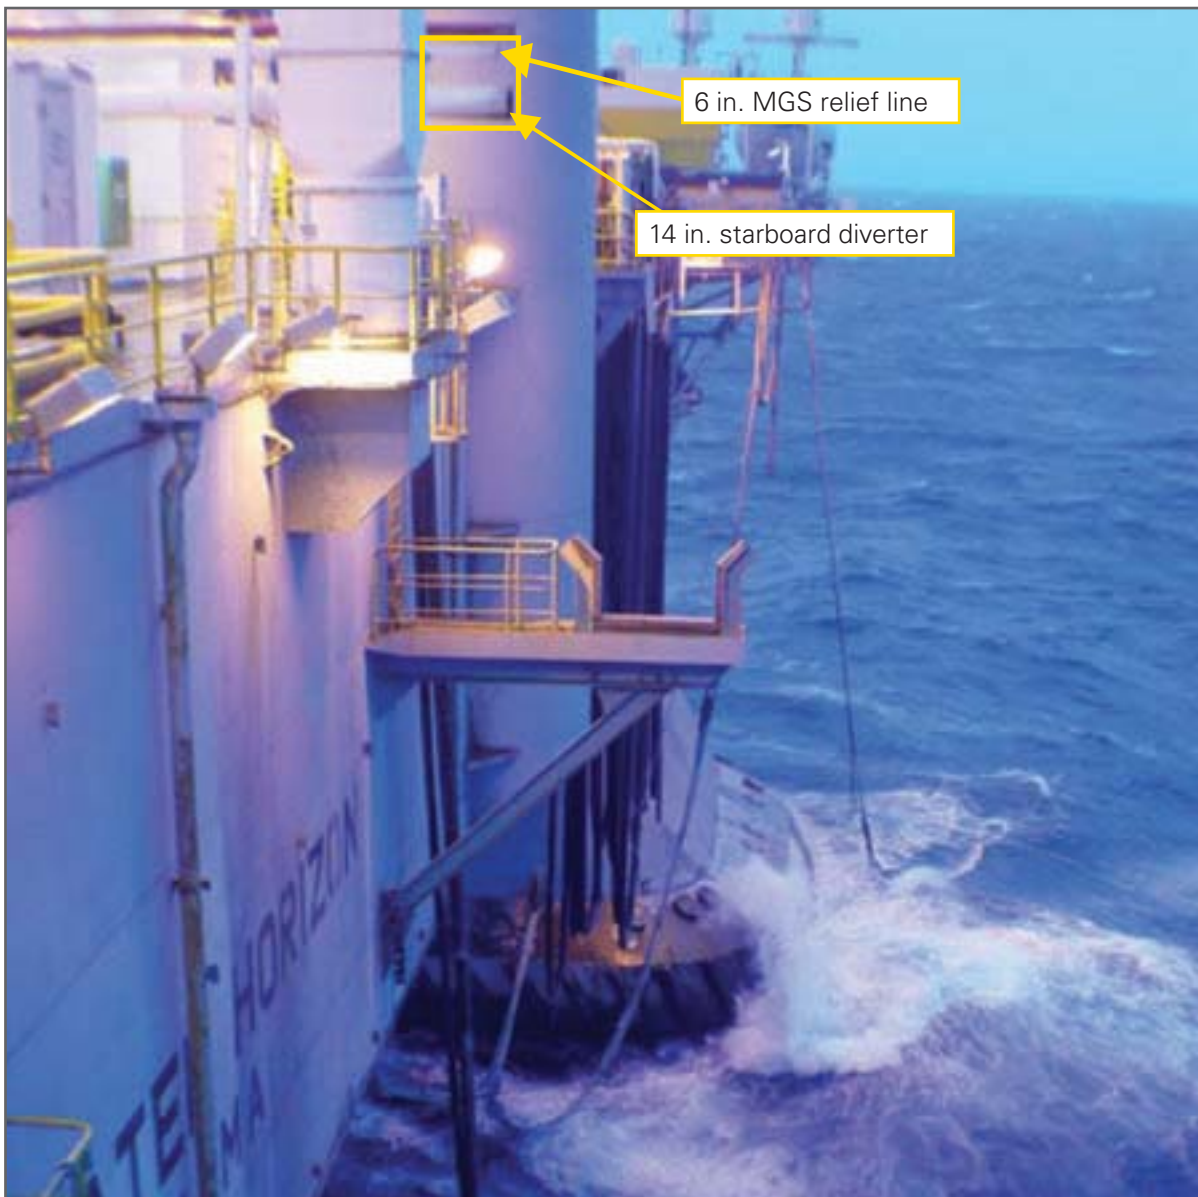
Figure 6. Photograph of Starboard Overboard Lines.

The photograph in *Figure 6* shows that the 6 in. MGS relief line was routed along the same path as the main 14 in. starboard diverter and terminated at the same location on the starboard side of the rig.

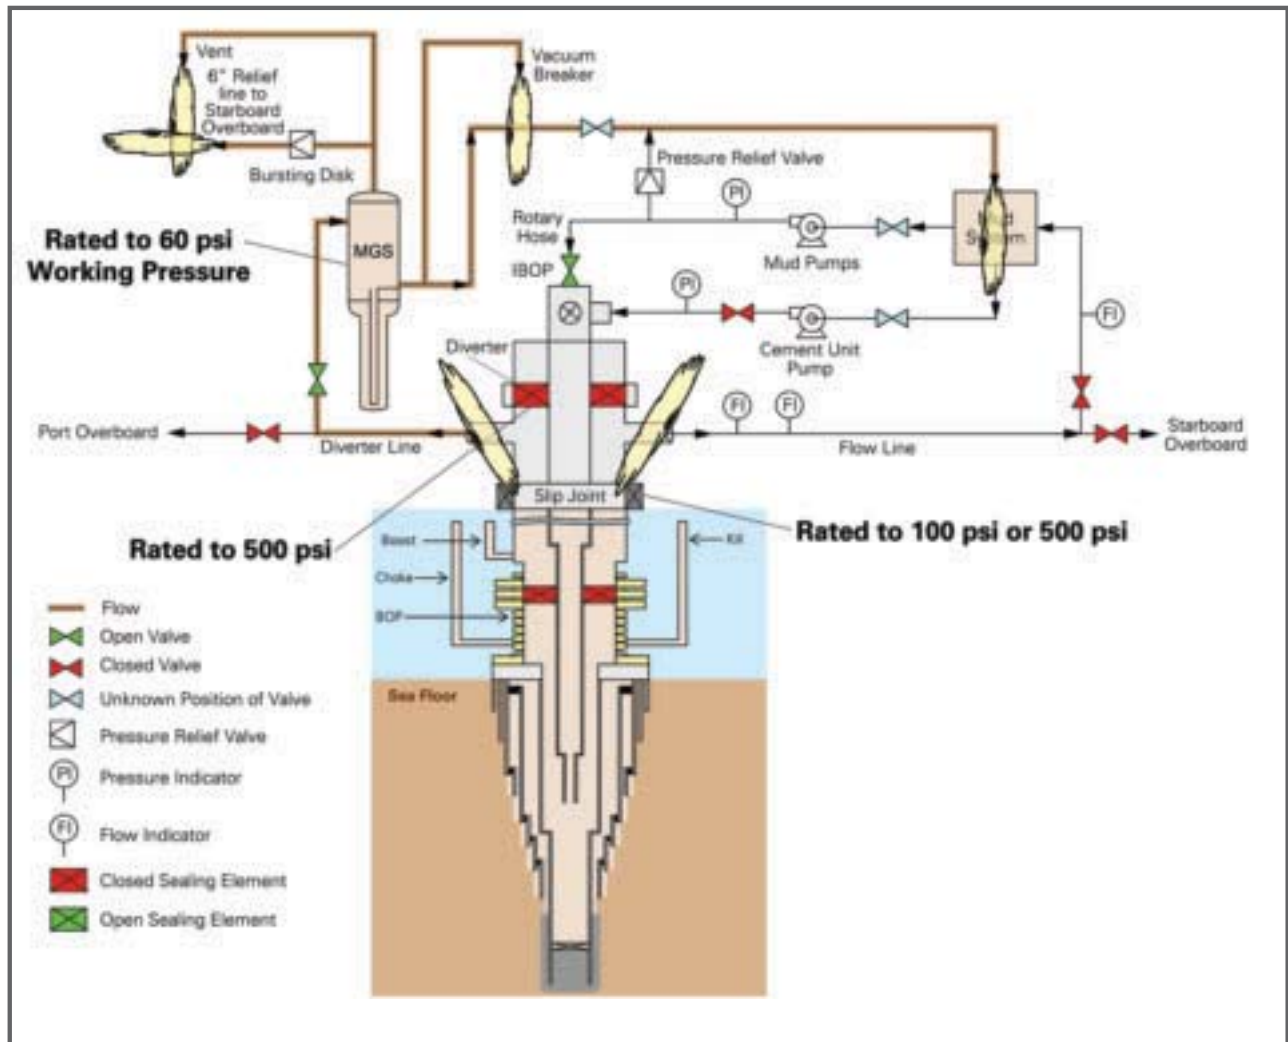
Figure 8. Schematic of Postulated Hydrocarbon Release Locations.

The case presented in this analysis assumes that the 12 in. MGS vent and the 10 in. MGS liquid outlet to the gumbo box, the riser slip joint seal, the MGS 6 in. bursting disk and the 6 in. MGS vacuum breaker vent were all open flow paths. *Figure 8* is a simplified illustration of these open flow paths.

Other scenarios, such as a closed MGS liquid outlet and no equipment failures (all fluid flowing out of the 12 in. MGS vent) or a catastrophic failure of the MGS vessel were possible, but the investigation team believes that these other scenarios would not substantially alter the net effect of the initial gas release.

The design of the MGS system allowed the rig crew to divert riser fluids to the MGS vessel when the well was in a blowout condition. The decision to divert the well through the MGS rather than the starboard diverter increased the potential for the gas to reach an ignition source. (Refer to Figure 8.)

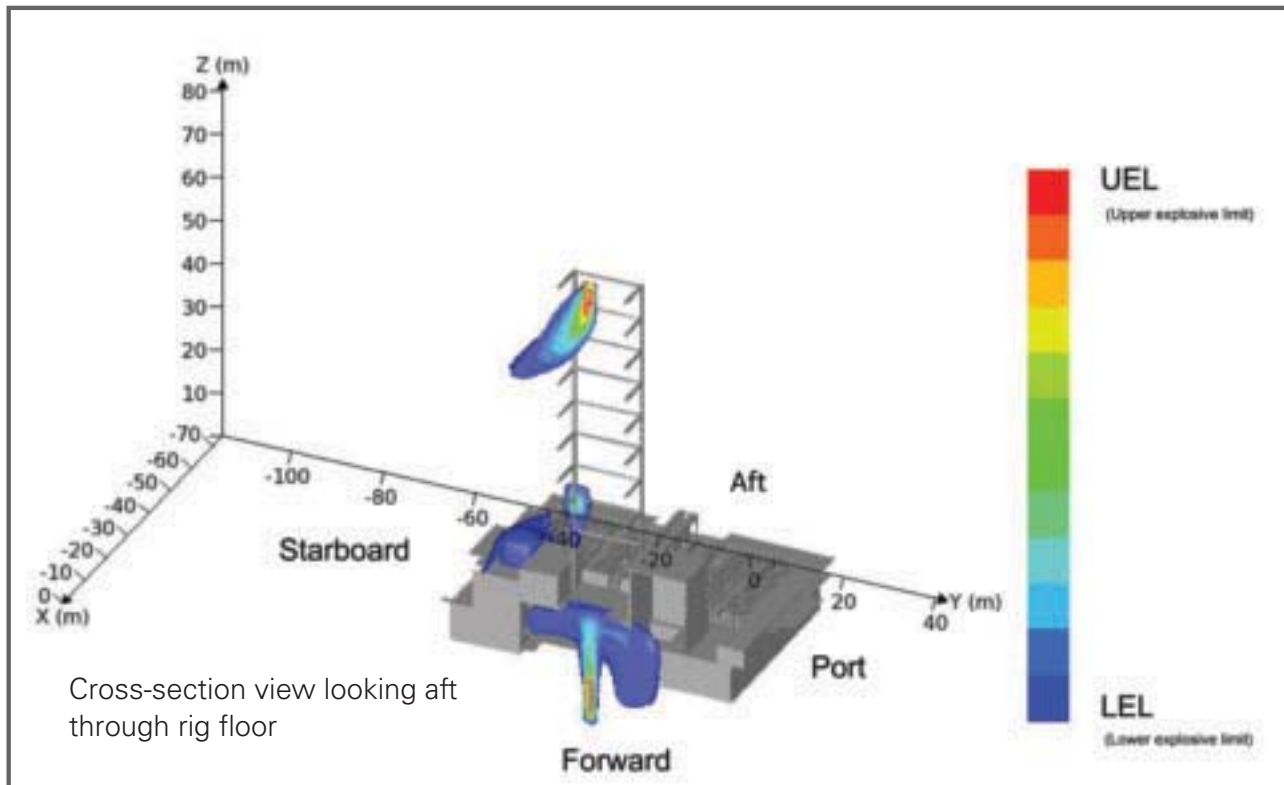
Figure 9. Vapor Dispersion at 100 Seconds.

The graphics in *Figure 9* and *Figure 10* show the modeled outcomes of gas rapidly dispersing across the drilling rig. Gas could have also migrated into enclosed spaces under the deck through the mud system or through the HVAC supply fans for the engine rooms.

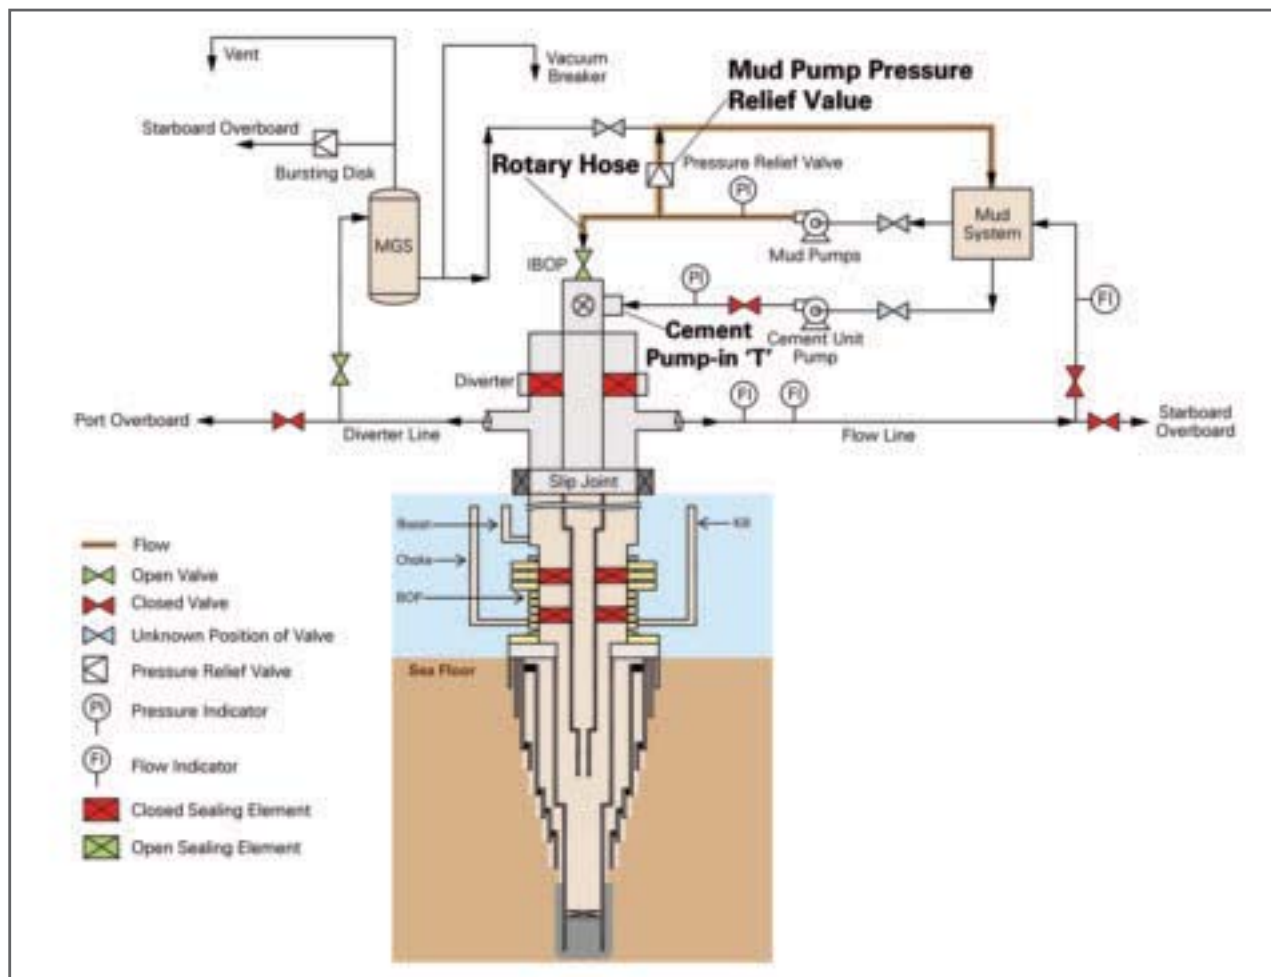
Figure 11. Relevant Surface Equipment Downstream of the IBOP at ~21:47.

It was important to clarify the position of the internal blowout preventer (IBOP) valve, as this determines the number of potential flow paths to the surface if the BOP had closed and sealed. The simplified process flow diagram in *Figure 11* shows that there were two pressure indicators (PIs), each of which was recorded via the real-time data system. One PI measured drill pipe pressure from upstream of the IBOP, and one measured drill pipe pressure from downstream of the IBOP.

With the IBOP open, there were a number of potential failure modes that may have created flow paths that sustained the fire following the initial hydrocarbon release from the riser (Refer to Figure 11):

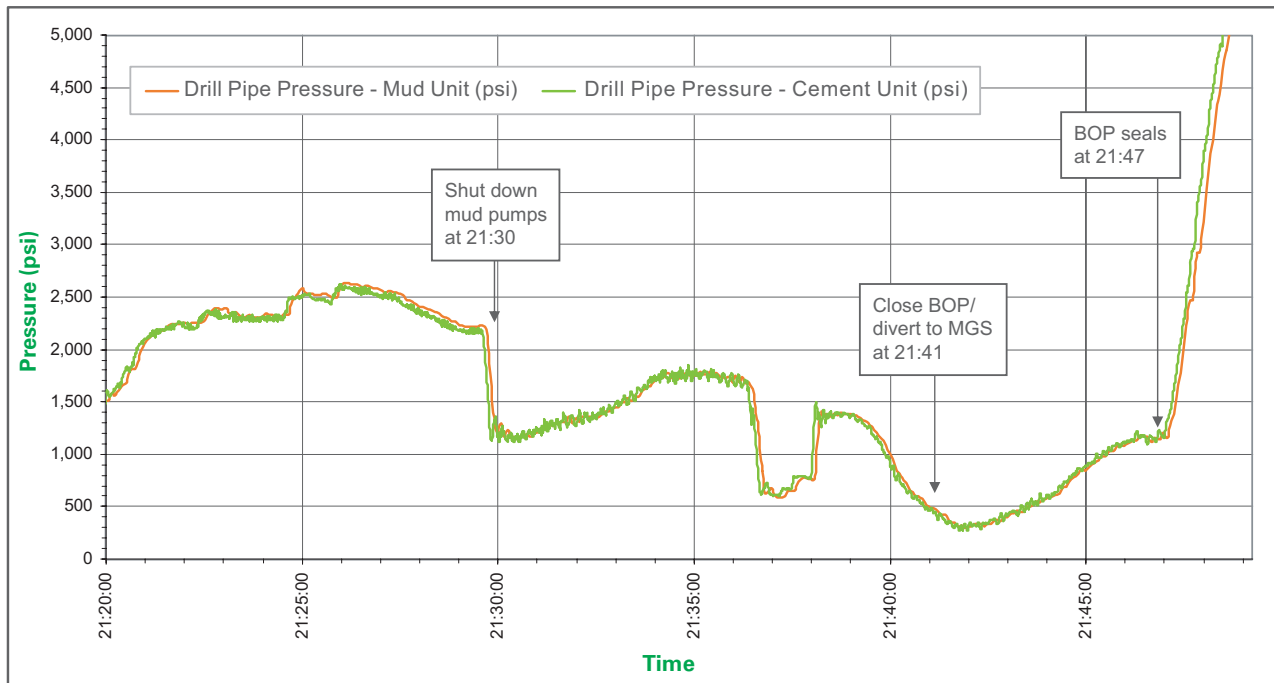
Figure 12. Drill Pipe Pressure Measured at Cement Pump PI and Mud Pump PI.

Figure 12 shows the pressure trend data from each of the PIs during the 30 minutes prior to the loss of power and the explosions. The fact that the trends tracked almost identically over a significant range of changing pressures indicates that the IBOP must have been open.

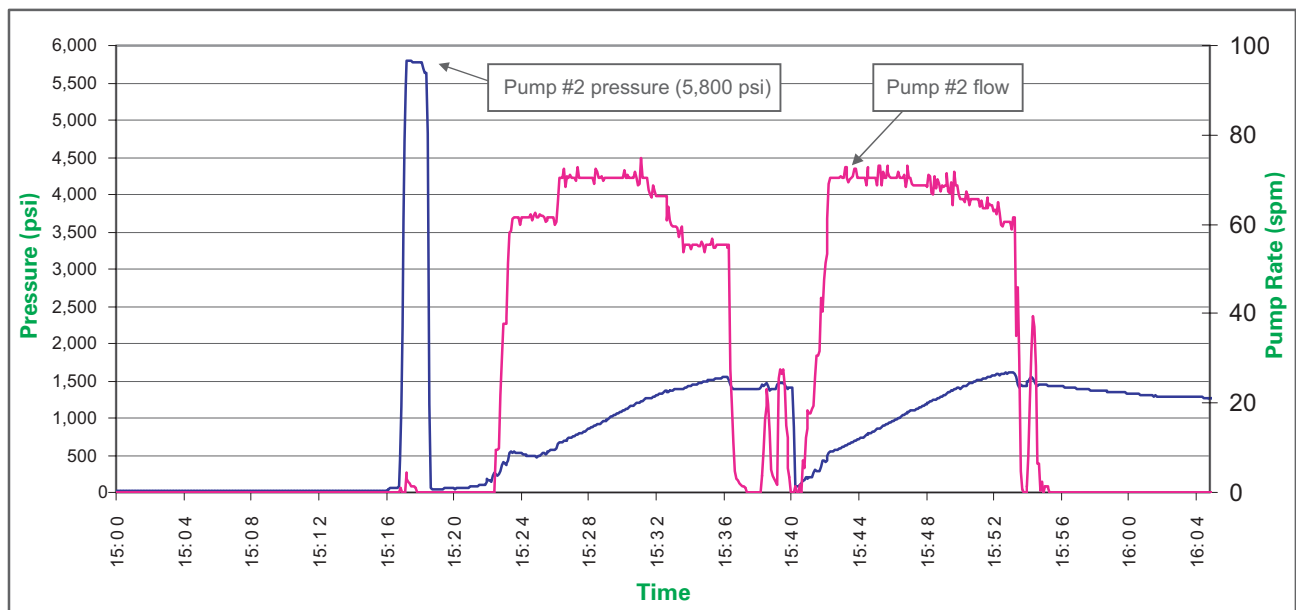
Figure 13. Mud Pump #2 Pressure Plot Showing Line Test During Negative-pressure Test.

Regarding the last of these potential failure modes, analysis of the mud pump PRVs was conducted to determine their likely set pressure (the investigation team was unable to obtain this information directly from Transocean). The investigation team believes that the setpoint for the high-pressure mud pumps' PRVs was approximately 6,000 psi, based on the two reference points from the real-time data pressure readings shown in *Figure 13* and *Figure 14*. These figures show that:

- Mud pump #2 was tested to 5,800 psi during the negative-pressure test procedure at 15:17 hours.
- While trying to start mud pump #2 at 21:17 hours, the pressure increased to 6,000 psi.

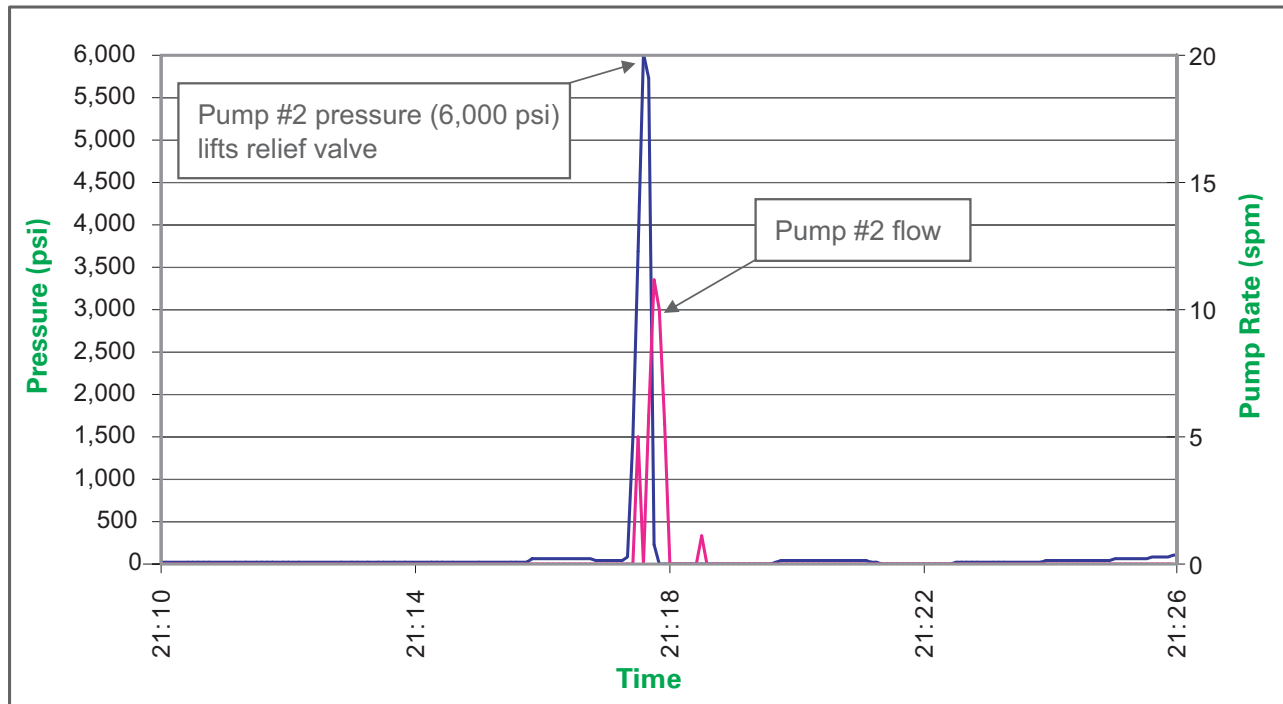
Figure 14. Mud Pump #2 Pressure Plot Showing Lift Pressure of PRV.

The investigation team believes that mud pump #2 was started against a closed discharge valve at 21:17 hours and the PRV lifted.

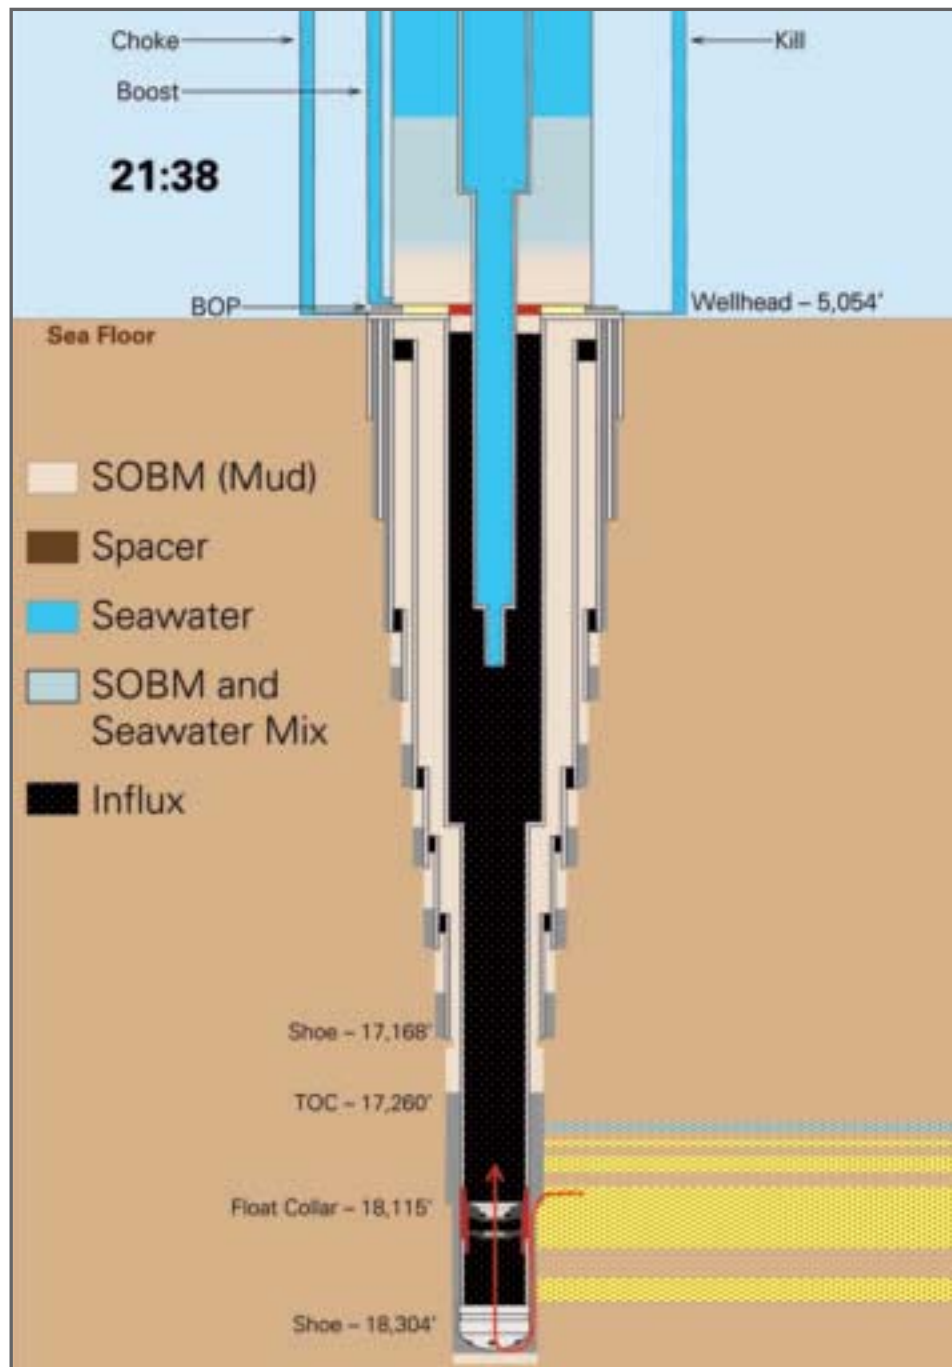
Figure 15. Illustration of Wellbore and Position of Hydrocarbons at 21:38 Hours if BOP Was Closed.

Figure 15 shows a view of the different fluids across the wellbore at 21:38 hours, if the BOP was closed, and illustrates that hydrocarbons would probably have been located below the BOP at that time. In the figure, a sharp interface among different fluids is shown for simplicity of illustration. In reality, there would have been varying degrees of fluid mixing.

The simulations have been proven to be quite sensitive to the net pay assumption. Therefore, the time of 21:38 hours, when hydrocarbons were assumed to be just below the BOP, could be off by 1 or 2 minutes.

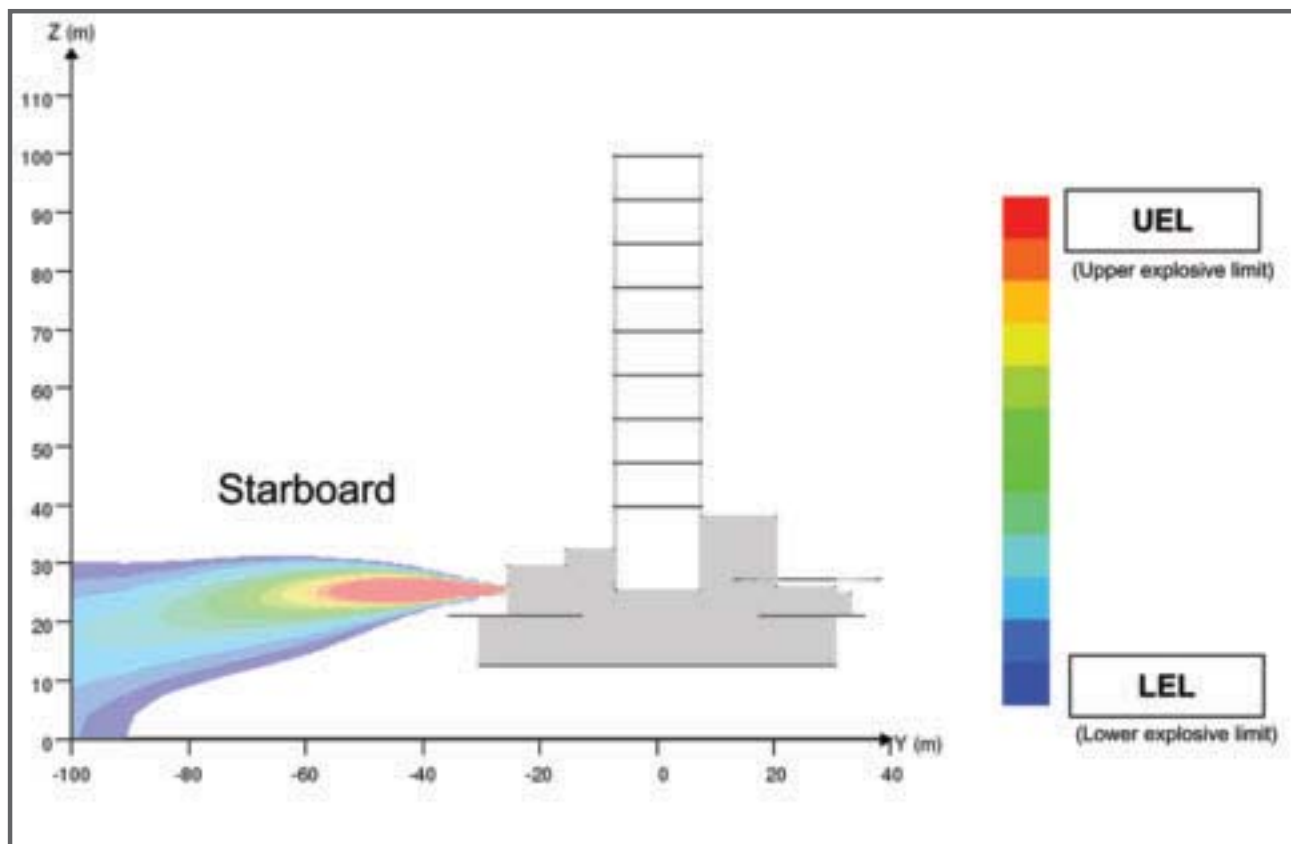
Figure 16. Vapor Dispersion Case for Diverting to the Starboard Diverter.

The investigation team has also concluded that if the well had been lined up to the starboard diverter rather than the MGS, the majority of the gas would have been diverted safely overboard. The pressure increase during the blowout may still have caused a failure of the riser slip joint seals, which would have allowed gas onto the rig floor through the moon pool. However, the majority of the gas would probably have vented through the starboard diverter, reducing the likelihood of hydrocarbons reaching an ignition source and may have reduced the consequences of the event.

Figure 16 shows the likely vapor dispersion pattern based on the orientation of the rig and the prevailing wind conditions on the evening of the accident.

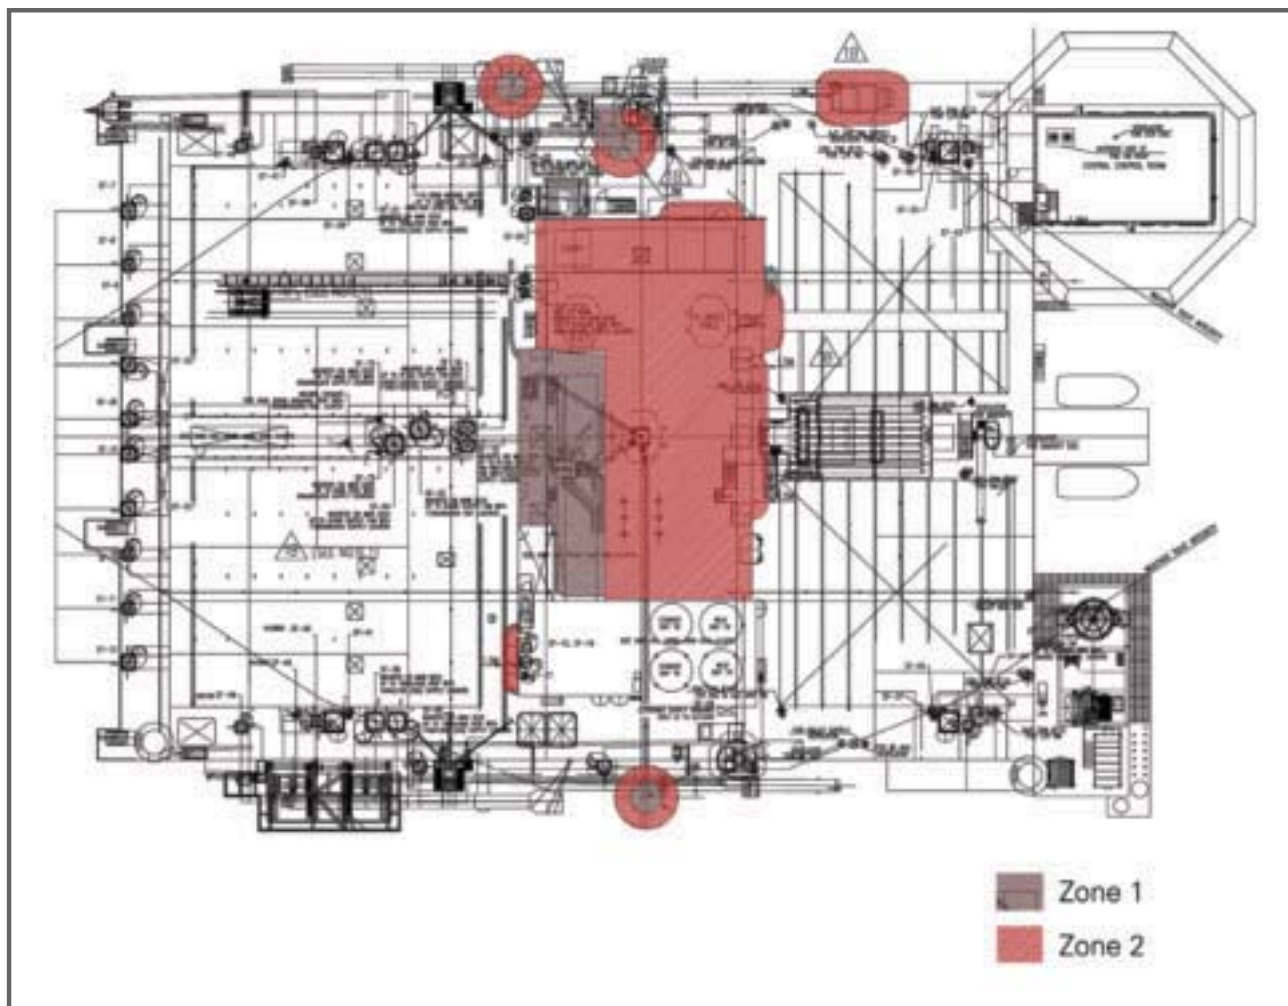
Figure 17. Hazardous Area Classification—Main Deck.

The moon pool and mud pit rooms below the main deck were electrically classified.

The extent of electrically classified areas on *Deepwater Horizon* appeared to be consistent with normal industry practices; however, for gas release events beyond the drill floor, multiple ignition sources could have existed. (Refer to Figure 17.)

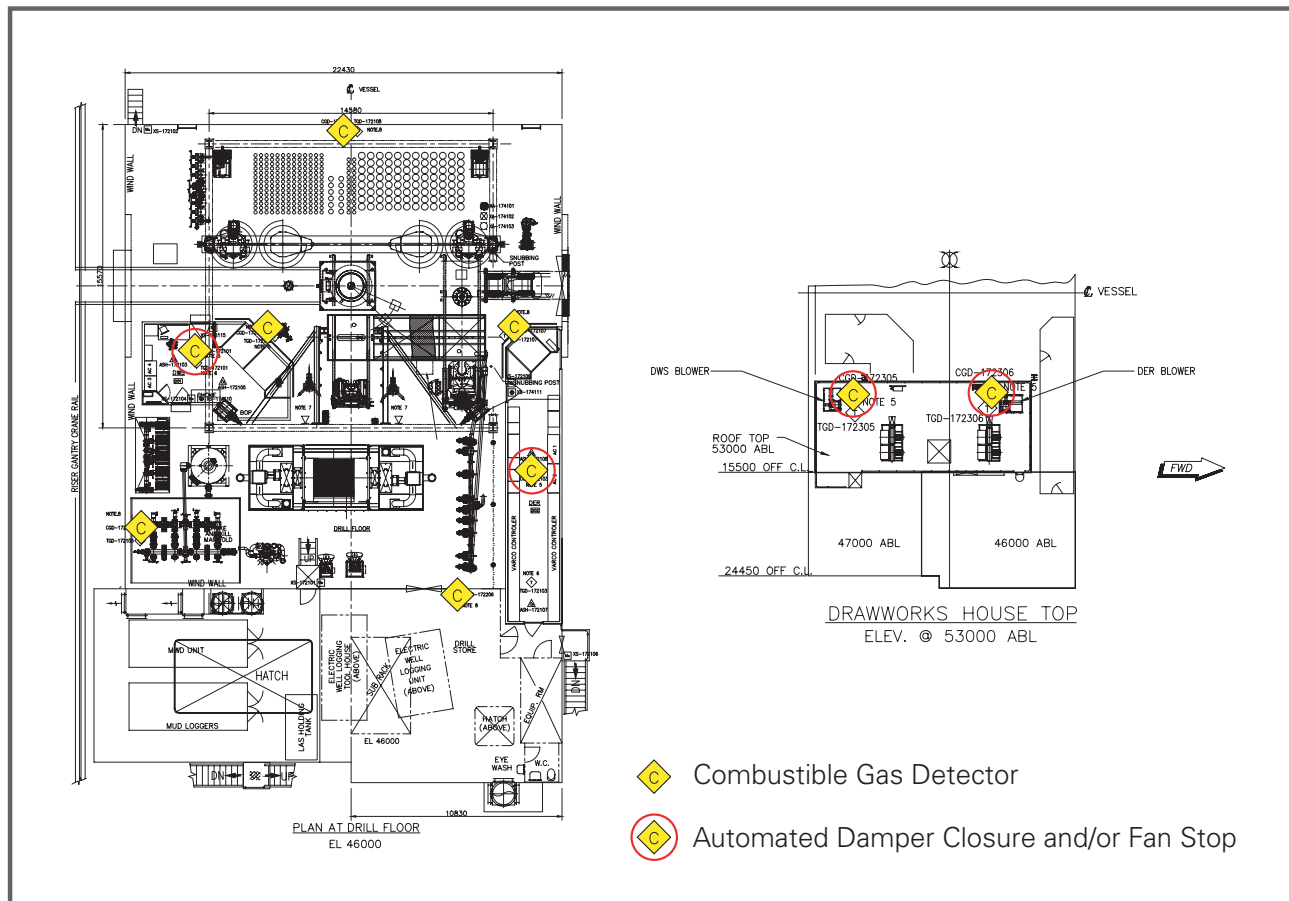
Figure 18. CGD Locations—Drill Floor and Above.

The design of the gas detection system was apparently based on a single CGD at each location. Such a system lacks the redundancy levels associated with a high-reliability design. If a single CGD did not work, was inhibited or was out of commission, the protective functions provided by that device would have been lost. Preliminary analysis of available maintenance records and a recent third party condition assessment indicated that gas detectors were adequately tested and maintained.

The physical locations of the CGDs are shown in *Figure 18* (drill floor and above), *Figure 19* (second deck) and *Figure 20* (main deck). These figures show the 13 CGDs that had automated actions and the 14 CGDs that did not.
