Deepwater Horizon Accident Investigation Report

September 8, 2010

This is the report of an internal BP incident investigation team. The report does not represent the views of any individual or entity other than the investigation team. The investigation team has produced the report exclusively for and at the request of BP in accordance with its Terms of Reference, and any decision to release the report publicly is the responsibility of BP. It has not been prepared in response to any third party investigation, inquiry or litigation.

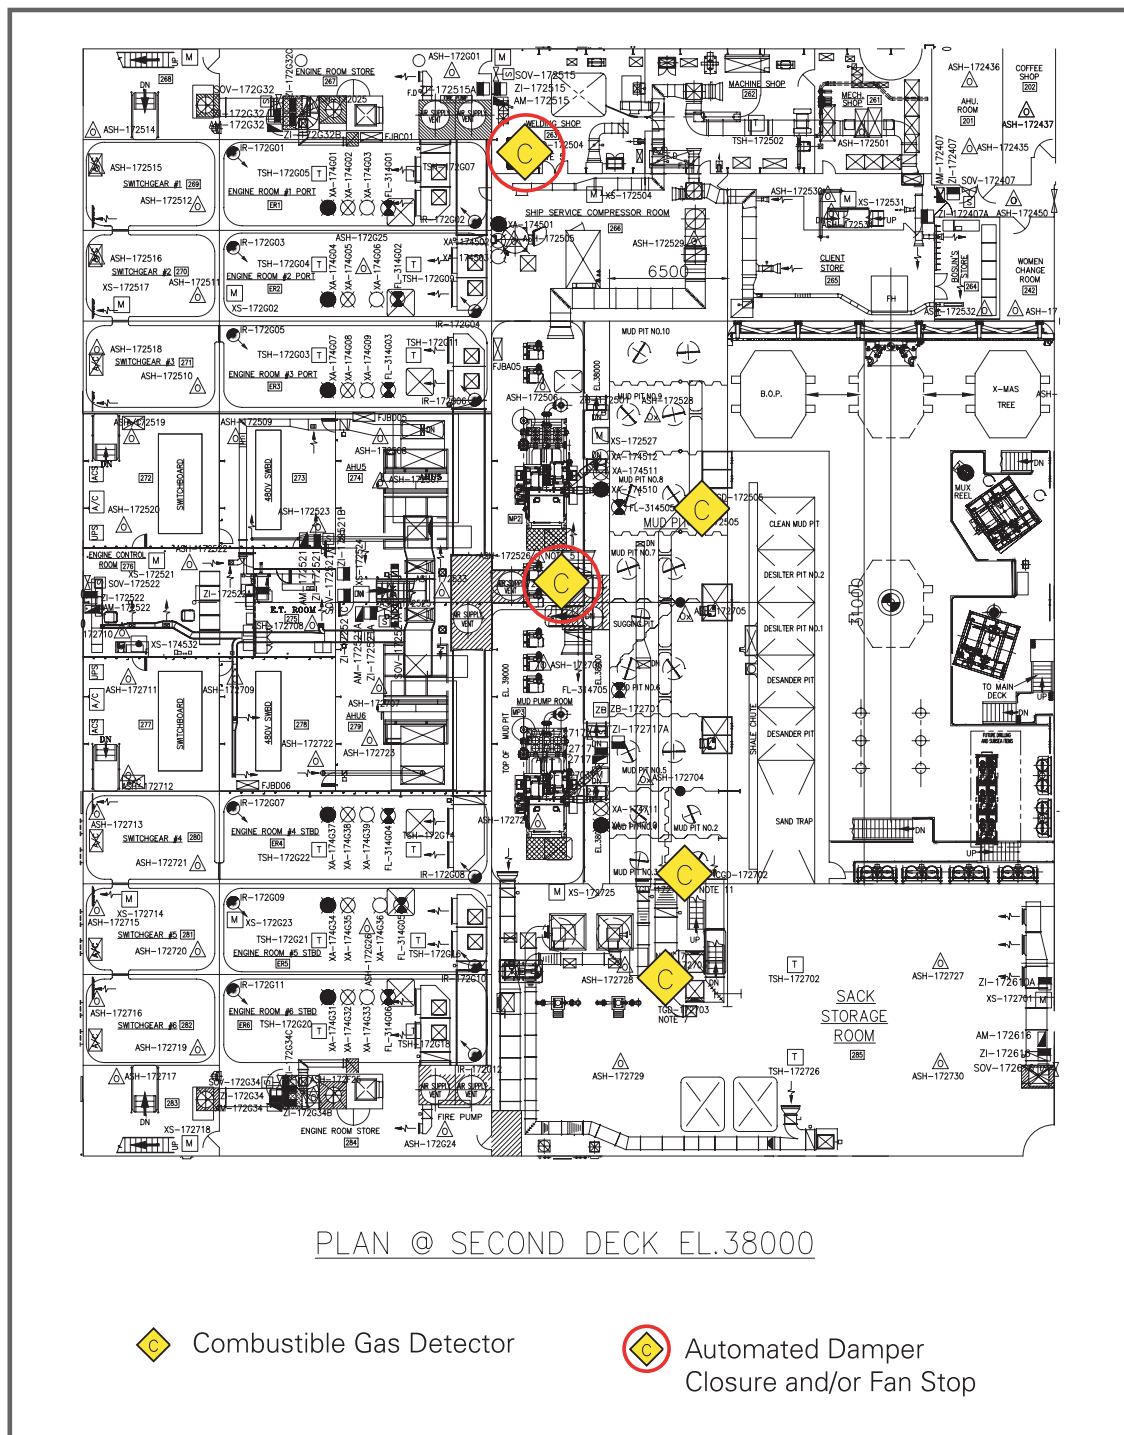
Figure 19. CGD Locations—Second Deck.

The physical locations of the CGDs are shown in *Figure 18* (drill floor and above), *Figure 19* (second deck) and *Figure 20* (main deck). These figures show the 13 CGDs that had automated actions and the 14 CGDs that did not.

The mud pump rooms on the second and third decks were supplied with air from the main deck by two fans located under the aft catwalk. (Refer to Figure 21.) Exhaust was provided by two fans that were also located on the aft deck. (Refer to Figure 21.) According to the C/E matrix in the *MOM*, automated actions should have closed the fire dampers and shut down the ventilation fans to the mud pump rooms upon high-level gas detection. The relevant CGDs were located near the ventilation fan intake on the main deck and in the mud pump room. (Refer to Figure 20 and Figure 19.)

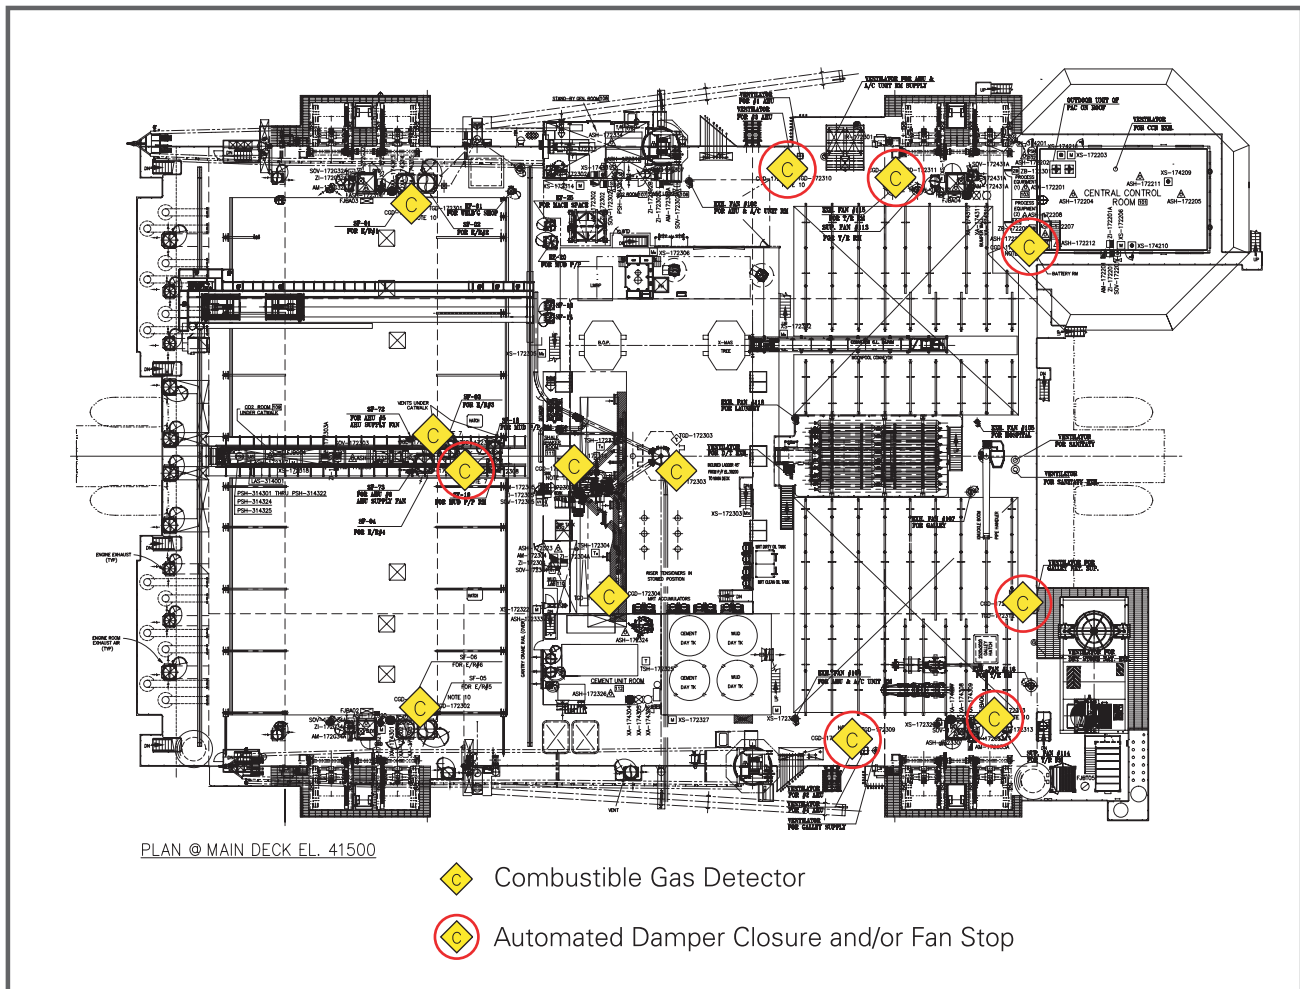
Figure 20. CGD Locations—Main Deck.

CGDs were located near the supply intakes for all the engine rooms, but these CGDs did not have associated automated actions to prevent gas ingress to the engine rooms. Therefore, the investigation team concluded that the HVAC system may have transferred gas into the engine room enclosures.

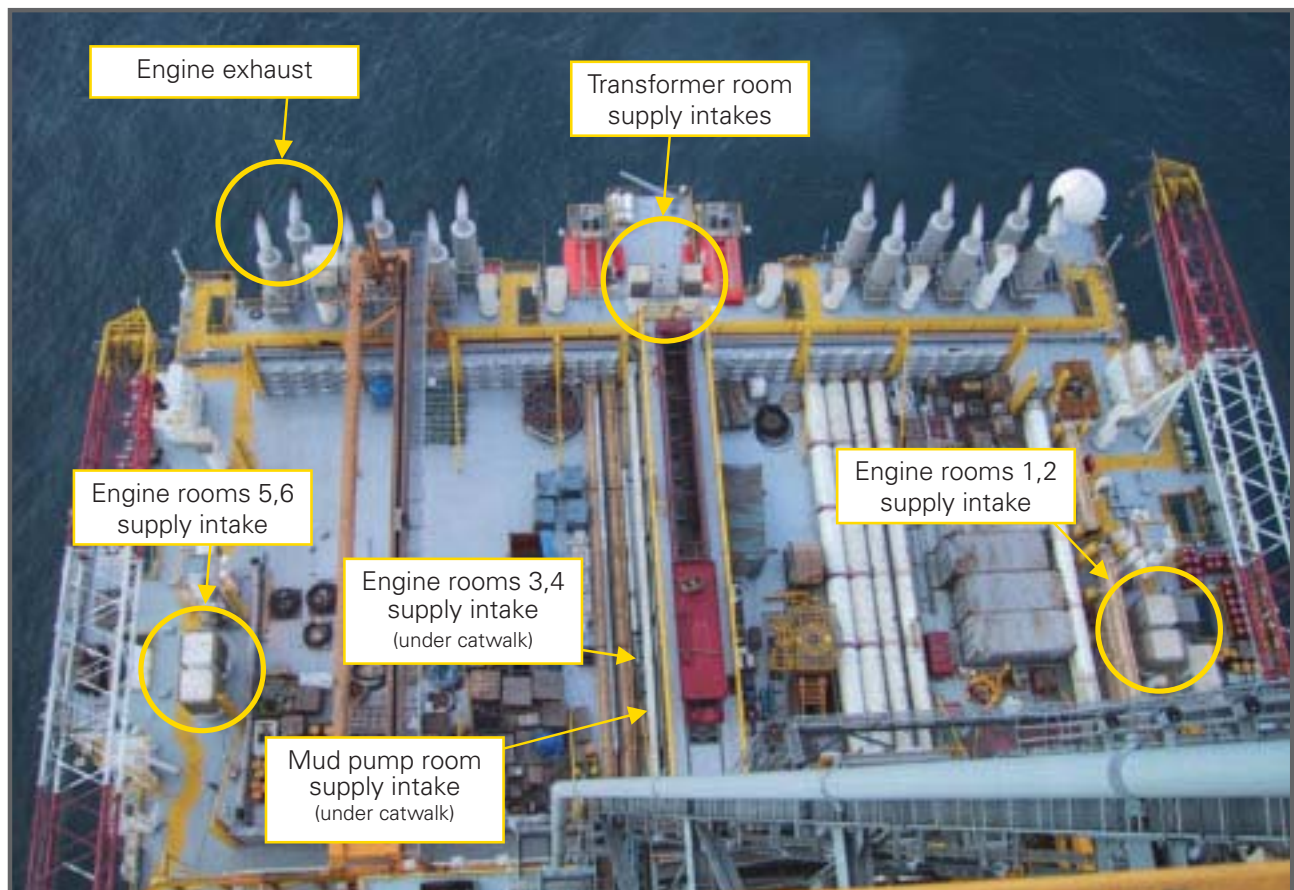
Figure 21. Photograph of Aft Deck of *Deepwater Horizon*.

Most air supply and exhaust vents were located on the main deck of *Deepwater Horizon*. Figure 21 shows a layout of key air supply and exhaust vents on the aft main deck and includes intakes to the engine rooms, mud pump room, aft transformer rooms and typical engine combustion exhaust stacks. The heights of the supply intake units above the main deck were approximately 14 ft. for engine room intakes #1, #2, #5 and #6. The heights above the main deck of the engine room intakes for engine rooms #3 and #4 were approximately 9 ft., presumably to fit under the aft catwalk. The radial distance from the center of the rotary table to engine room intake #3 was approximately 70 ft.

According to the *MOM*, each of the engine rooms had a single supply fan and a single exhaust fan. Air supply was drawn from the aft main deck, as shown in Figure 21. The *MOM* also states that the supply fans provided combustion air to the main generators and cooling air to the engine rooms. Backdraft and solenoid-controlled fire dampers were provided on the engine room air intakes, and solenoid-controlled fire dampers were provided for the engine room exhaust vents. Supply and exhaust fans were controlled and monitored by the integrated automation and control system.

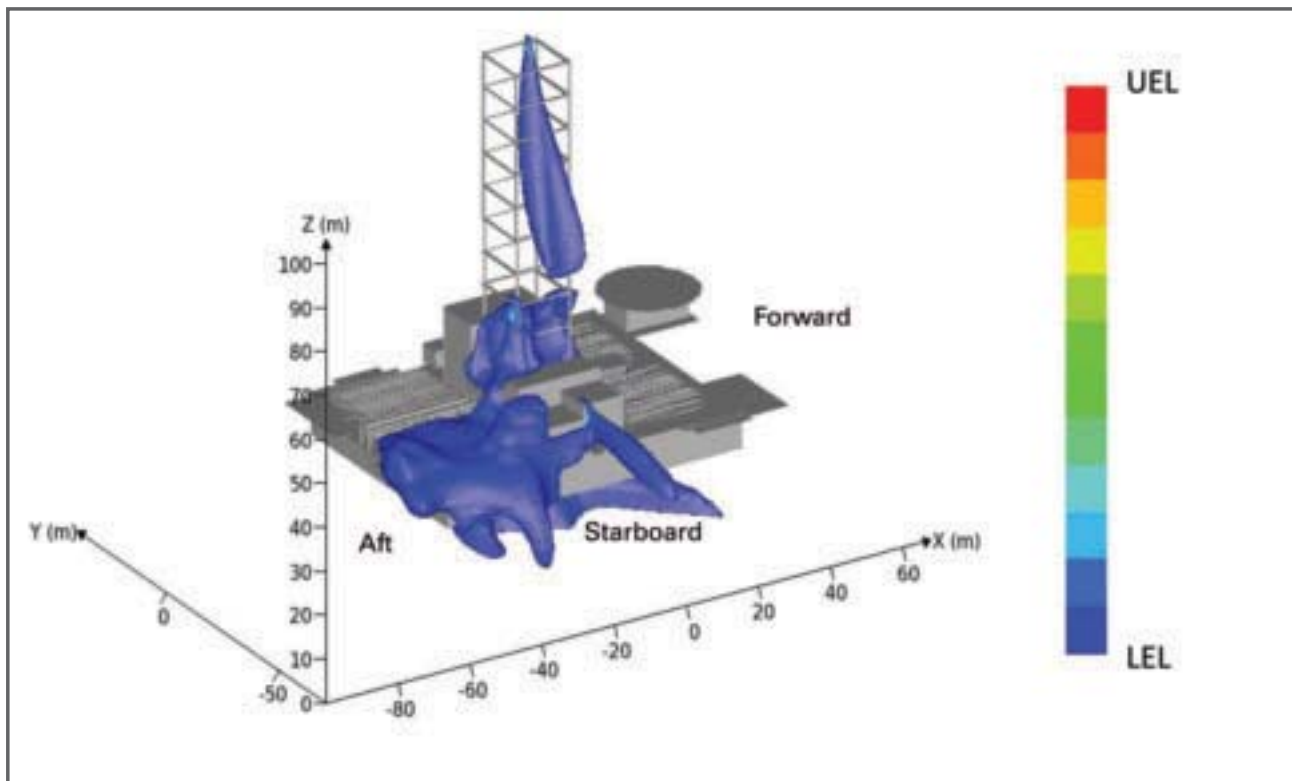
Figure 22. Vapor Dispersion Aft Deck—190 Seconds.

Although the F&G system visual and audible alarms were automatically triggered upon gas detection, there were no automated actions to close the fire dampers or shut down the engine room ventilation fans. *Figure 22* shows the modeled vapor dispersion cloud across the aft main deck 190 seconds after gas reached the surface. Gas would probably have reached the engine room HVAC fans and been transferred into the enclosures for engine rooms #3, #4, #5 and #6.

A review of personnel injury locations (including fatalities) and facility damage accounts suggested that one likely epicenter of the explosion was in the starboard aft quadrant; this corresponded to the area of the rig containing engine rooms #3 and #6 (the running engines) and the mud pump rooms. The initial vapor release probably reached the HVAC intakes in this area. (Refer to Figure 22.)

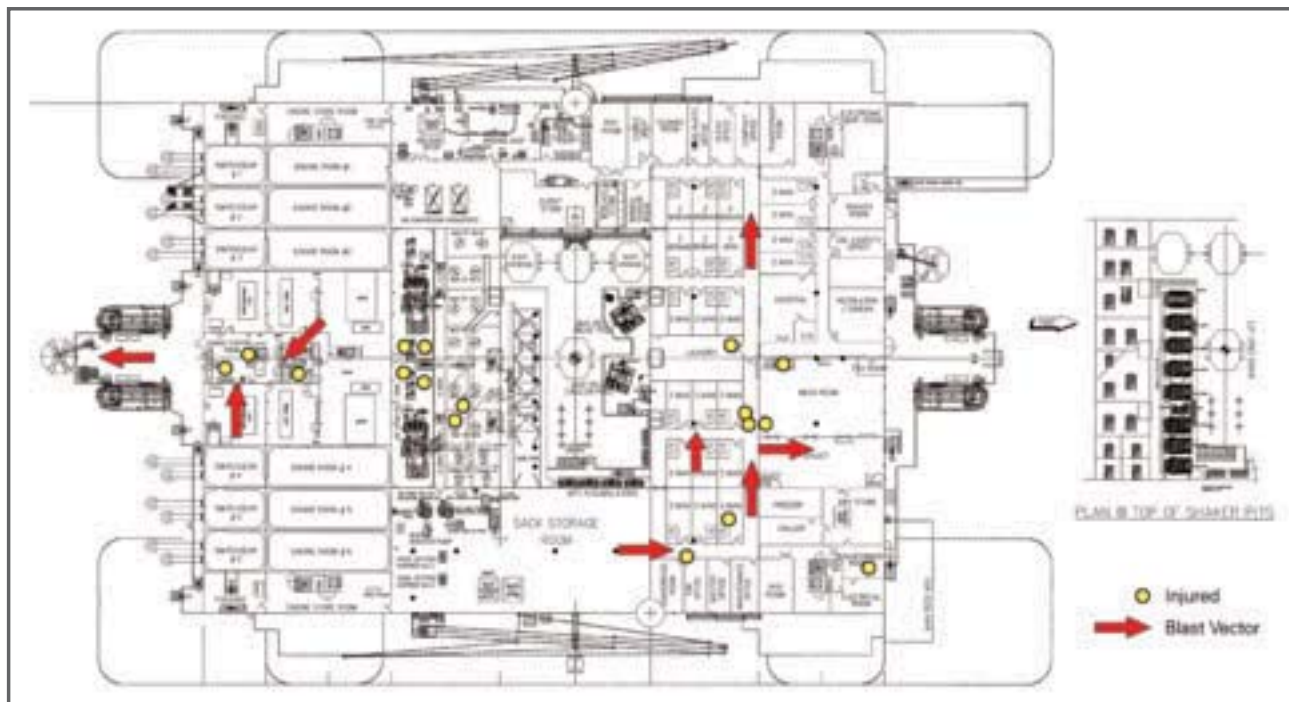
Figure 23. Second Deck Damage Vector Diagram.

The blast over-pressure that occurred at the second deck level created a pressure wave that caused significant damage to the aft starboard side of the accommodations area, where multiple personnel injuries occurred. This pressure wave also caused significant damage to the engine control room on the second deck level at the aft end of the rig. (Refer to Figure 23.)

There was at least one major explosion at the second deck level, which created significant over-pressure and caused structural damage.

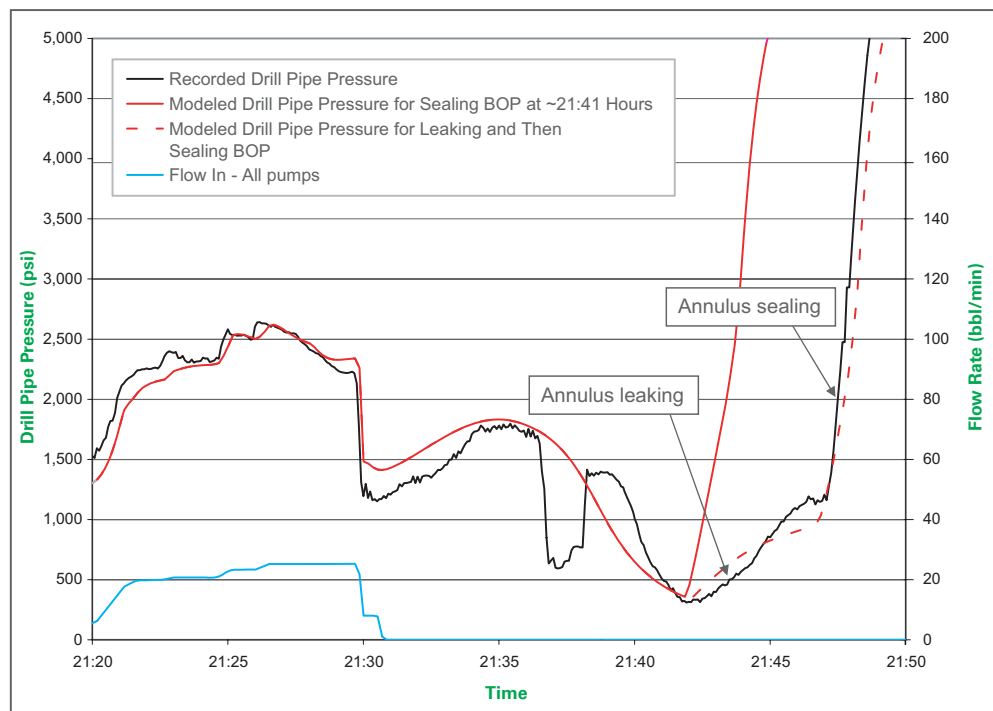
Figure 1. Drill Pipe Pressure—OLGA® Well Flow Modeling of Drill Pipe Pressure for a Closing BOP Versus Recorded Data.

The recorded surface data, from approximately 21:41 hours to 21:49 hours on April 20 (the time at which Sperry-Sun real-time data stopped transmitting), is critical to understanding the BOP operation prior to the explosions. The data suggests that the normal mode of BOP operation sealed the annulus less than 2 minutes prior to the loss of data transmission just before the explosions. (Refer to *6. Modes of BOP Operation* of this analysis, which provides a discussion of BOP normal and emergency modes of operation.) The BOP closed, but it was slow to seal. Based on the evidence and analysis to date, it is not certain which BOP components were operated to seal the annulus prior to the explosions. It is likely that a variable bore ram (VBR) eventually sealed the annulus.

As established in *Analysis 5B.*, the rig crew activated the BOP at approximately 21:41 hours. *Figure 1* shows the results from the OLGA® well flow modeling of the BOP as activated at 21:41 hours and closing and sealing the annulus in 30 seconds (solid red curve). (Refer to *Appendix W. Report—Dynamic Simulations Deepwater Horizon Incident BP*) However, the recorded drill pipe pressure (solid black curve) indicates that the annulus was sealed approximately 5 minutes later than the OLGA® well flow modeling predictions. Further OLGA® well flow modeling of the BOP closing in 30 seconds, but allowing leakage past the annular preventer for 5 minutes before fully sealing the annulus, resulted in a drill pipe pressure (dashed red curve) that closely followed the recorded pressure. This analysis indicates that the BOP closed within the expected time, but it did not fully seal for another 5 minutes.

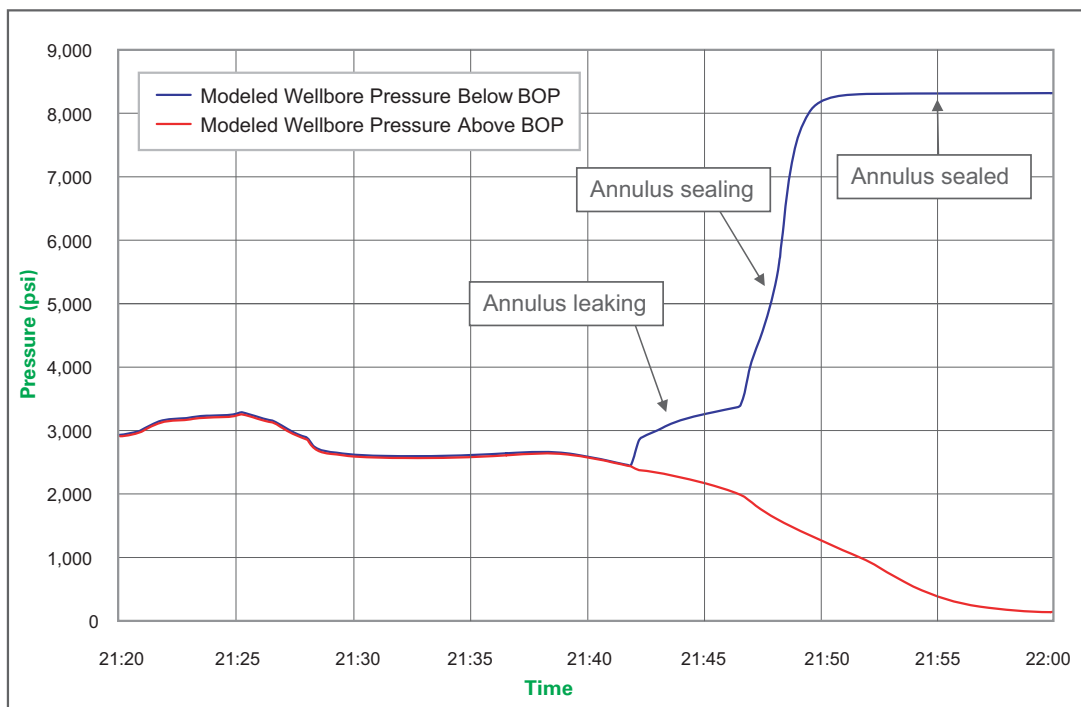
Figure 2. OLGA® Well Flow Modeling of Wellbore Pressure for a Leaking and Sealing Annular Preventer.

Wellbore pressure simulation using OLGA® well flow modeling indicates a differential pressure across the annular preventer of over 8,000 psi after the annulus was sealed. (Refer to Figure 2.) Given that the lower annular preventer was rated at 5,000 psi working pressure, it might not have held a differential pressure of over 8,000 psi. It is therefore less likely that the lower annular preventer would have sealed the annulus.

The annular preventer likely leaked for 5 minutes before the annulus was sealed. Given this finding combined with the evidence suggesting that at least one VBR could have been closed by the rig crew, it is likely that a VBR eventually sealed the annulus. (Refer to 4.1 of this analysis.) However, events subsequent to the explosion and fire could have impaired the integrity of the seal. (Refer to 4.2 *Status of the Drill Pipe Across the BOP After the Explosion* of this analysis.)

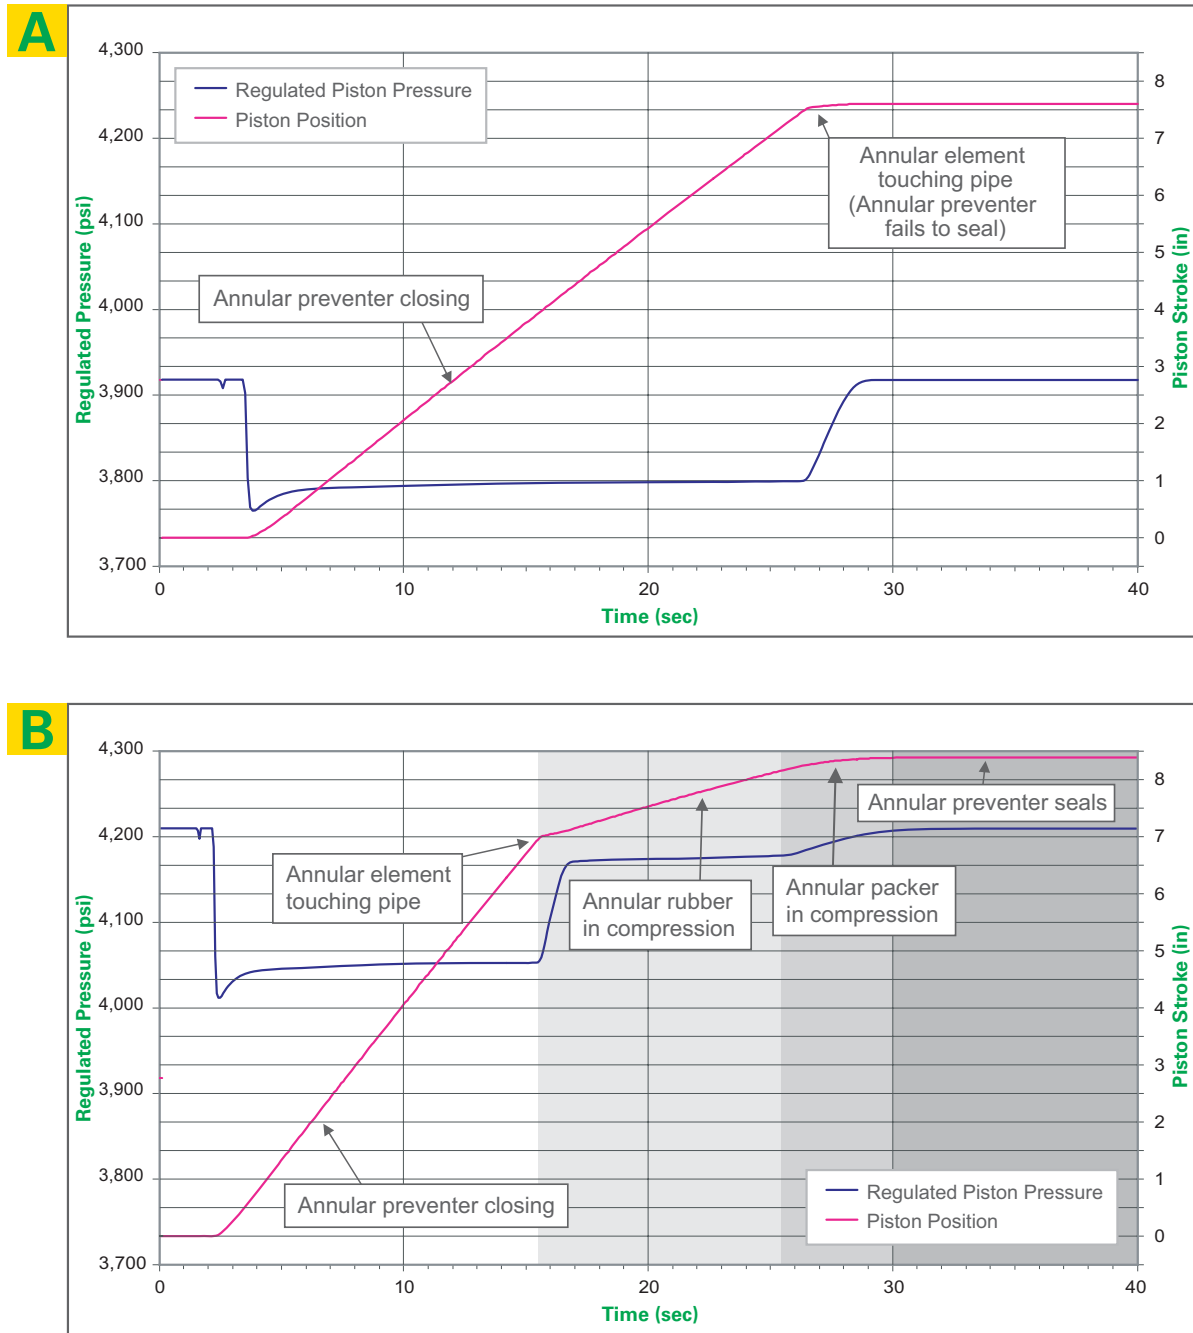
Figure 5. Hydraulic Analyses of an Annular Preventer.

Figure 5 shows the dynamic response of an annular preventer at 5,000 ft. water depth (WD) operating under 1,700 psi and 2,000 psi regulated closing pressures. (Refer to Figure 5.) (Hydraulic pressures in this analysis are quoted in terms of differential pressure, which is the difference between the hydraulic system pressure and the hydrostatic pressure at the sea bed.) The wellbore pressure at the time of the closure of the annular preventer was approximately 2,500 psi. To represent an annular preventer closing in a flowing condition, the simulated pressure in the BOP was increased from 2,500 psi to the shut-in pressure of approximately 8,000 psi as the annular preventer elastomeric element was about to touch the drill pipe.

The dynamic response of the annular preventer operating under 1,700 psi regulated pressure indicated that the annular preventer failed to seal due to rapid increase in wellbore pressure as shown in *Figure 5(A)*. Hydraulic analysis further indicates that an annular preventer would seal around the pipe under a regulated pressure setting of 2,000 psi, as shown in *Figure 5(B)*.

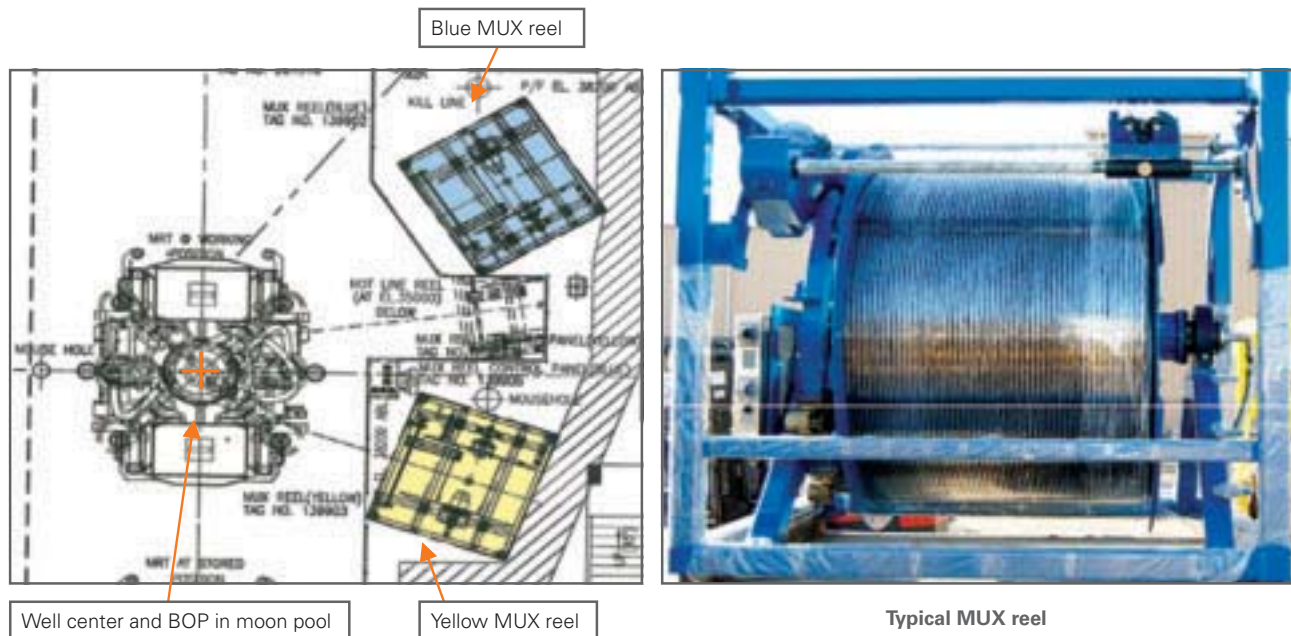
Figure 6. Moon Pool Layout Showing the Location of Blue and Yellow MUX Reels.

The subsea supervisor testified during the MBI hearings on May 26–29, 2010, that the TCP had a low accumulator alarm indicating loss of hydraulic power. The witness testified, “I hit the EDS button. Everything in the panel did like it was supposed to at the panel, but it never left the panel. I had no hydraulics.” This account suggests that the EDS did not initiate. Both methods, high-pressure BSR and EDS, would have required communication with the BOP control pod through MUX cables.

The MUX reels were located in the moon pool area within the explosion and fire zone. (Refer to Figure 6.) Since the MUX cables were not protected against explosions or fire, it is very likely that the early explosion and fire damaged the MUX reel slip rings and the cables to the extent that the communication line and electrical power required to initiate the high-pressure BSR and EDS functions were no longer available.

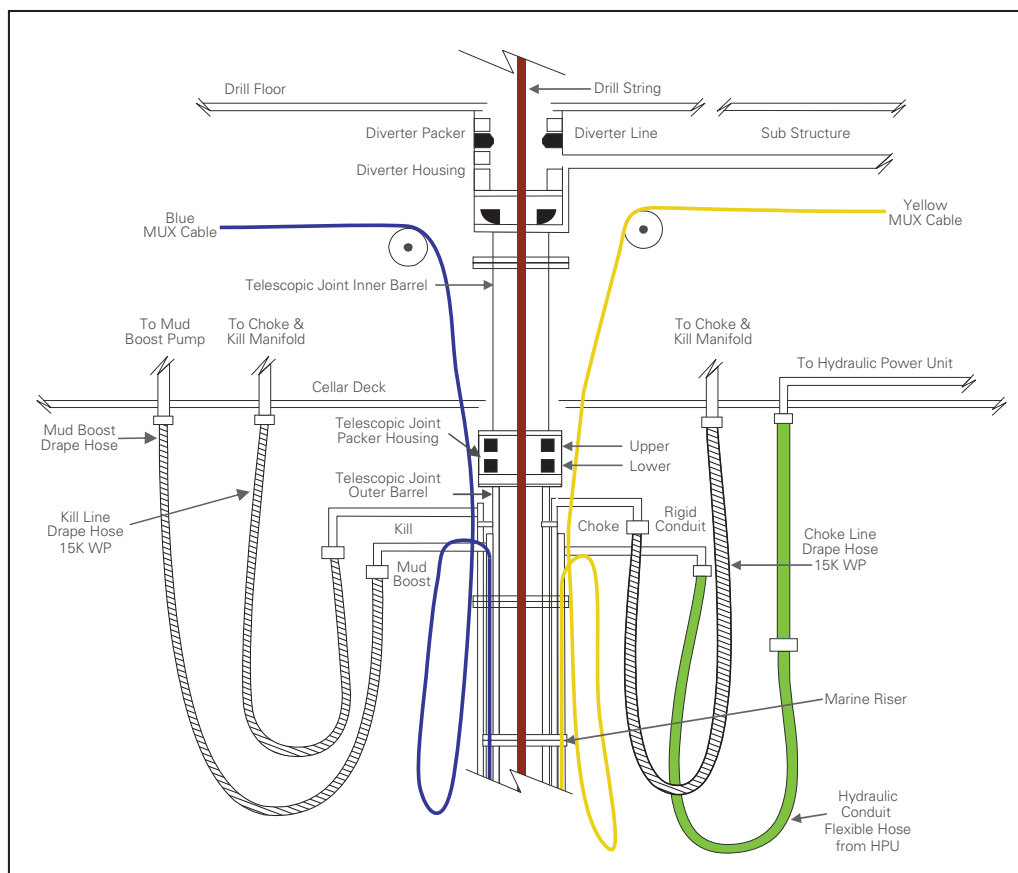
Figure 7. Typical Configuration of Flexible Hoses in the Moon Pool.
(Hydraulic conduit flexible hose is shown in green).

The AMF sequence is initiated when electrical power, communications and hydraulic pressure are lost to both pods. To initiate an AMF, all three services must fail (i.e., after damage to the MUX reels or cables and to the hydraulic conduit, caused by explosions and fire). As indicated in 3.1 of this analysis, the MUX cables, which carry electrical power and communications, were vulnerable to explosion and fire damage. Though the hydraulic conduit flexible hose was less vulnerable to damage than the MUX cables, it was located close to the MUX cables in the moon pool and could have been damaged by the explosions and fire. (Refer to Figure 7.)

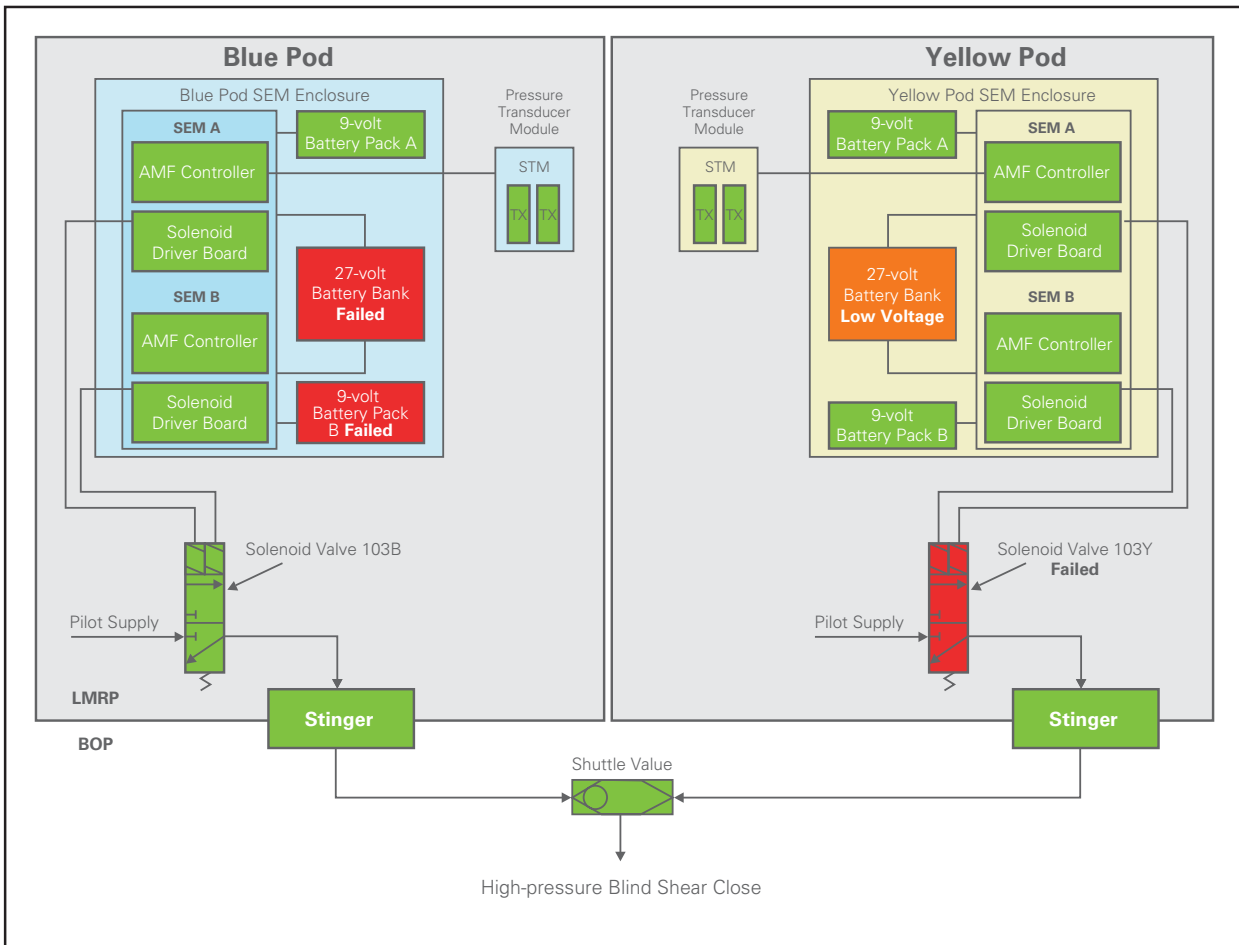
Figure 8. Simplified Schematic of the AMF Control System.

During the yellow pod test performed by Transocean and Cameron after the accident, both coils on solenoid valve 103 failed to energize, suggesting electrical coil faults. The investigation team found no evidence that this failure occurred after the accident; rather, the team concluded that this failure condition very likely existed prior to the accident. (Refer to 5.1 *Maintenance* of this analysis.) A faulty solenoid valve 103 would mean that the yellow pod could not have performed the AMF sequence, as no pilot

signal could have been sent to the pilot-operated control valve to activate the high-pressure BSR close function. As described in *5.5 Monitoring and Diagnostic Capability* of this analysis, the rig's BOP control diagnostic system should have been capable of remotely detecting the faulty solenoid valve and recording it on the system event logger.

Figure 8 shows a simplified schematic of the AMF system. There were two 9-volt battery packs and a 27-volt battery bank (made up of 3 packs of 9-volt batteries connected in series) in each pod. These batteries were not rechargeable. The 9-volt AMF battery packs were used to power the AMF card processors. When the AMF was enabled, these batteries provided continuous power to the AMF cards. The 27-volt battery bank was used to provide power to the 24-volt rated AMF card relays, the pressure sensors and the solenoid valves that were used in the AMF sequence, including solenoid valve 103.

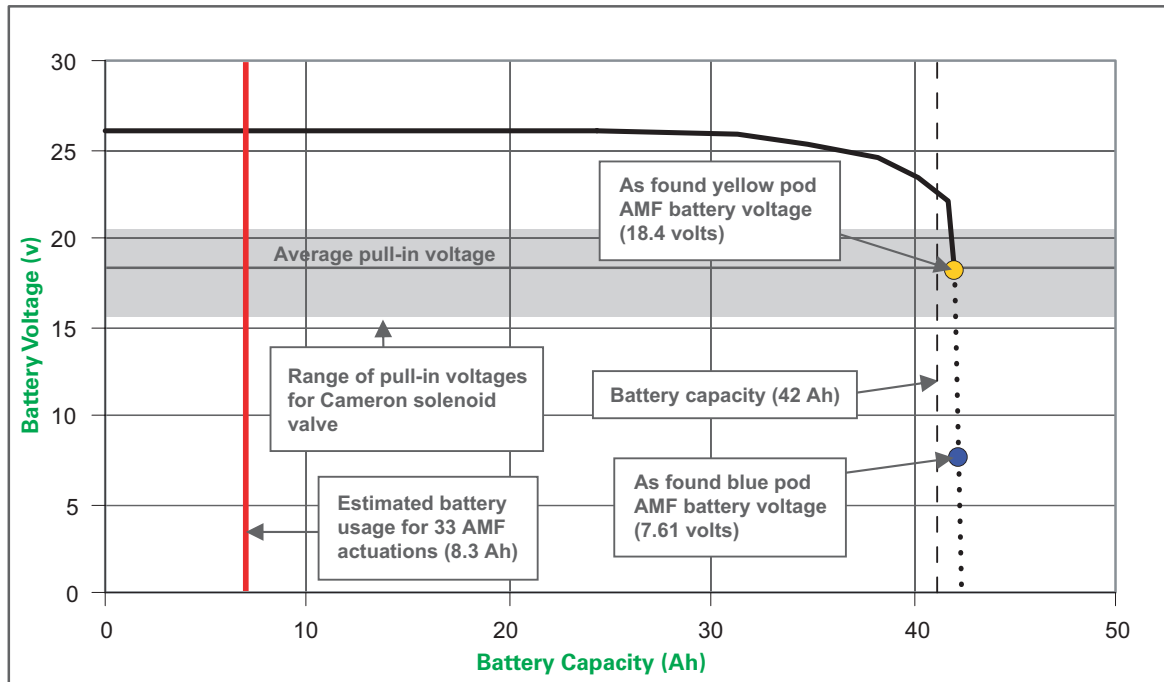
Figure 9. Discharge Curve for a 27-volt AMF Battery Bank.

In 2004, Cameron, the BOP manufacturer, issued an engineering bulletin, *EB 891D*, recommending that battery banks be replaced after one year of operation or when the number of actuations exceeds 33 for that year, whichever comes first. The discharge curve for a 27-volt battery bank indicates that after 33 actuations, the battery bank would have expended only 20% of its expected life, as measured in ampere hours (Ah). The measured charge of 7.61 volts on the 27-volt battery bank was past the expected annual usage and was beyond the design life of the battery bank. (Refer to Figure 9 and *Appendix X. Deepwater Horizon Blue Pod AMF System Batteries.*)

The investigation team considers that it is very likely that the charge at the time of the accident would have been insufficient to activate the AMF.

The available maintenance records from 2001 to 2010 indicate that during this period, the AMF batteries were changed at a frequency less than the manufacturer's recommendation. The BOP control diagnostic functionality did not include measuring the charge on the AMF batteries. Transocean maintenance records for AMF batteries are discussed in 5.1 of this analysis.

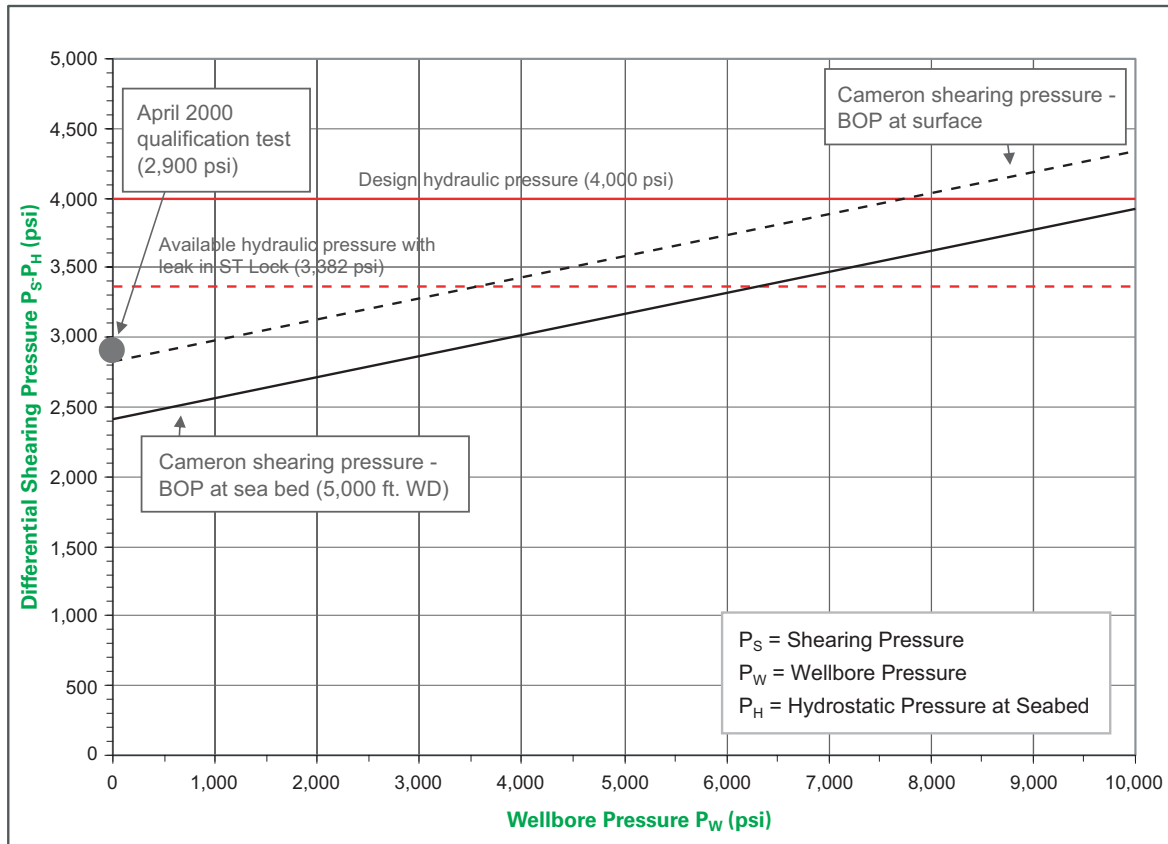
Figure 10. Shear Pressure Requirement for 5 1/2 in., 21.9 ppf, S-135 Drill Pipe.

Based on Cameron's shearing formula (*EB 702D, Revision B9*, dated January 21, 2008), the hydraulic pressure required to shear 5 1/2 in., 21.9 ppf, S-135 pipe at the surface is estimated as 2,840 psi. Cameron's shearing formula is plotted in *Figure 10* for varying wellbore pressures for a BOP at the surface (dashed black line) and a BOP at 5,000 ft. WD (solid black line). Shearing pressure is represented with respect to hydrostatic pressure at the sea bed. This formula takes into account the statistical variance in pipe wall thickness, material yield strength and ductility. A qualification test of *Deepwater Horizon* BOP BSRs was conducted at the surface in April 2000, when a joint of 5 1/2 in., 21.9 ppf, S-135 drill pipe was successfully sheared at a shearing pressure of 2,900 psi, which is slightly greater than the pressure predicted by Cameron's shearing formula.

It is not expected, therefore, that the increase in wellbore pressure would have been greater than 3,000 psi. *Figure 10* shows that at 4,000 psi design hydraulic pressure, the BSR should have been capable of shearing the 5 1/2 in. pipe. This assumes that there was no reduction in the available hydraulic pressure due to leaks or loss of BOP stack accumulator nitrogen pre-charge pressure.

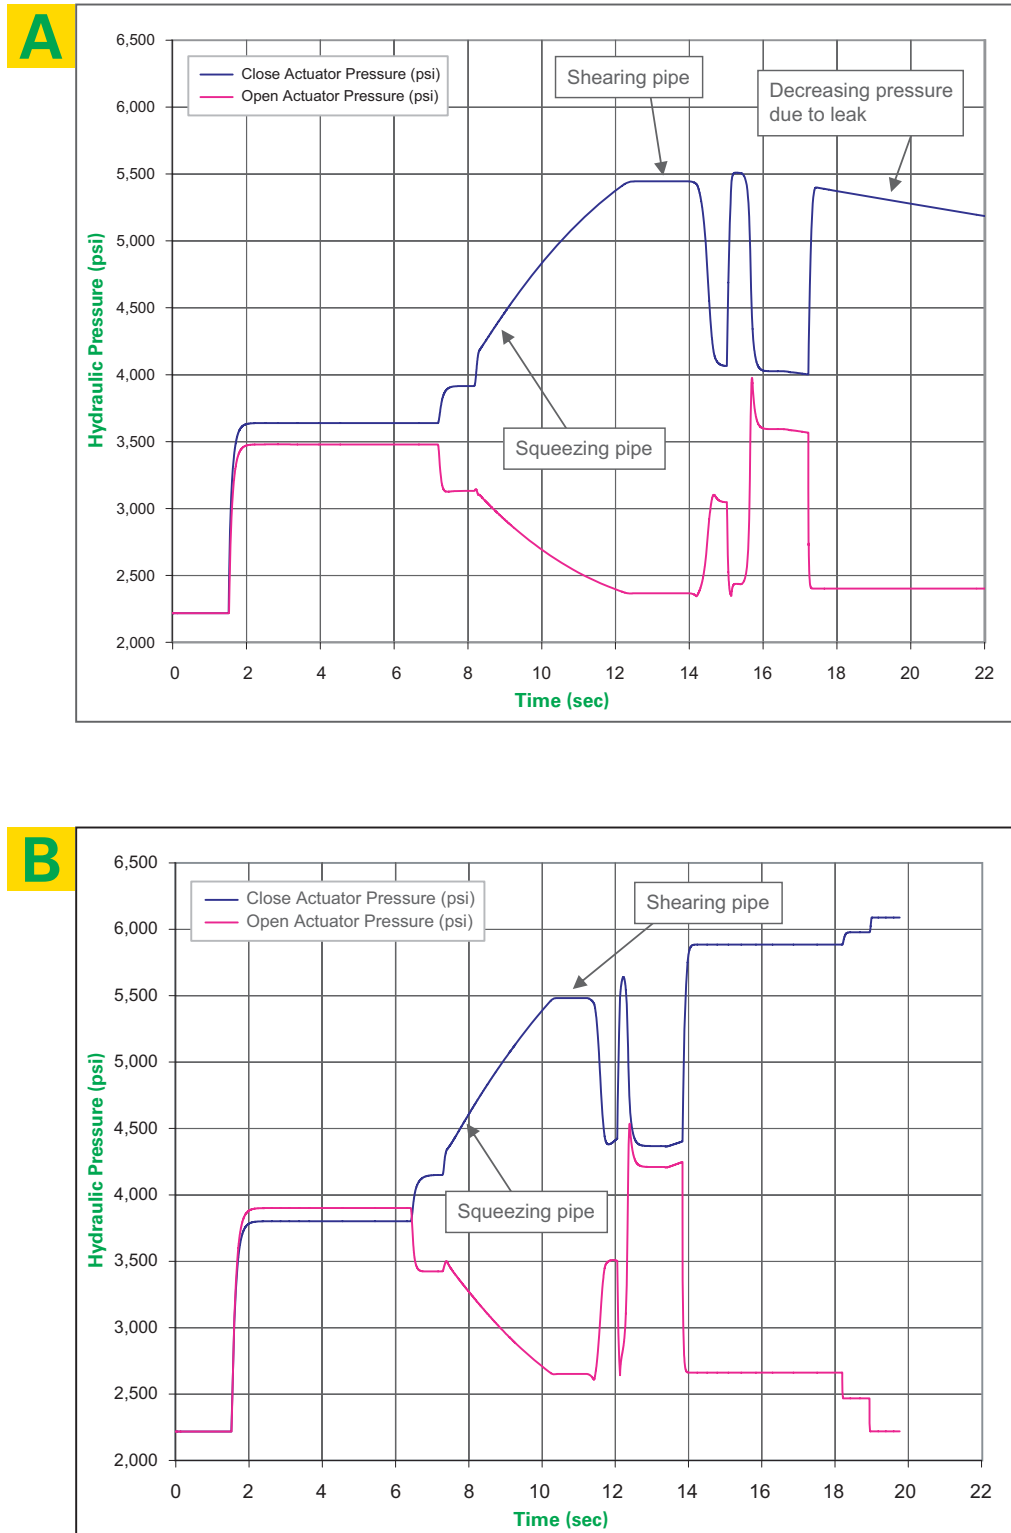
Figure 11. Hydraulic Analyses of BSR Closure Response (at a Wellbore Pressure of 3,000 psi and 5,000 ft. WD) **(A)** With and **(B)** Without a Leak in the ST Lock Hydraulic Circuit. (All pressures include hydrostatic head at the sea bed.)

Figure 11 shows the responses of the BSR with and without a leak in the ST lock hydraulic circuit. The analysis assumes a pipe shearing pressure derived using Cameron's formula for 5 1/2 in., 21.9 ppf, S-135 pipe at a wellbore pressure of 3,000 psi. *Figure 11(B)* illustrates that without a leak, there was sufficient pressure to shear and seal the drill pipe. In comparing *Figure 11(A)* and *Figure 11(B)*, the impact of a leak is seen to increase the time it takes to build up hydraulic pressure in the actuator to be able to shear the pipe (12.5 seconds versus 10.5 seconds). However, even with the presence of the leak, sufficient hydraulic pressure was achieved to complete the shearing operation. With the leak, the overall shearing operation would have taken 17 seconds to complete, whereas without a leak, shearing operations would have finished in 14 seconds.

The impact of the second leak on the BSR ST-lock circuit, potentially within an ST-lock sequence valve, could not be fully investigated without access to the BOP. (Refer to 5.2 of this analysis for further discussion of all leaks of which BP is aware.)

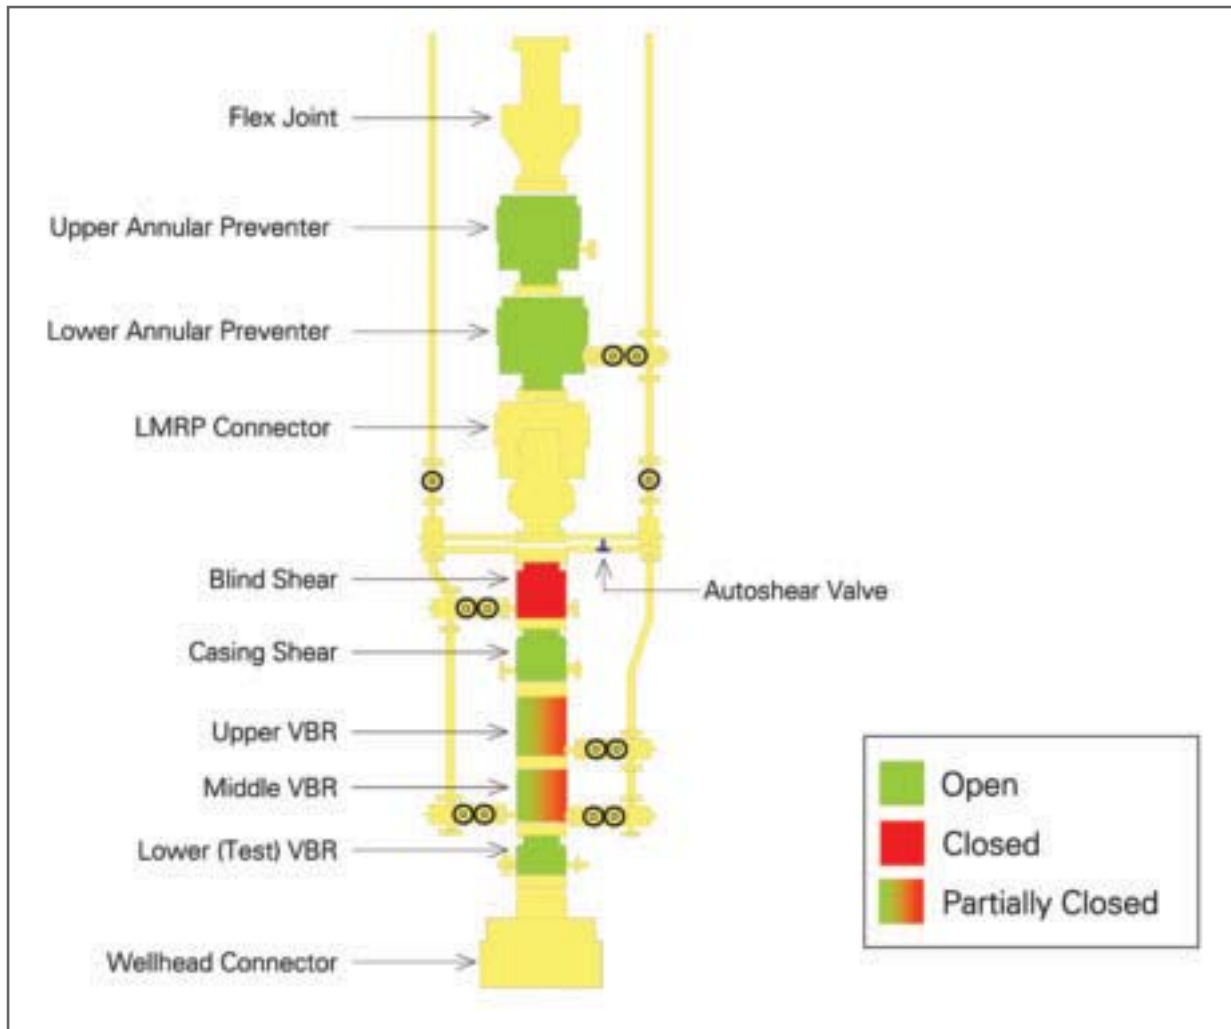
Figure 13. Likely Status of BOP Rams Immediately After Autoshear Initiation.

Based on these findings, the investigation team concluded that the upper, and possibly the middle, VBRs were likely closed by the rig crew.

Figure 13 shows the likely status of the BOP rams immediately after the initiation of autoshear.

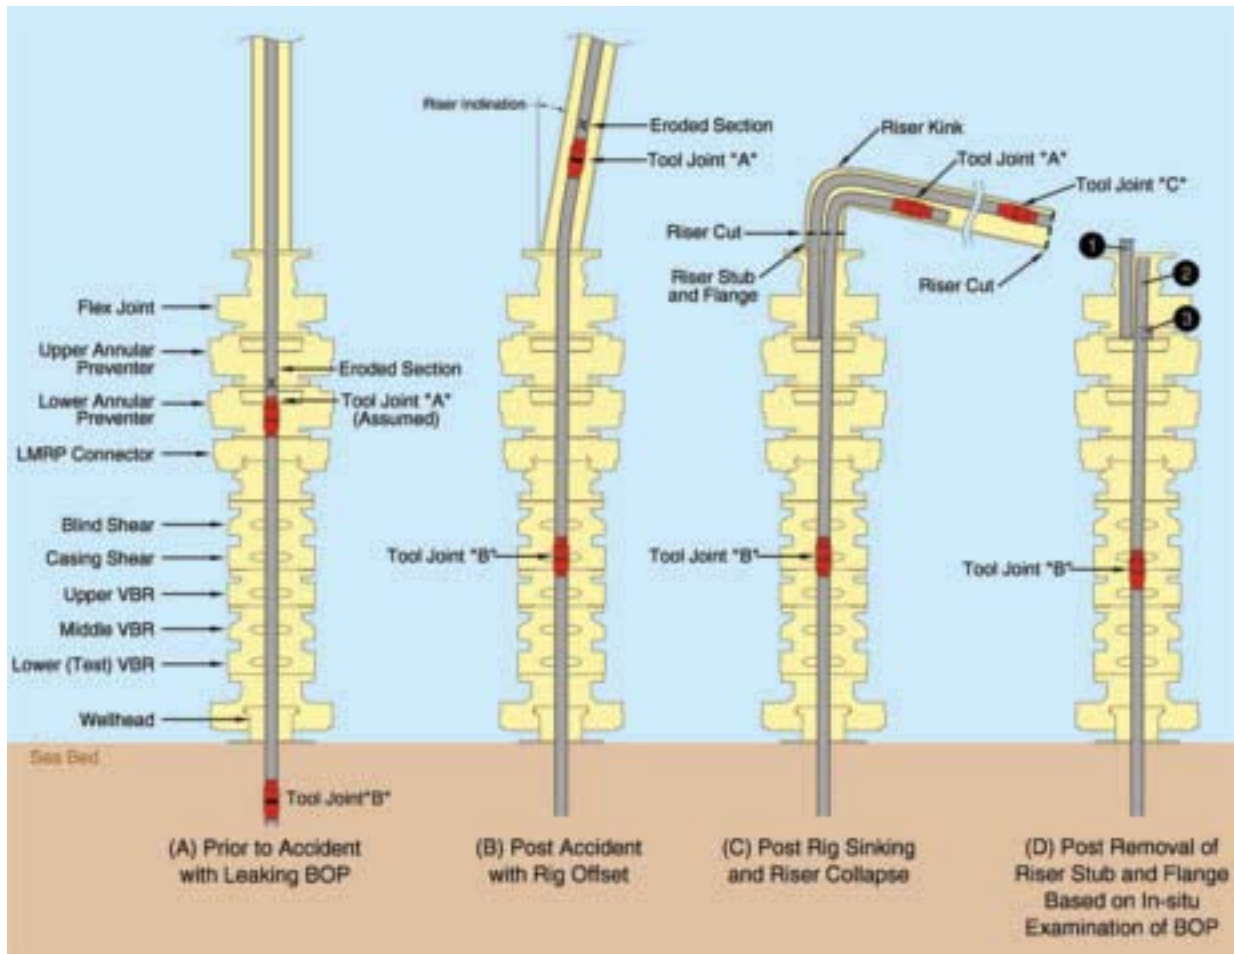
Figure 15. A Schematic of Drill Pipe Configuration Across the BOP Over Time.

The investigation team determined that this erosion may have occurred when the section of pipe was in the BOP, where it experienced extremely high flow velocities during the leaking of a ram or annular preventer, indicating that this section of drill pipe was continuous through the BOP. The approximately 22 in. long erosion zone could suggest that the erosion event took place in an annular preventer.

Assuming the erosion took place at the lower annular preventer, the right-hand pipe must have moved by approximately 25 ft. This could have happened as the rig drifted off location after power was lost. (Refer to time period [B] in Figure 15.) The metocean records indicate that the current velocity at sea level at the time of the accident could have been above 0.69 ft./sec. The investigation team did not have access to the vessel's hydrodynamic characteristics in order to perform a drift-off analysis of the rig. However, it is likely that a current of this magnitude would have caused the vessel to drift off after the power was lost at approximately 21:49 hours.

For the drill pipe to have moved upward by 25 ft., the next tool joint down the drill string (Tool Joint "B" in Figure 15 with an outside diameter of 7 in.), would have had to pass through the middle and upper VBRs. This could indicate that the ST locks were not operated when the rig crew likely attempted to close the VBRs, and the rams allowed the pipe to move upward through the BOP.

The drill pipe likely broke off at the eroded section while moving upward through the BOP. There are eyewitness accounts stating that the top drive fell onto the rig floor (by approximately 26 ft.), possibly due to the failure of the draw works during rig evacuation. The drill pipe likely had already failed at the eroded section by this time, as it was being pulled upwards due to increasing vessel offset. It is therefore inconclusive whether downward movement of the top drive would have imposed any load on the closed VBR.
