Deepwater Horizon Accident Investigation Report

September 8, 2010

This is the report of an internal BP incident investigation team. The report does not represent the views of any individual or entity other than the investigation team. The investigation team has produced the report exclusively for and at the request of BP in accordance with its Terms of Reference, and any decision to release the report publicly is the responsibility of BP. It has not been prepared in response to any third party investigation, inquiry or litigation.

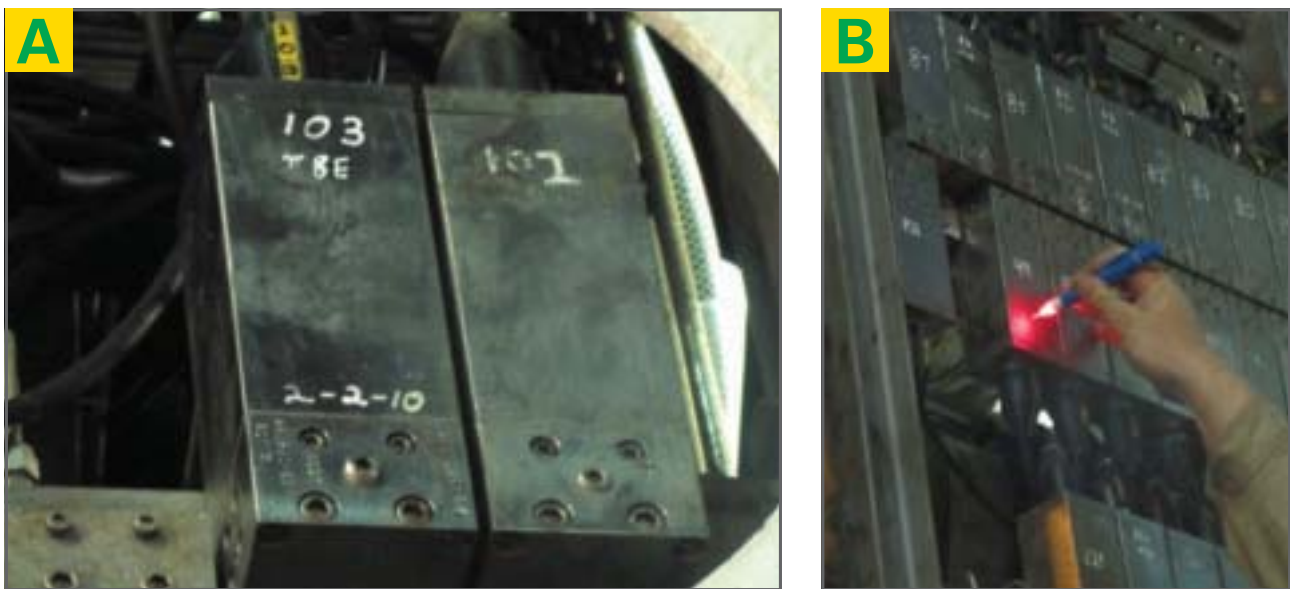
Figure 16. (A) Photograph of Solenoid Valve 103 in the Yellow Pod. **(B)** Testing of Solenoid Coils.

- Solenoid valve 103 in the yellow pod, which was required to operate the high-pressure BSR close function, was found to be defective. (Refer to Figure 16.) This solenoid valve also had a non-OEM electrical connector installed.
- Solenoid valve 3A in the yellow pod, which was required to increase the upper annular preventer regulator pressure, was also found to be defective.

- The investigation team considers that even if the yellow pod batteries had sufficient charge, the status of the solenoid valve 103 would have prohibited the closure of the BSR from the yellow pod.

The control system was capable of identifying the coil defects in solenoid valves 103 and 3A in the yellow pod and logging them in the event logger. A failure mode effects and criticality analysis (FMECA) performed as part of a BOP assurance analysis of *Deepwater Horizon* BOP stack identified this failure mode. As stated in the FMECA report, when this failure is detected, the mitigation is "Switch to alternate pod, secure well and pull LMRP."

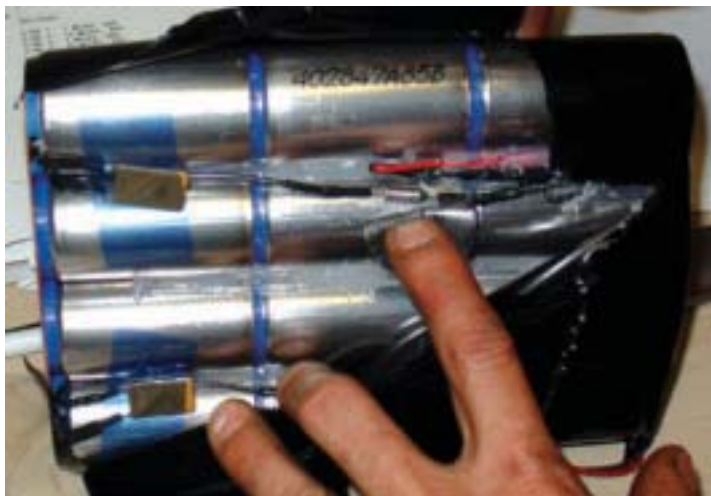
Figure 17. Photograph of a 9-volt AMF Battery Pack.
(Not from *Deepwater Horizon* BOP pod.)

- The 27-volt AMF battery bank in the yellow pod (made up of three packs of 9-volt batteries), which was required to operate the AMF, had a charge of 18.41 volts. (Refer to Figure 17.) The battery bank discharge curve indicates that the battery bank voltage was already in rapid decline. (Refer to Figure 9.) While this charge was low, it was sufficient to complete the AMF sequence multiple times during tests conducted at the surface. During the August 23-27, 2010, MBI hearings, a subsea superintendent stated that the battery bank voltages were measured incorrectly (i.e., the 18.41-volt measurement) and that, prior to re-installing the yellow pod after it was retrieved, the voltages were rechecked and a battery bank voltage of 27 volts was measured.

- The 27-volt AMF battery bank in the blue pod, which was required to operate the AMF, was reported to have a charge of 7.61 volts, which was too low to complete the AMF sequence. The investigation team could not determine from the available maintenance records exactly when the batteries were last replaced.
- The charge on the 9-volt AMF battery pack for SEM B in the blue pod, which was required to power the SEM B AMF system, was reportedly measured to be at 0.142 volts (i.e., almost fully discharged).

The charge level of the batteries for the AMF sequence could not have been monitored on the surface while the BOP was deployed subsea. If the battery voltage was not checked on the surface prior to the BOP deployment, there would have been no means of determining the charge on the batteries once the BOP was deployed.

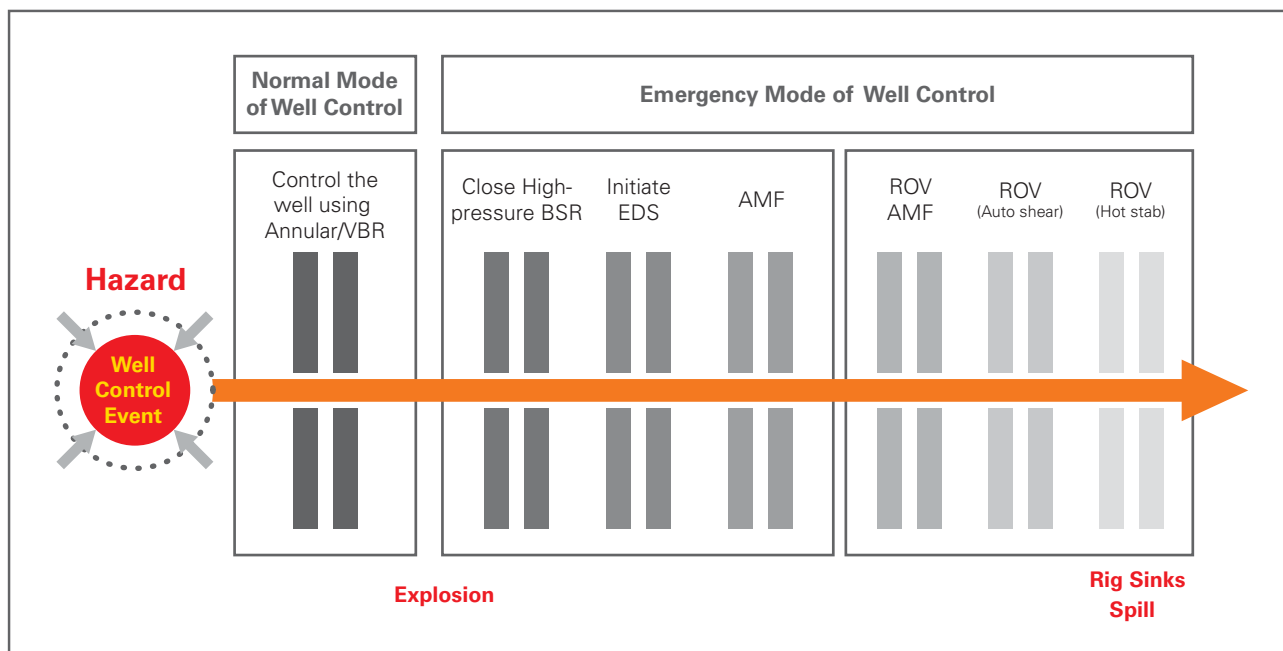
Figure 20. BOP Well Control Modes of Operation.

There were six possible methods of closing the BSR in emergency mode that pertain to this accident (refer to Figure 20):

- **EDS function (crew-initiated):** initiated by rig personnel from a control panel on the rig. EDS was primarily designed to mitigate the risk of losing containment as a result of the dynamic positioning system not being able to keep the rig on station. This function also requires at least one operational control pod and associated MUX cable. The sequence activates the high-pressure BSR. All three sets of accumulators provided hydraulic power for this activation of the high-pressure BSR. Witness accounts indicated that the subsea supervisor initiated this function from the TCP, but it would have been unsuccessful because the MUX cables had already been rendered inoperable due to the explosions and fire.

- **AMF:** an automatic means of closing the high-pressure BSR when electrical power, electronic communication and hydraulic pressure are all lost. AMF is designed to mitigate the risk caused as a result of catastrophic failure of the riser with the resultant reduction of hydrostatic head of mud in the riser to seawater hydrostatic head. This function had to be manually armed by rig personnel from the BOP control panel and required at least one operational control pod. The accumulators on the BOP stack were the only source of hydraulic power for this function. The investigation team concluded that the AMF very likely did not function due to the condition of critical components in the control pods.

- **ROV-initiated AMF:** a simulation of AMF conditions to close the high-pressure BSR by using an ROV to cut power/communication and hydraulic lines at the LMRP. This was attempted hours before the rig sank, but the investigation team concluded that the AMF very likely did not function due to the condition of critical components in the control pods.

The rig crew attempted the normal mode of BOP system operation (using an annular preventer and possibly a VBR) prior to the accident. The emergency mode of well control shown in *Figure 20* relates to the period after the accident, but only the ROV hot stab intervention continued after the rig sank.
